# Geophysical Investigation into the Cause(S) of Structural Failure within Bacosa and Faculty of Science Buildings, Bowen University Temporary Site, Iwo

Cracks on concrete and walls could be bothersome for quality of life and for property claims. Geophysical investigations was carried out around Faculty of Science and BACOSA buildings of Bowen University Temporary site, Iwo with a view to establish the possible cause(s) of failure of buildings within the study area.

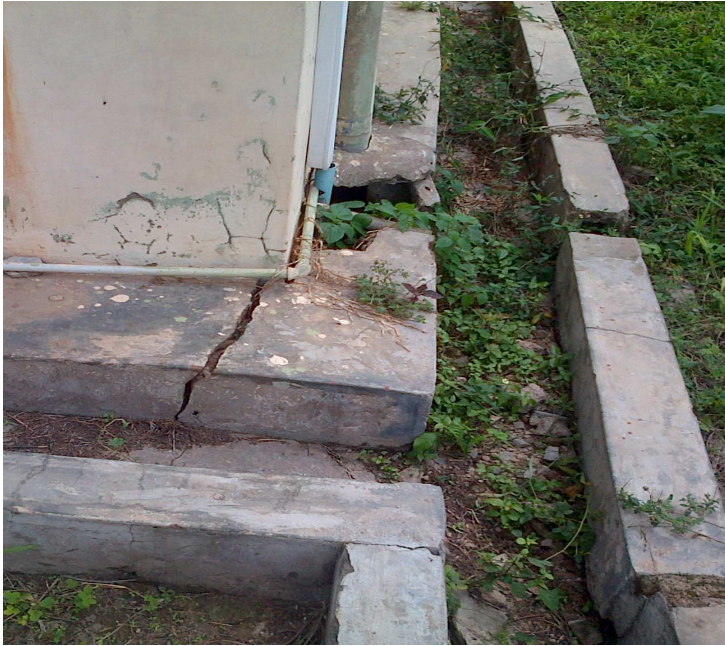
Figure 1: Distressed Building in the Study area Showing Cracks on the wall of BACOSA building

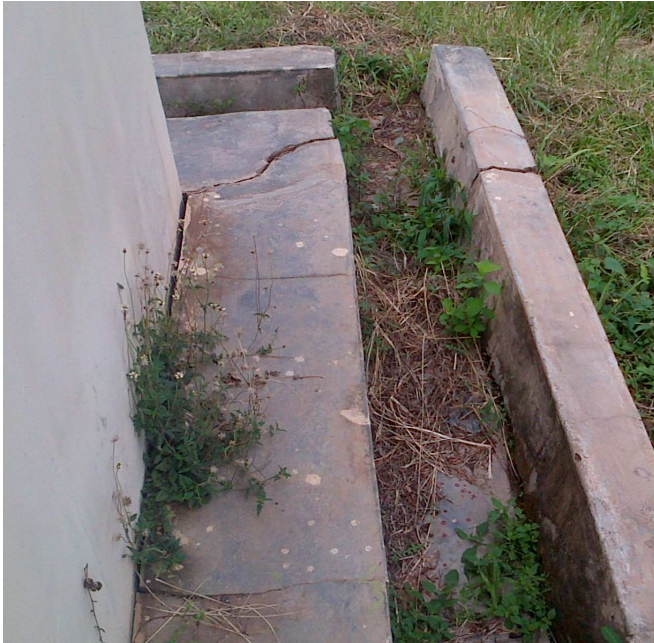
Figure 2: Distressed Building in the Study area Showing Cracks on the wall of BACOSA Extension I

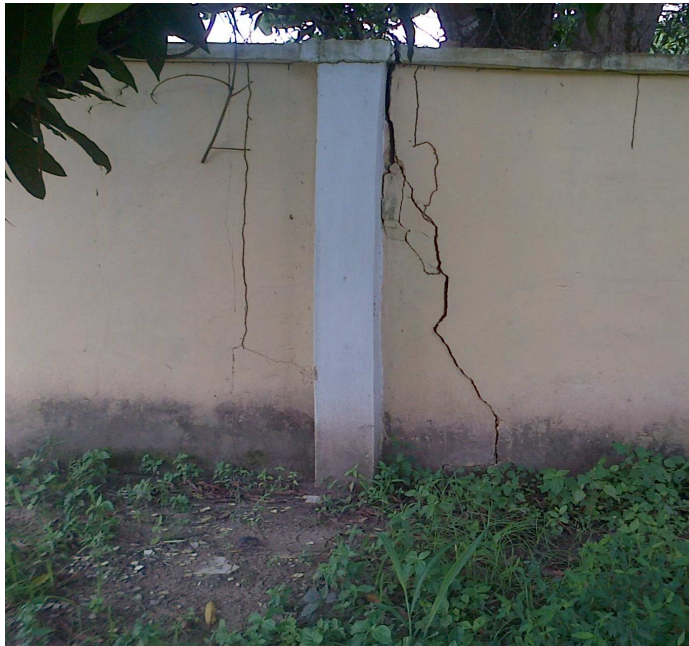
**Figure 3:** Distressed Building in the Study area Showing Cracks on the wall of a fence behind BACOSA Extension I

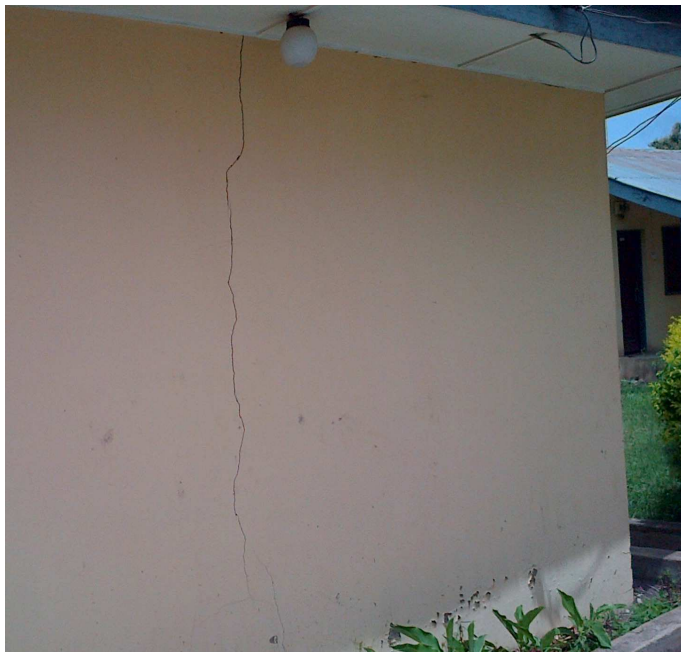
**Figure 4:** Distressed Building in the Study area Showing Cracks on the wall of BACOSA Extension II

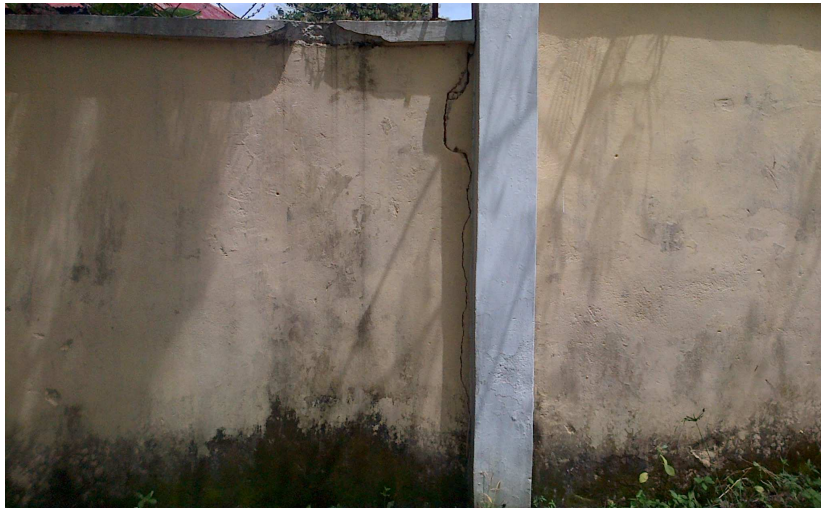
**Figure 5:** Distressed Building in the Study area Showing Cracks on the wall of fence behind MICOM Lab.

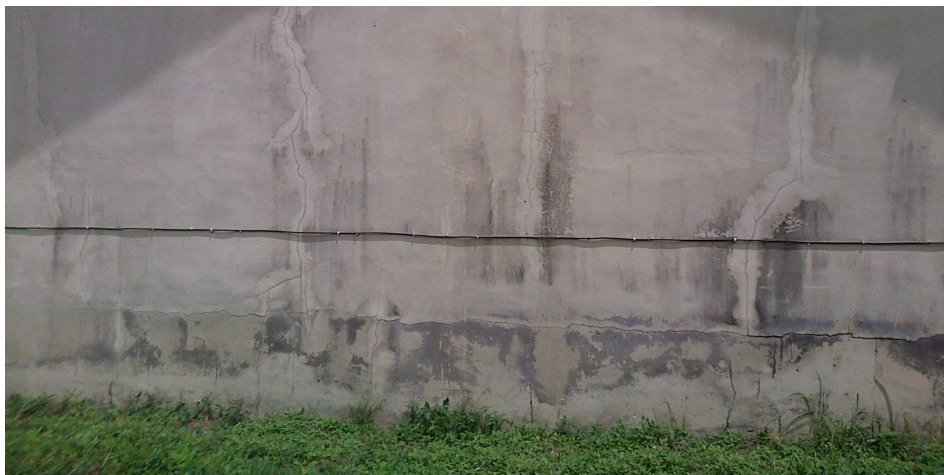
**Figure 6:** Distressed Building in the Study area Showing Cracks on the wall of General Lab

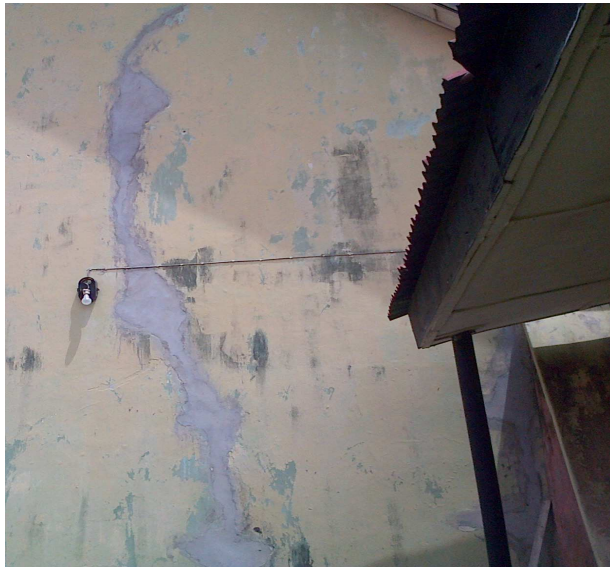
**Figure 7:** Distressed Building in the Study area Showing Cracks on the wall of 200Level Physics Lab.

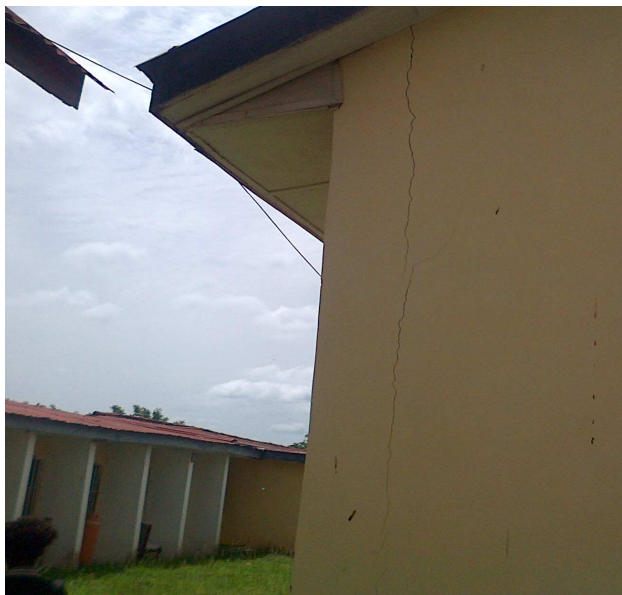
**Figure 8:** Distressed Building in the Study area Showing Cracks on the wall of Faculty of Science building

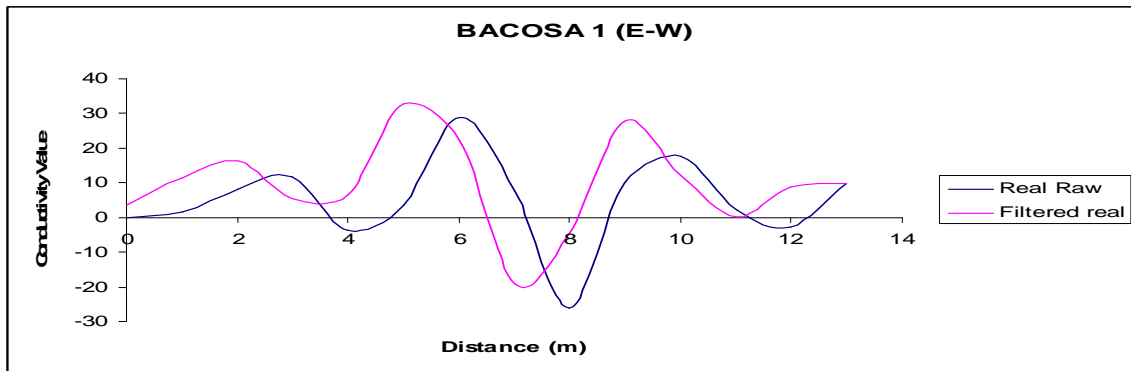
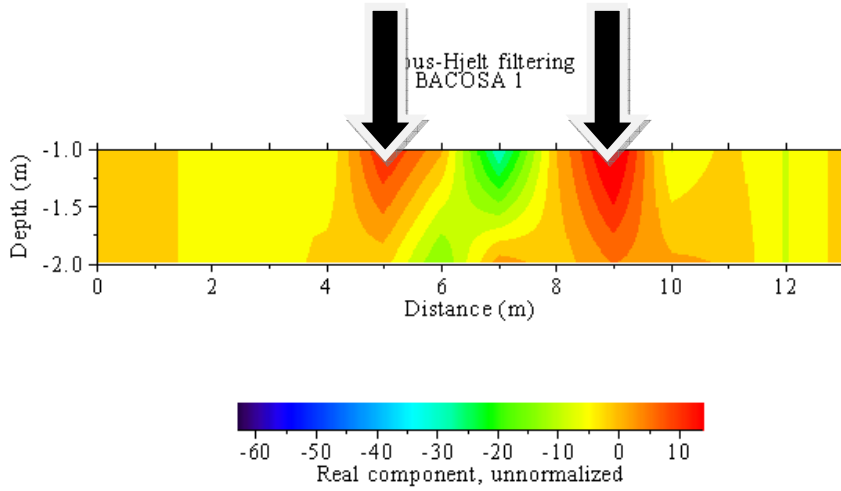
Figure 10a: Raw and Filtered real profile along BACOSA 1

Figure 10a shows the raw and filtered real profile along BACOSA 1. Three positive peaks mapped as fractures, joints, contacts, or faults at distances between 10-30m, 40-65m and 82-110m on the filtered real are shown with two well pronounced positive peaks at distances between 40-65m and 82-110m. These are zones of interest in fault and fracture detection in basement terrain. Figure 10b shows the corresponding K-H pseudosection on the profile. The pseudosection is a measure of conductivity of the subsurface as a function of depth. The conductivity is shown as colour codes with the zones of high conductivity coded with red colour. Different features of varying degree of conductivity were delineated on the profile with two highly conductive zones clearly revealed (Red colour). Several other closures of conductive bodies represented with colour codes are present on the section with each conductive body coinciding with the points already identified on the profile as fractures and joints.

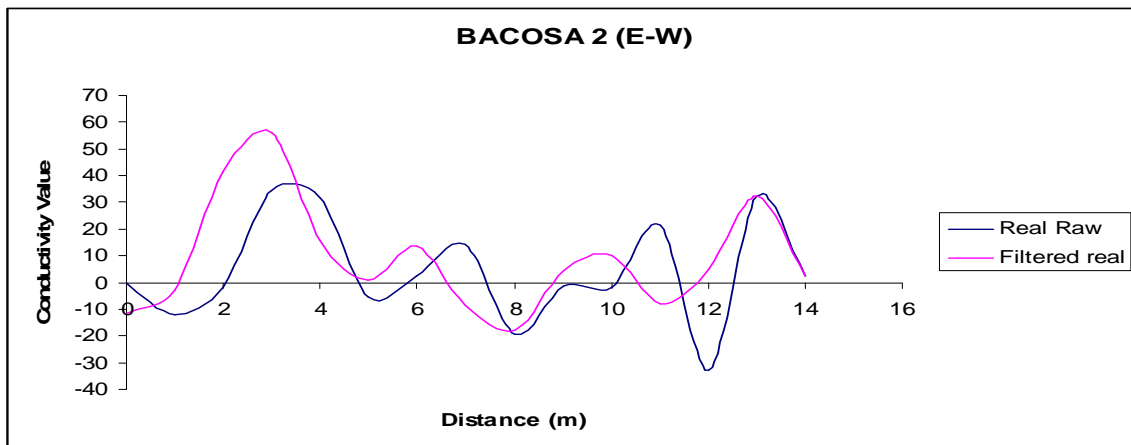
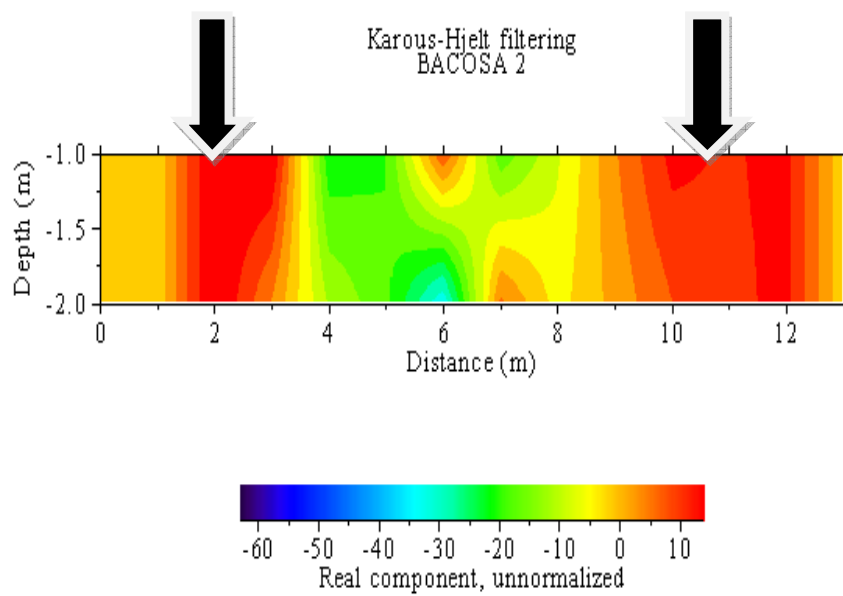
Figure 11a: Raw and Filtered real profile along BACOSA 2

Figure 11a, also shows the raw and filtered real profile along BACOSA 2. Four positive peaks which were zones of interest are again mapped as fractures, joints, contacts, or faults at distances between 10-40m, 60-70m, 90-105m and 130-140m on the filtered real as shown with two well pronounced positive peaks at distances between 40-65m and 85-110m. Figure 11b shows the corresponding K-H pseudosection on the profile with two very distinct zones of high conductivity (red colour coded).

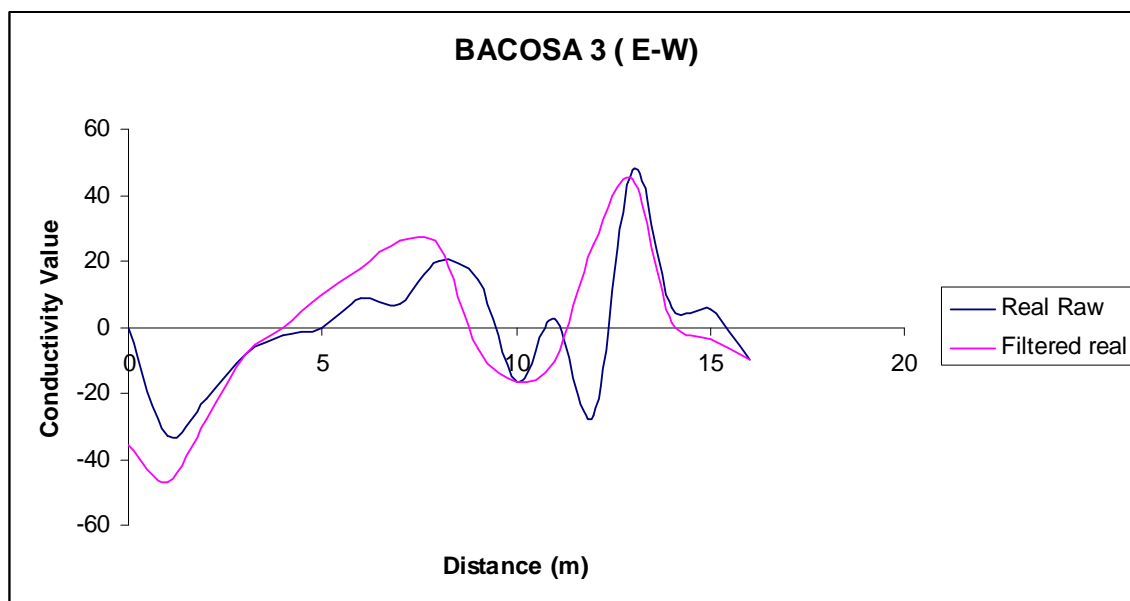
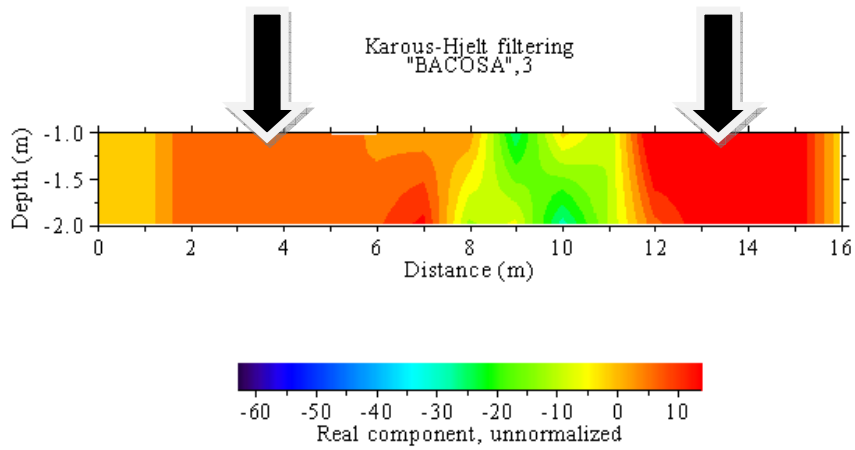
**Figure 12a:** Raw and Filtered real profile along BACOSA 3

Figure 12a, also shows the raw and filtered real profile along BACOSA 3. Two pronounced positive peaks were observed and mapped as possible fractures, joints, contacts, or faults zones at distances between 40-90m and 110-140m on the filtered real. Figure 12b shows the corresponding K-H pseudosection on the profile with the two zones of high conductivity (red colour coded).

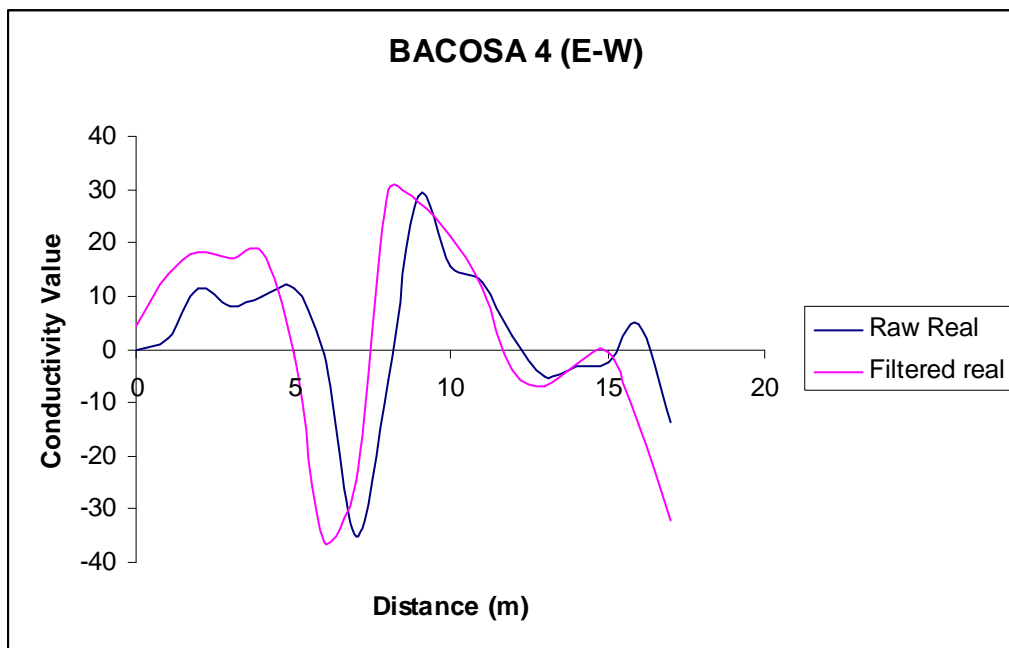
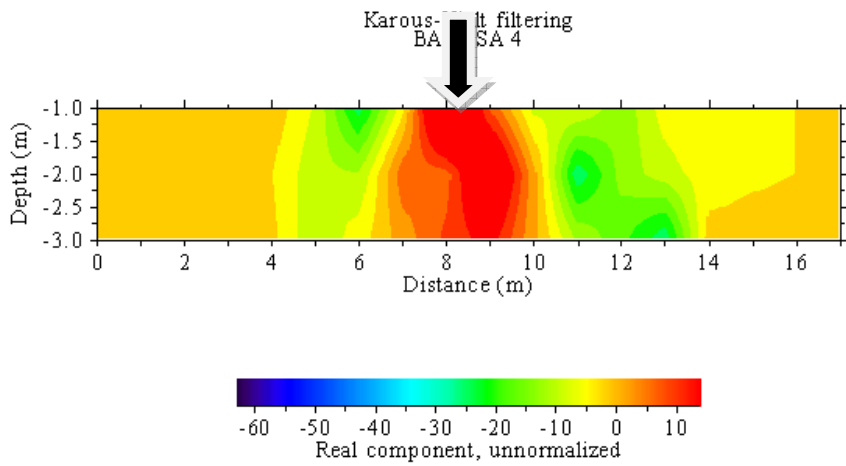
**Figure 13a:** Raw and Filtered real profile along BACOSA 3

Figure 13a, depicted the raw and filtered real profile along BACOSA 4. Two positive peaks were observed with only one very pronounced at a distance between 70-120m which serves as point of interest. Figure 13b equally shows the corresponding K-H pseudosection on the profile with only one point of high conductivity (red colour coded).

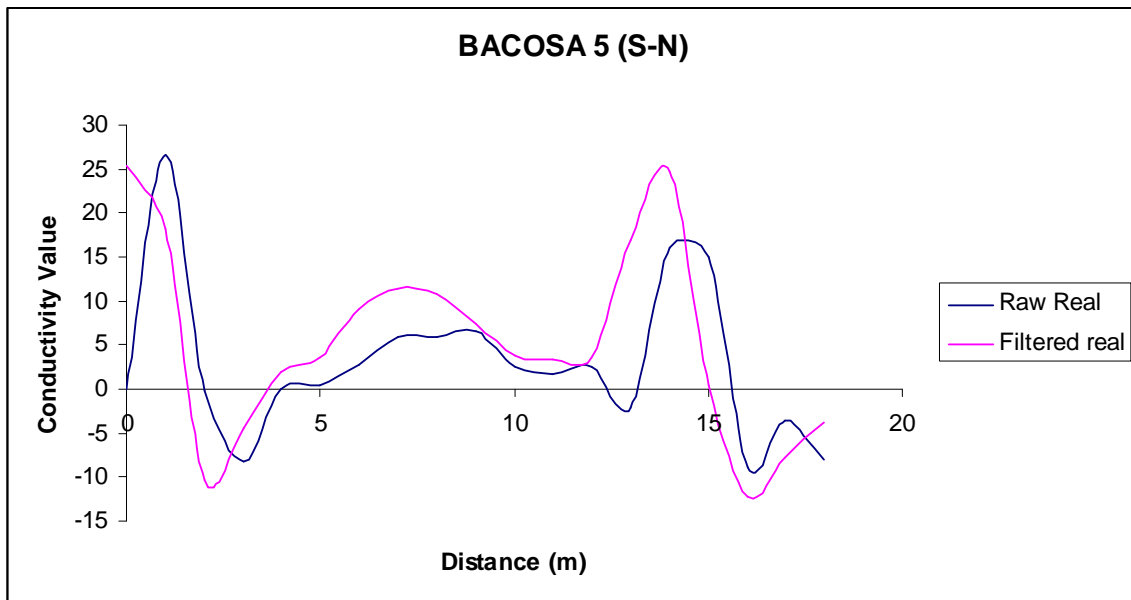
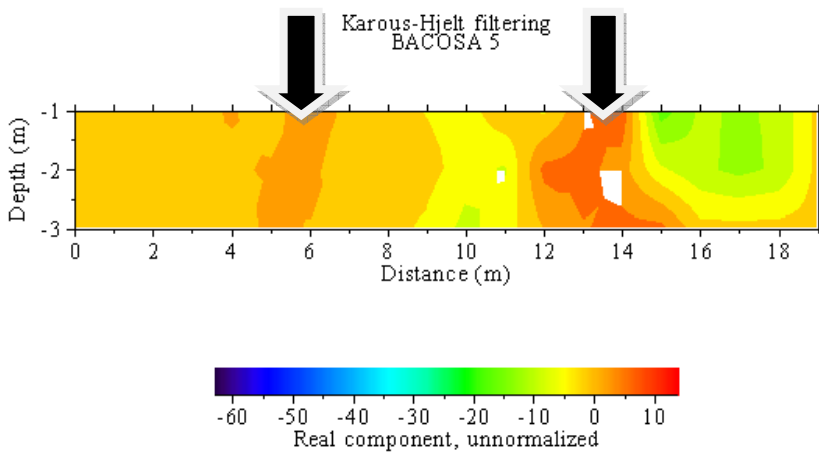
**Figure 14a:** Raw and Filtered real profile along BACOSA 5

Figure 14a, also shows the raw and filtered real profile along BACOSA 5. Two pronounced positive peaks were observed and mapped as possible fractures, joints, contacts, or faults zones at distances between 40-100m and 120-150m on the filtered real, but only one at distance 120-150m is well revealed as this could be observed on the corresponding K-H pseudosection (Figure 14b).

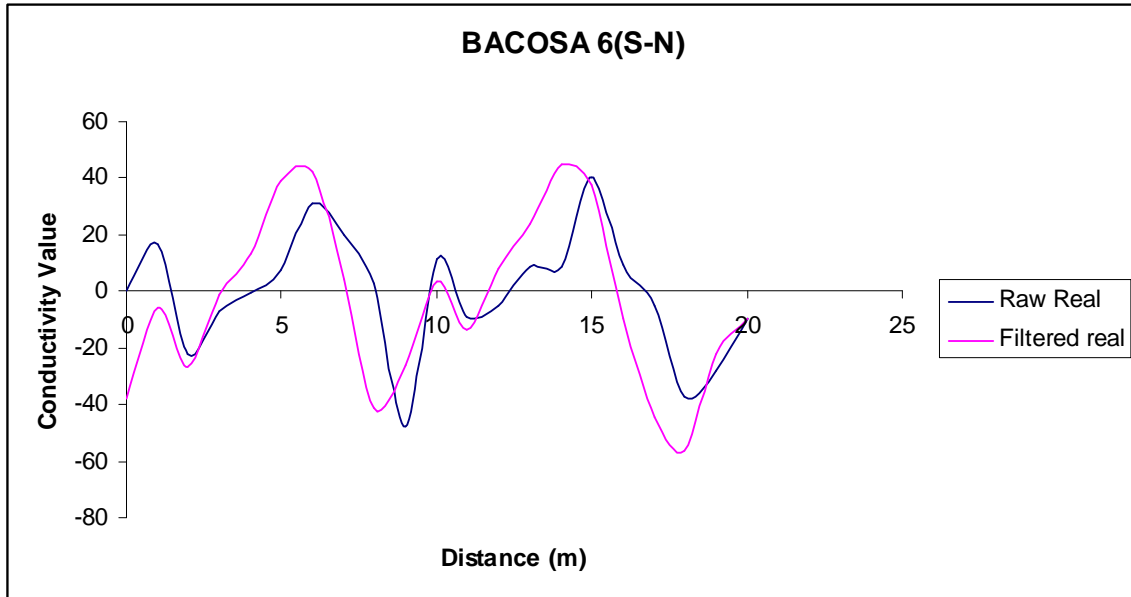
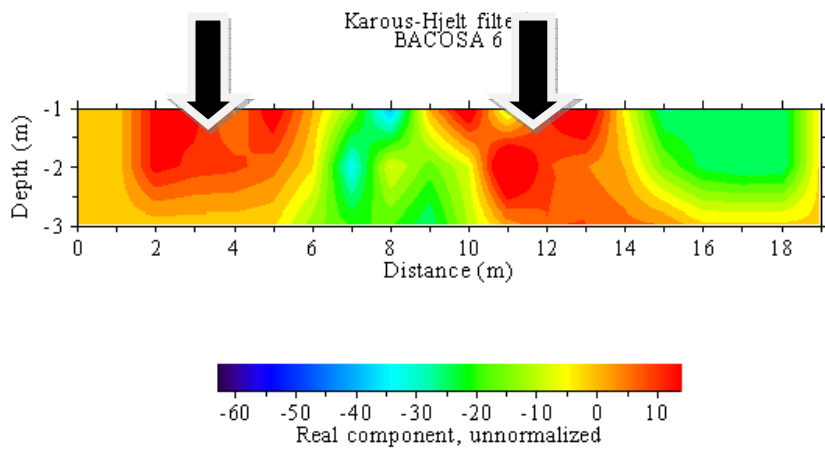
**Figure 15a:** Raw and Filtered real profile along BACOSA 6

Observed on Figure 15b is the raw and filtered real profile along BACOSA 6. Three positive peaks mapped as zones of interest at distances between 0-20m, 40-70m and 110-155m on the filtered real as shown with two well pronounced positive peaks at distances between 40-70m and 110-155m. Figure 15b shows the corresponding K-H pseudosection on the profile with two highly conductive zones clearly revealed (Red colour).
