# Non-Destructive Testing Techniques for Corrosion Assessment in Reinforced Concrete Structures in Kenya

Violah J. Salbei<sup>1</sup> Cox M. W. Sitters<sup>2</sup> Prof. John Vantomme<sup>3</sup>

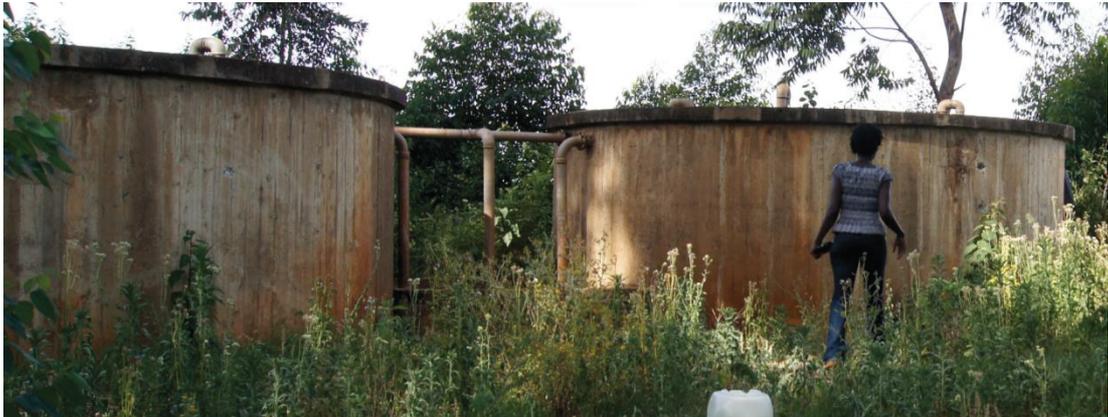
Figure 2: Twin water tanks

Half-cell potential measurements for the twin tanks were on average -100 indicating that the tanks are in a passive corrosion state. Nevertheless, chloride samples were collected to verify the presence of chloride in the concrete. From the analyzed chloride samples at the given depths, the chloride content was on average 0.016 expressed as a percentage by weight of concrete for all the drilled depths. This clearly indicates that there is no chloride external source in the environment; chloride contamination could have been the result of the use of additives in the concrete mix, such as retarders. The experimental results also show no carbonation activity.

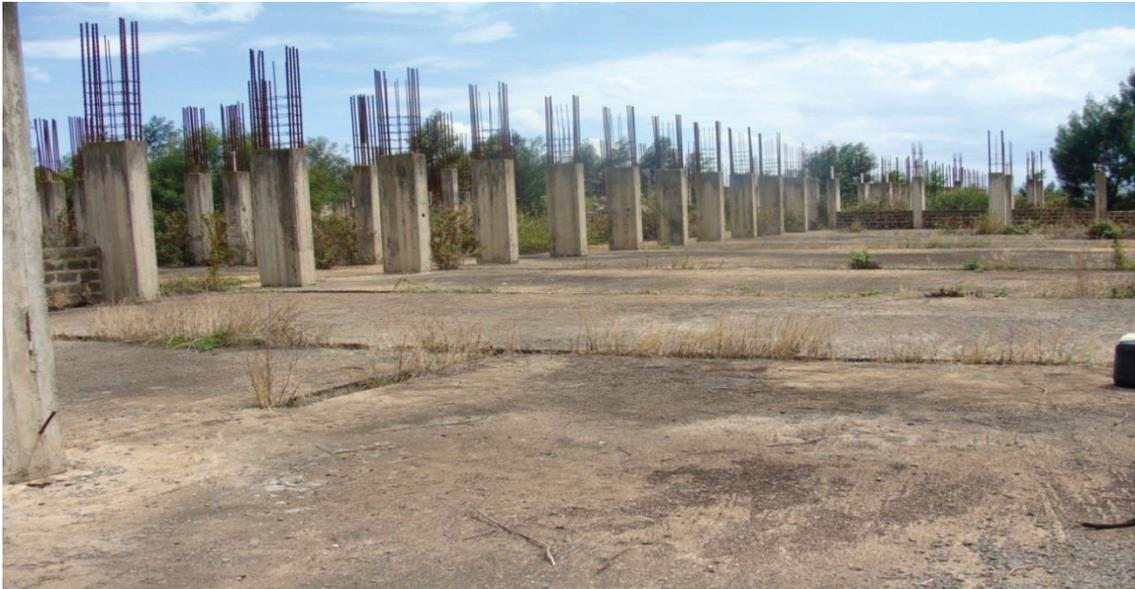
Figure 3: Proposed school f health

The potential values for the proposed school of health were in the range 100 to -500 mV. Active steel corrosion is expected with potential values of -350 mV and below. For this reason, the slabs appeared to be in an active state of corrosion but the chloride content analysis and the carbonation check confirmed that the concrete was still passivated. The high values of the measured potential may be due to high moisture content in the concrete. The chloride content was below the threshold values for steel corrosion to be initiated; the average value was 0.015 similar to that of the tanks. Also the carbonation check indicated that there was no carbonation in the concrete. From the results, it is clear that chloride could have been present from the construction phase and not from an external source.

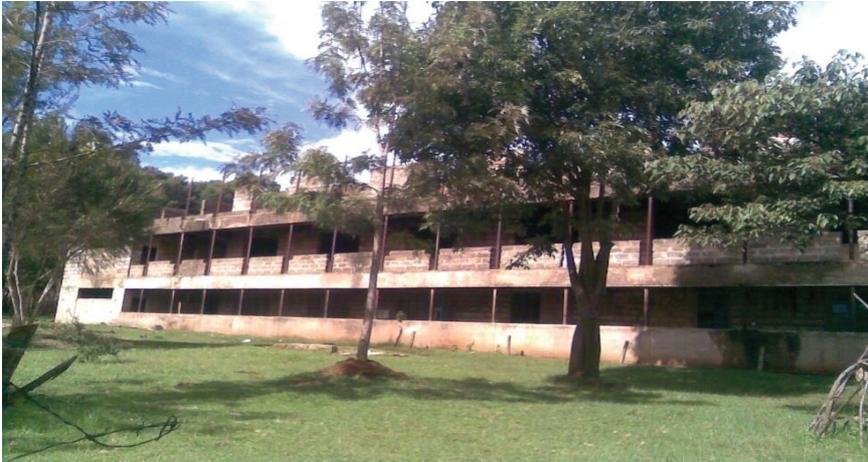
Figure 4: Stalled construction at Kapsuya Secondary (Eldoret)

In the tested structures, neither carbonation nor chloride-induced corrosion was detected but from the background information, carbonation is expected in the inland regions of Kenya whereas chloride ingress is expected in the coastal region due to presence of sea water. To verify carbonation, a structure in Eldoret, Kapsoya Secondary School was tested for carbonation. From the available sources, the structure was built in 1987 but due to financial constraints the construction was stopped. The was a two-storey building and is presented in Figure 4.

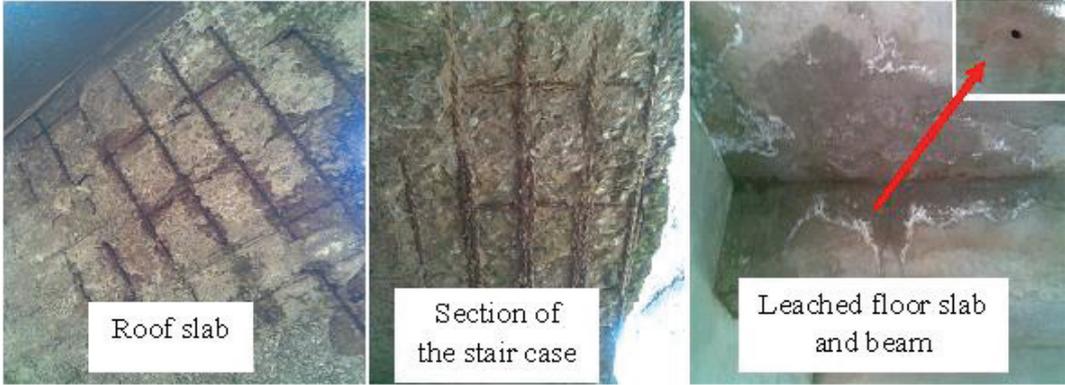
From visual inspection, corrosion of the rebars was evident from the spalled concrete and leaching as seen in Figure 5. A hole was drilled through the beam shown to verify carbonation; the concrete cover was 18 mm and the cover was fully carbonated.

Figure 5: Rebar corrosion of stalled building at Kapsoya Secondary (Eldoret)

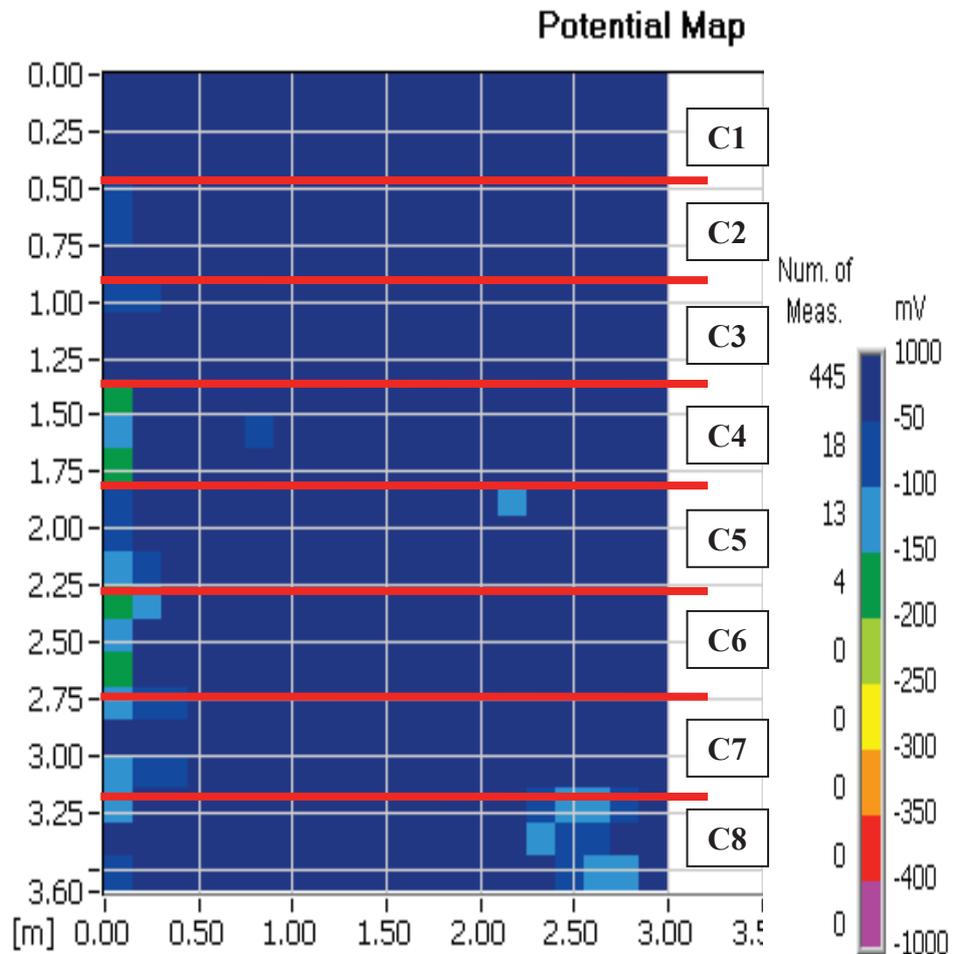
The figure below is a potential map for the eight tested columns C1 to C8
