An Investigation of the Failure of the Hydrogenated Copper Pipes in the Water Supply Systems

Salman Al-Duheisat

Al-Balqa Applied University, Faculty of Engineering Technology, Civil Engineering Dept., P.O. Box 15008,
Amman – Jordan

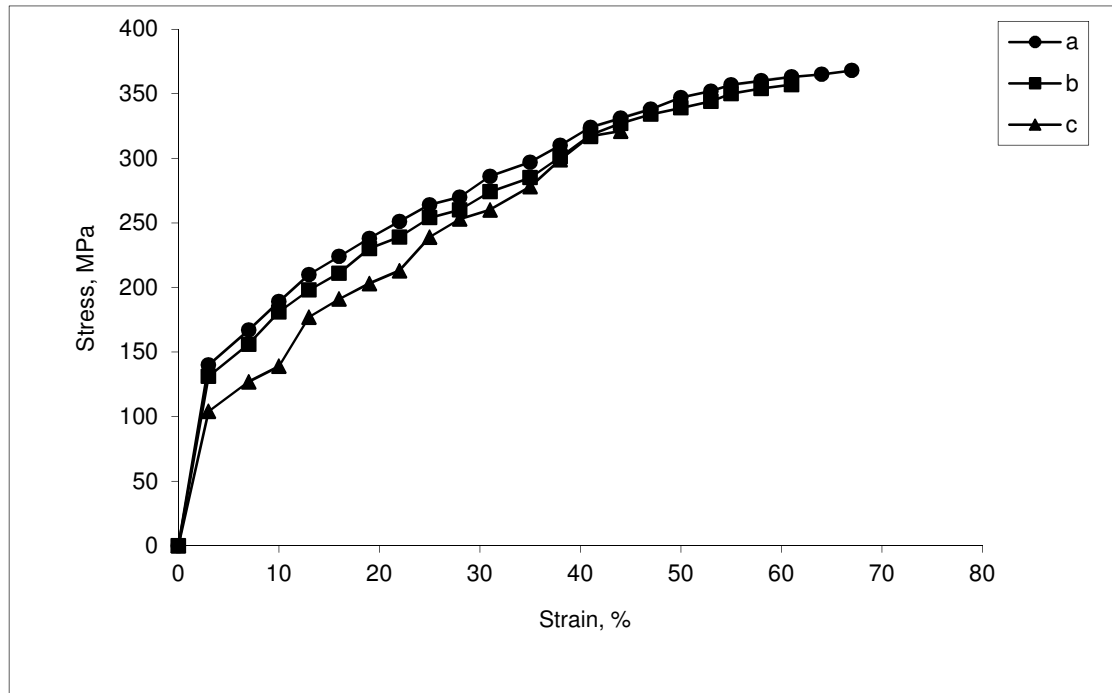
Engineering stress-strain curves of the non-hydrogenated and hydrogenated copper pipe specimens at two current densities are compared in figure 1. The results indicate that the hydrogenation decreases both ultimate tensile strength (UTS) and ductility of the copper specimens. The ultimate tensile strength was decreased by hydrogen from 368 MPa for the non-hydrogenated copper pipe specimen to 357 MPa for the specimen hydrogenated at 15mA.cm⁻² and to 321 MPa for other specimen hydrogenated at 65mA.cm⁻². The loss of the strength observed is probably due to cracking caused by hydrogen on the surface of the copper pipe specimens. Grain boundaries, subgrain boundaries and dislocation pile-ups could act as crack-initiating sites.

The strength and ductility calculated from the engineering stress-strain curves for the non-hydrogenated and hydrogenated copper pipe specimens are summarized in table 1. As can be obtained from this table, the higher the current density applied to the copper pipe specimens, the more decrease in both ultimate tensile strength and elongation to fracture i.e. ductility. Additional experiments were conducted on the copper pipe specimens in order to investigate the effect of hydrogenation time at a fixed current density. The results of these experiments are shown in table 2. These results indicate that the copper pipe specimens hydrogenated for longer time at a fixed current density exhibited more severe decrease in the ultimate tensile strength and ductility than those hydrogenated at different current densities for a fixed hydrogenation time (table 2). These observations may be explained by the fact that the first hydrogenation condition (i.e. for longer time at a fixed current density) allows to hydrogen to diffuse into the copper pipe specimens, while the diffusion of hydrogen during the second hydrogenation condition (i.e. at different current densities for a fixed hydrogenation time) might limit to the surface region.

Figure 1 Engineering stress-strain curves of copper pipe specimens at ambient temperature. (a) Non-hydrogenated copper pipe specimen, (b) Copper pipe specimen hydrogenated at $15\text{mA}\cdot\text{cm}^{-2}$, (c) Copper pipe specimen hydrogenated at $65\text{mA}\cdot\text{cm}^{-2}$ for 24 hrs.

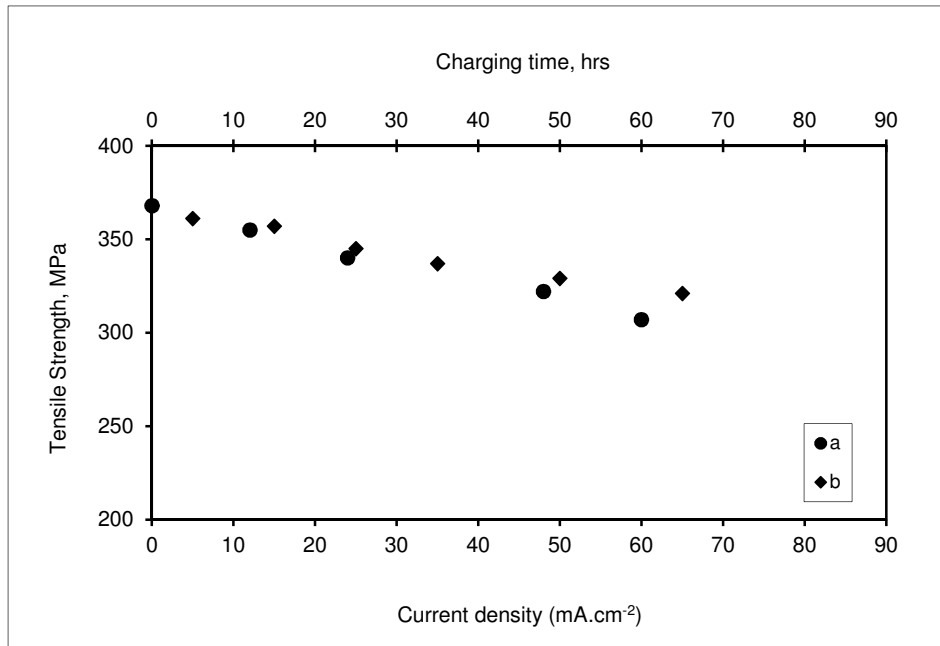
The hydrogenation current density and hydrogenation time versus the tensile strength of the copper pipe specimens are shown in figure 2. As can be seen from this figure, The copper pipe specimens hydrogenated for longer times at a fixed current density show more degradation in the tensile strength than those hydrogenated at higher current densities for a fixed hydrogenation time. This indicates that more hydrogen absorbed during first hydrogenation condition which resulted in lowering the tensile strength of the charged material. The ultimate tensile strength was decreased by hydrogen from 67% for the non-hydrogenated copper pipe specimen to 61% for the hydrogenated pipe specimen at $15\text{mA}\cdot\text{cm}^{-2}$ and to 44% for the hydrogenated pipe specimen at $65\text{mA}\cdot\text{cm}^{-2}$.

Figure 2 Current density and hydrogenation time versus tensile strength of copper pipe specimens.

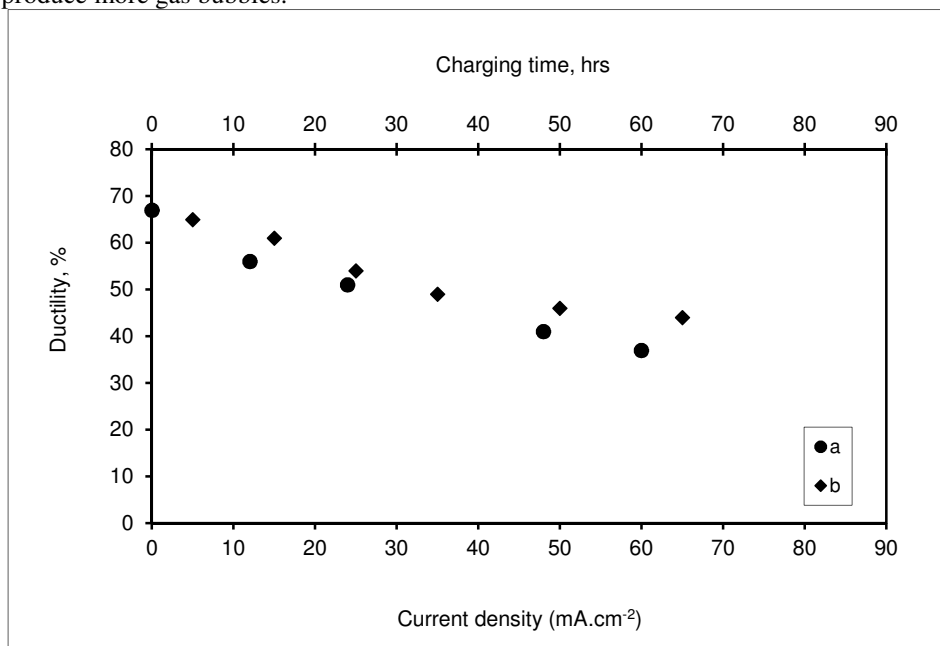
The reduction in ductility may be attributed to the formation of hydrogen gas bubbles during hydrogenation process of the copper pipe specimens. These results were compared with the copper pipe specimens hydrogenated for longer time at a fixed current density. Thus the ductility was decreased from 67% for the non-hydrogenated copper pipe specimen to 56% for the specimen hydrogenated for 12 hours and to 37% for the specimen hydrogenated for 60 hours. The effect of current density and hydrogenation time is shown in figure 3. Similar to the tensile strength degradation observed above, the ductility of the specimens hydrogenated for longer time at a fixed current density exhibited more decrease in ductility than those hydrogenated at a higher current density for a fixed hydrogenation time. This also demonstrates that more hydrogen uptake in the copper pipe specimens hydrogenated at second hydrogenation condition. The more decrease in the ductility observed on the copper pipe specimens hydrogenated for longer time at a fixed current density is believed to be due to fact that higher hydrogen concentrations introduced into copper pipe specimens during this hydrogenation condition which may produce more gas bubbles.

Figure 3 Current density and hydrogenation time versus ductility of copper pipe specimens.

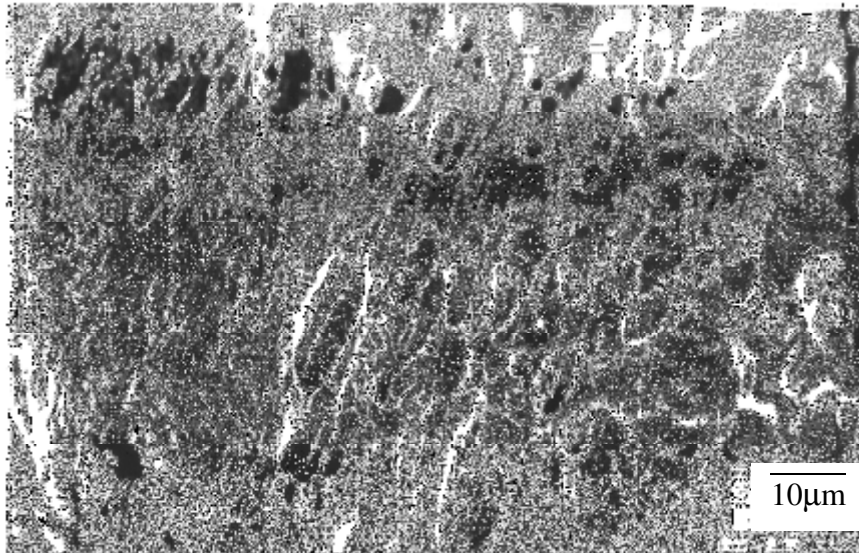
The characteristic of the fracture surfaces of copper pipe tensile specimens also varied with the applied hydrogenation current density. Figure 4 shows the fracture surface of the non-hydrogenated copper pipe specimen and tested in tension. This fractograph shows a dimpled surface typical of microvoid coalescence. It is clearly seen from this fractographs that the non-hydrogenated copper pipe specimen was fractured in completely ductile manner. However, the hydrogenated copper pipe specimens were fractured at different manners. Figures 5 and 6 show the fracture surfaces of copper pipe specimens hydrogenated at $15\text{mA}\cdot\text{cm}^{-2}$ and $65\text{mA}\cdot\text{cm}^{-2}$ current densities respectively and then tested in tension. As can be seen from these figures, the outer areas of the fracture surfaces of hydrogenated copper pipe specimens exhibit brittle fracture, while the inside areas are still ductile.

Figure 4 Fracture surface of the non-hydrogenated copper pipe tensile specimen.

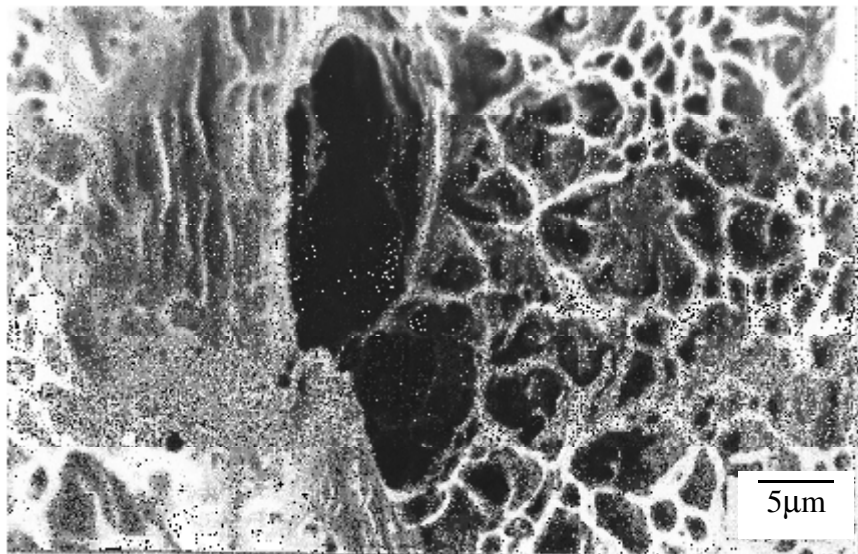
Furthermore, the fracture surface of the specimen hydrogenated at $65\text{mA}\cdot\text{cm}^{-2}$ current density exhibited larger brittle area than that of the hydrogenated at a lower current density of $15\text{mA}\cdot\text{cm}^{-2}$. These results indicate clearly that the hydrogenation changed the ductile fracture of the non-hydrogenated copper pipe specimens into brittle fracture. Moreover, the brittle areas resulted from hydrogenation were increased with increasing the current density applied to the copper pipe specimens as can be seen in the fracture surface of the copper pipe specimens which had been hydrogenated at a current density of $65\text{mA}\cdot\text{cm}^{-2}$ for a fixed hydrogenation time of 3hrs (figure 6). This may indicate that the hydrogen penetrate more deeply into copper pipe specimens during hydrogenation at a higher current densities. Moreover, it is believed that the hydrogenation at $65\text{mA}\cdot\text{cm}^{-2}$ current density provides a higher hydrogen fugacity than the hydrogenation at lower current density of $15\text{mA}\cdot\text{cm}^{-2}$, which resulted in larger brittle area.

Figure 5 Fracture surface of the copper pipe specimen hydrogenated at $15\text{mA}\cdot\text{cm}^{-2}$ current density for 3 hrs.

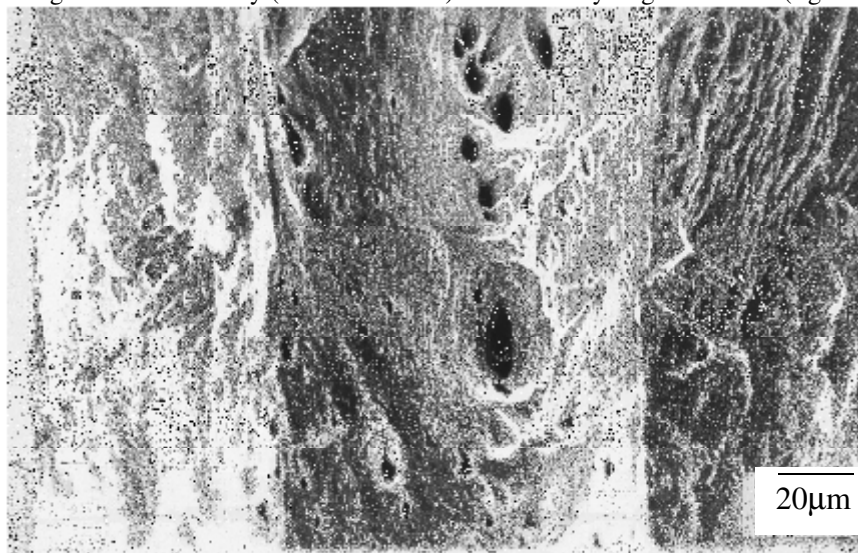
Figure 6 Fracture surface of the copper pipe specimen hydrogenated at $65\text{mA}\cdot\text{cm}^{-2}$ current density for 3 hrs.

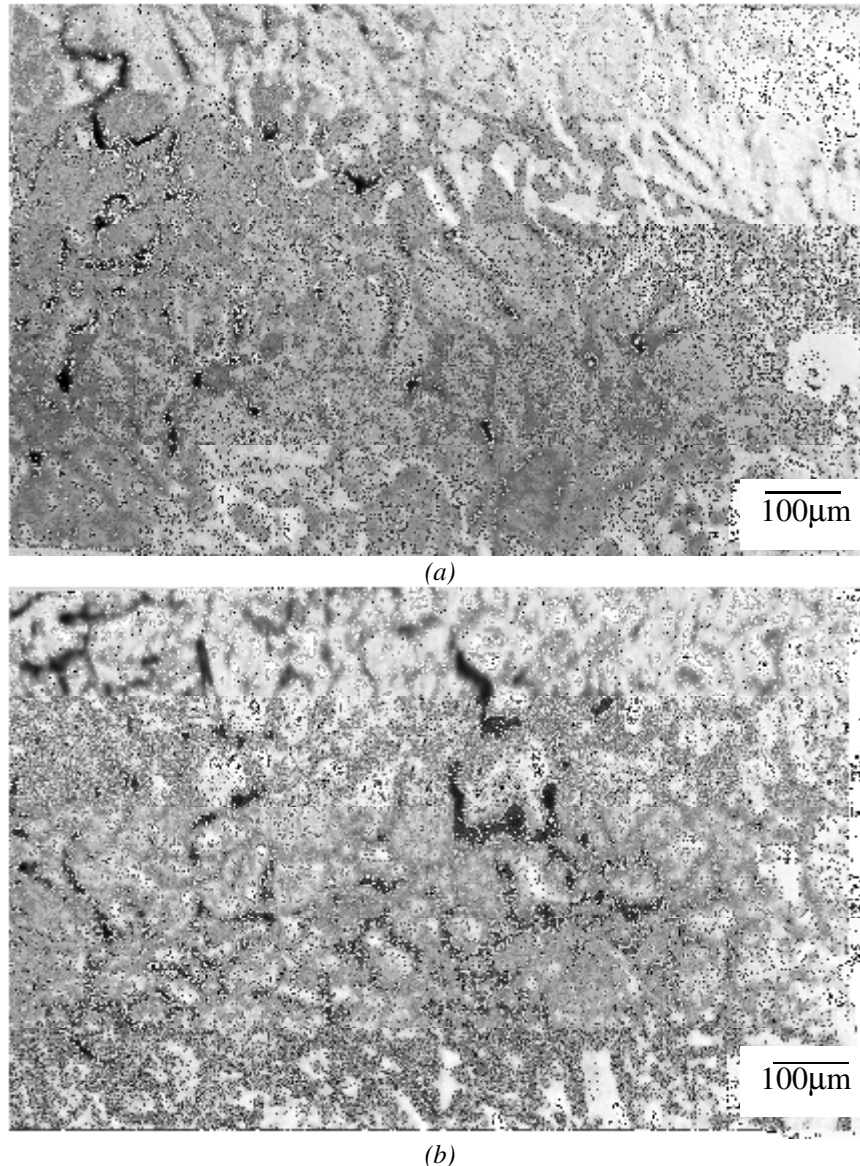
The cross-sectional views of the copper pipe specimens hydrogenated at current densities of 15 and $65\text{mA}\cdot\text{cm}^{-2}$ and fractured in tension are shown in figures 7(a) and (b) respectively. Several microcracks can be seen in both specimens. At low current density (i.e. $15\text{mA}\cdot\text{cm}^{-2}$), the microcracks are formed only near the external surface of the copper pipe specimen as shown in figure 7(a), while, at higher current density (i.e. $65\text{mA}\cdot\text{cm}^{-2}$) the microcracks are formed throughout the entire cross section and can be seen even at the center of the copper pipe specimen 7(b). Close examinations of the micrographs of copper pipe specimens hydrogenated at different hydrogenation conditions revealed that the cracking mode was changed from intergranular mode for the copper pipe specimen hydrogenated at a lower current density (i.e. $15\text{mA}\cdot\text{cm}^{-2}$) for a fixed hydrogenation time (figure 7a) into mixed mode of cracking i.e. both intergranular and transgranular cracking for the copper pipe specimen hydrogenated at a higher current density (i.e. $65\text{mA}\cdot\text{cm}^{-2}$) for a fixed hydrogenation time (figure 7b).

In addition to the above results, it is evident that the hydrogenation condition of higher current density for a fixed hydrogenation time applied to the copper pipe specimens (figure 7b) resulted in the formation of larger number of microcracks than those charged at the other hydrogenation condition of lower current density for a fixed hydrogenation time (figure 7a).

Figure 7 Cross-sectional views of the copper pipe specimens hydrogenated at current densities of (a) 15mA.cm⁻², (b) 65mA.cm⁻² and then fractured in tension.
