Bridge Collapse in Nigeria: A Case Study of Tatabu Bridge in Mokwa Local Government Area of Niger State

Jibrin Sule., Ibrahim A. Inuwa., Surajo Lawan Abdullahi., Danladi S. Matawal
(Affiliation): Nigerian Building & Road Research Institute, NBRI House
10 I.T. Igban Street, Off Obafemi Awolowo Way, Jabi PMB 5065 Abuja, FCT, Nigeria

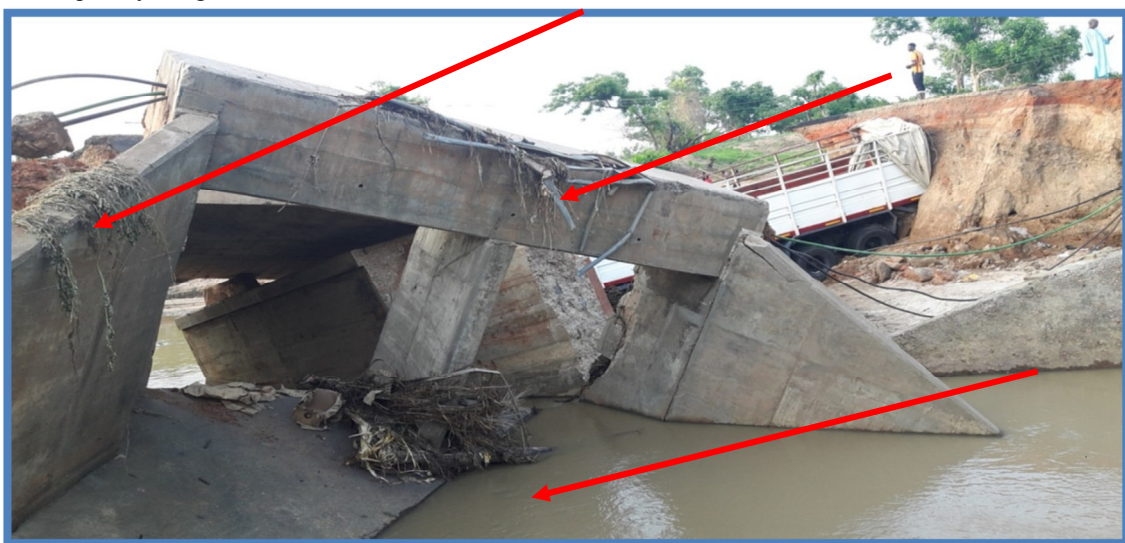
Plate 1: Image showing remnant debris

3- It is also observed that the debris settlement within the cell of the collapsed bridge contributed to reduction of the cross sectional area single cell.

Hence, this can be averted if the flood sediment analysis previewed had been consider during the initial design phase, which will cater for both flood and debris when delay had been attributed to expect periodic dredging and maintenance.

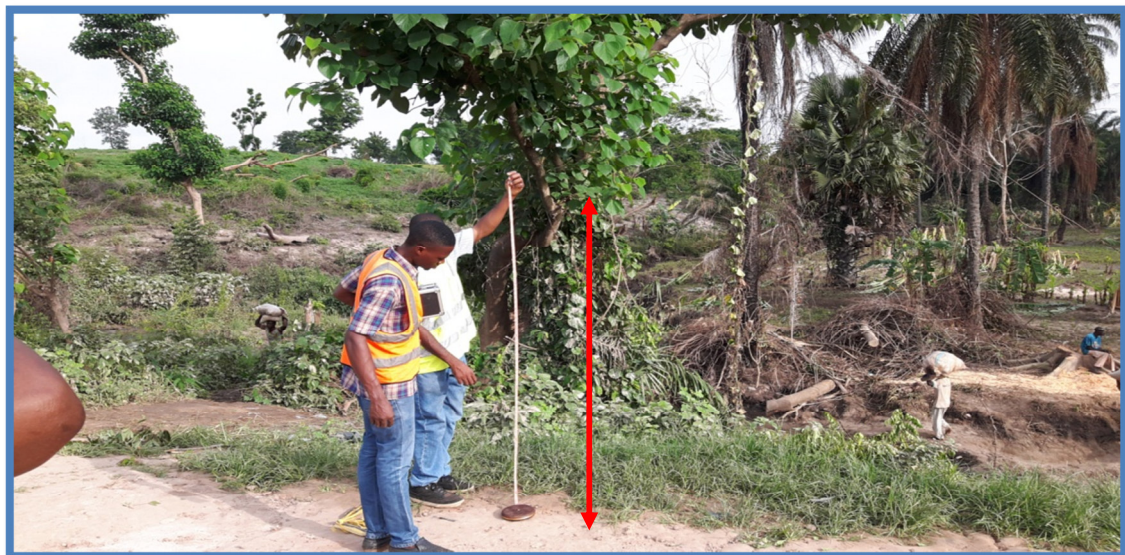
Plate 3: Image Showing Flood height

Surface runoff data results are depicted in Figure 5. In August 2015, runoff of 17.632 mm/month was recorded as the peak in the year. While in 2016 and 2017 the peaks were both recorded in September at 25.027 mm/month and August at 23.456 mm/month respectively. Generally it can be observed that the runoff data shows a similarity in trend to precipitation. There was a considerable increase in runoff from 2015 up to 2016 and then a slight decrease was observed in 2017. This decrease however may be due to higher evaporation rate in 2017 as shown in Figure 5, which happened to be much higher in August 2017 with 164.456 mm/month compared to 154.742 mm/month in August 2016. Other factors may be due to higher transpiration or penetration into the surface to become groundwater. The resultant flood due to the increase in surface runoff and high precipitation transported debris into the single span bridge passage reducing its capacity and colliding with the structures as shown in Plate 1 and 2. This repeated action may weaken both the bridge structures and its embankments support and subsequently weighed down the structures as shown in Plate 3.

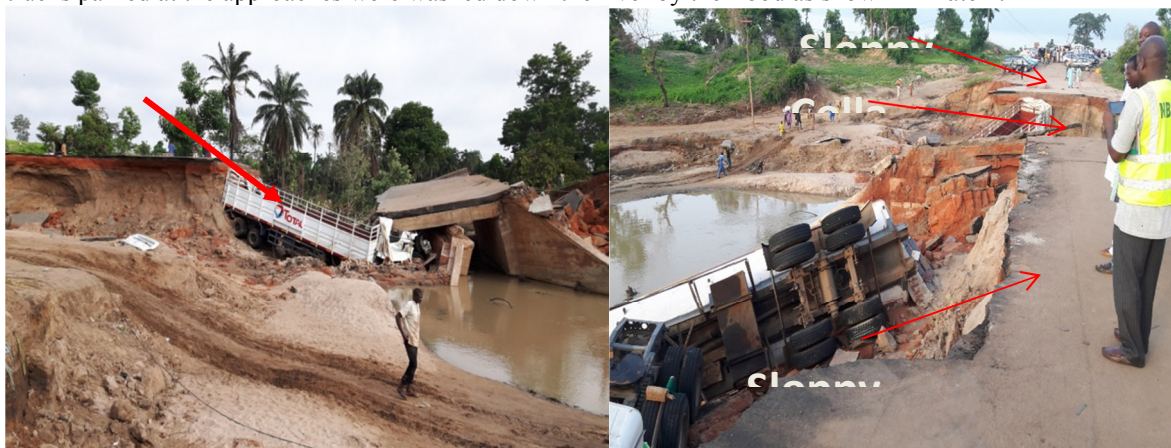
Plate 4: Bridge positioned between a valley

Tatabu bridge is directly positioned in a lower part of a valley. Due to the steep nature of the valley, surface water quickly runs down into the bottom of the valley and subsequently into the river. High volume water with high velocity at the same time transporting debris exerted its force into the single span bridge at a rate that overwhelmed the capacity of the bridge. The bridge and its two embankments were overtopped and also cars and trucks parked at the approaches were washed down the river by the flood as shown in Plate 4.

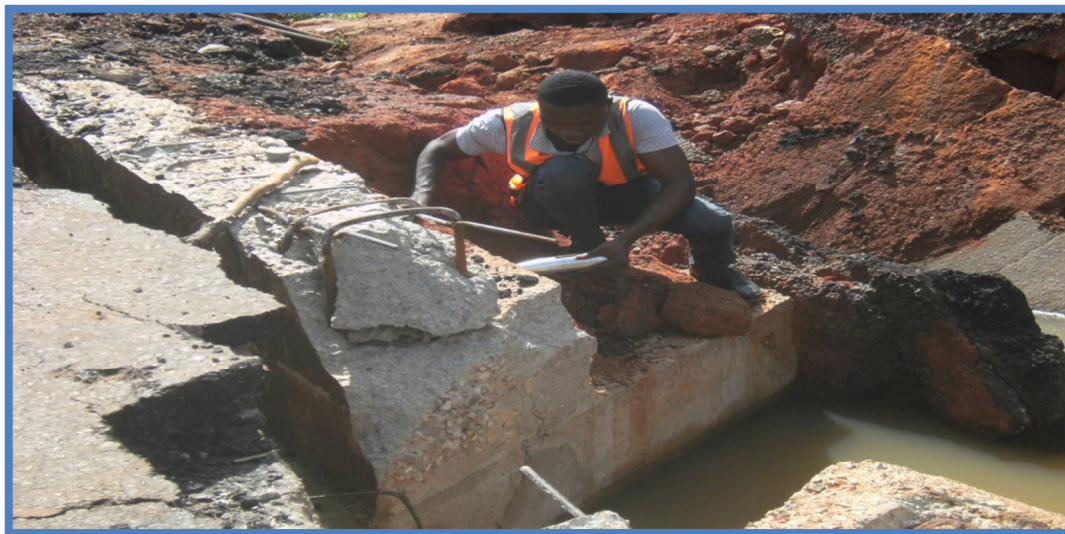
Plate 5: Concrete strength test using rebound hammer device

The team also had a thorough investigation on the collapsed bridge concrete structural component which consists of bridge deck, single span beams which is fixed and free supported on abutment walls. Compressive tests were performed per ASTM D198 (2005) using rebound hammer. The dimensions were measured at the top, middle and bottom of each of the visible members of the bridge as presented in Plate 5.

The compressive strength results obtained are shown in Table 2. From the standard (Main Roads Western Australia level 3 Inspection Guide lines for concrete and steel bridges) the concrete strength are within the acceptable limits.

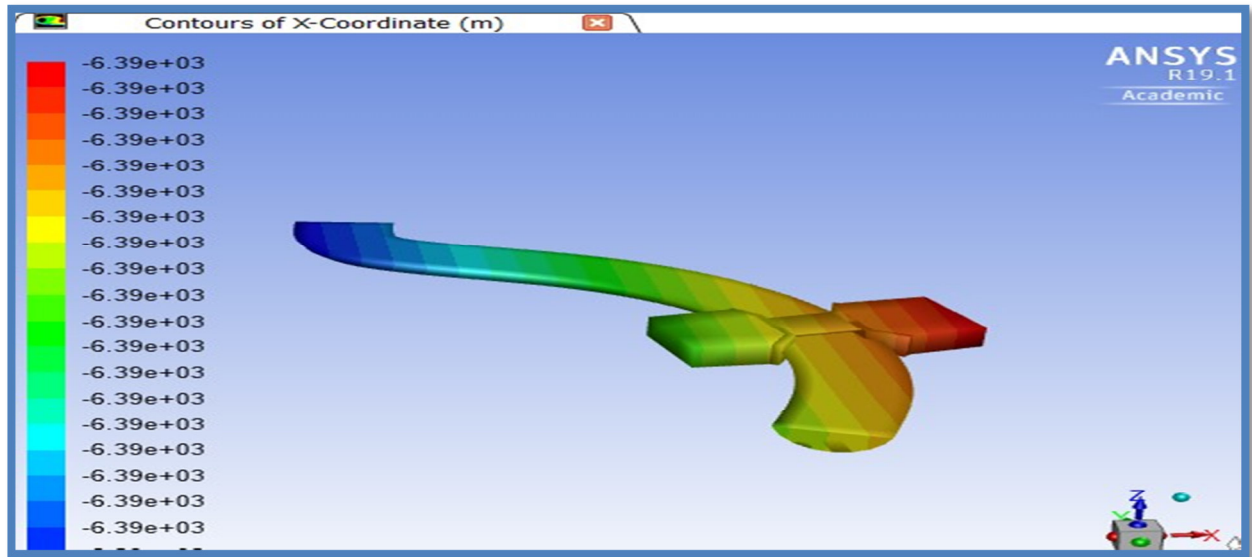
Figure 9: Pressure Contour of the Fluid Flow.

The contours adaptation of velocity and pressure during the flood are shown in Figure 8. As presented in Figure 9, the pressure of the flow within the Abuja approach bridge abutment is higher than the other parts. Possibly, this happened as a result of the meandering nature of the flood path. This high pressure flood collide and wash off the relatively soft in-fill soil providing support to the embankments resulting to collapse of the entire structure. Figure 9, Figure 10 and Figure 11 shows von Mises stresses in the bridge and displacement of embankment soil respectively.
