# Assessment of Major Bridges Along Nasarawa, Plateau, Bauchi and Gombe State Highway, Northern Central, Nigeria

Mlanga Victor Musa Kyauta Ekpo Ekpeyong Alhassan Iko David  
Nigerian Building & Road Research Institute, 10 NBRRI Road/ I.T. Igbani Street, Jabi District, Abuja, FCT, Nigeria

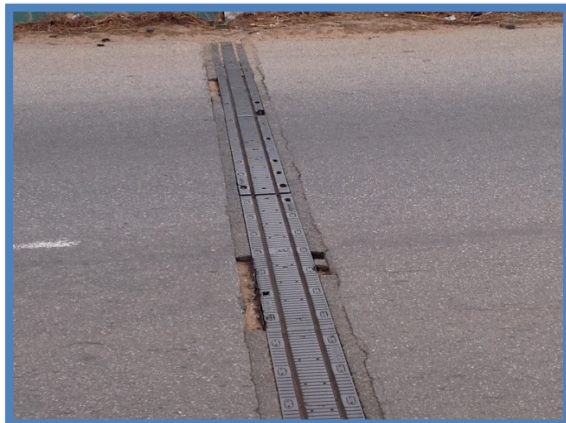
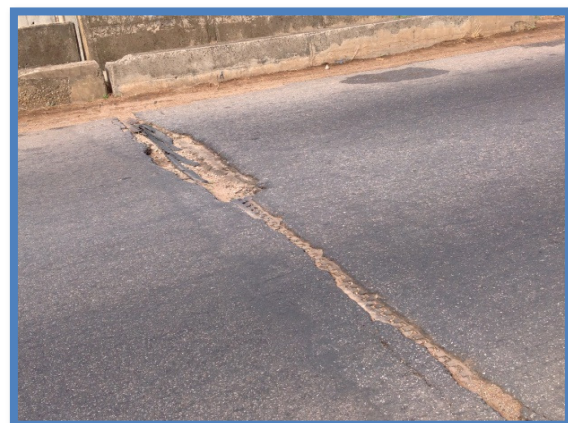
The Uke Bridge is located along Abuja-Keffi expressway on coordinate N08° 54.742' E07° 42.803' of the prime meridian. They each have 2 lanes. It was observed here that some deck expansion joints are deteriorated and leakage has been observed at the joints and the surrounding concrete. There is major spalling of bituminous wearing course at the adjacent decks near the joints. Also the stone pitching done to the embankments has partly dislodged due to poor concrete mix, allowing vegetation to grow and run off to then erode the slope. Several pile caps have become exposed and are vulnerable to scouring which would lead to exposure of the piles and weaken the pier supports. Concrete spalling 3 inches deep was observed on one of the piers. This has led to rebar exposure and loss of section. The exposed reinforcement bars can be seen to be undergoing corrosion due to the presence of water. Debris was observed to have lodged and settled between the girders on the pier caps due to deck joint leakage. This has encouraged unwanted vegetation growth which can limit longitudinal and lateral movement of the beams and lead to deterioration of the elastomeric bearings. Fig. 2.

**Figure 3a.** Deteriorating expansion joint

**Figure 3b.** Deteriorating expansion joint.

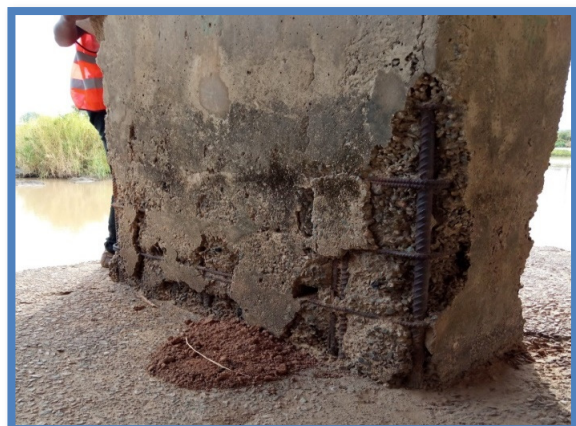
**Figure 5.** Exposed rebar with section loss

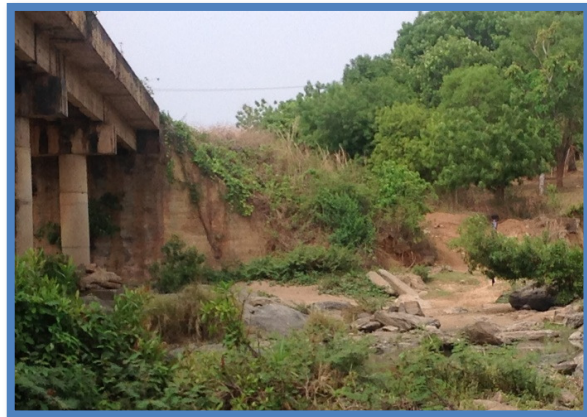
Lastly, the engineers observed that the embankments of the bridge had been left unprotected without stone pitching or any other erosion-preventive treatment. Thus erosion and landslide due to runoff has removed much of the embankment backfill and trees have grown directly behind the wing wall.

**Figure 10.**Unwanted vegetation on embankment.

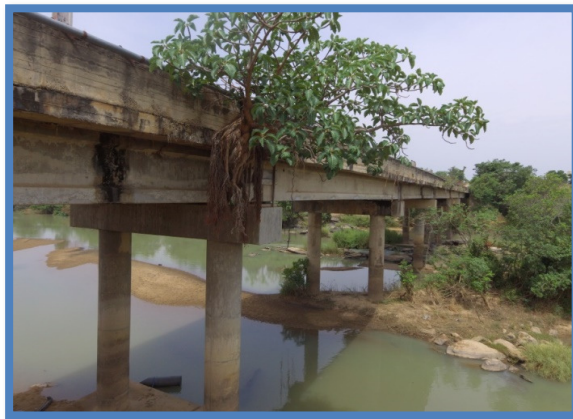
**Figure 14.**Tree growing on bridge fascia.  
**Source: Field Survey 2019**

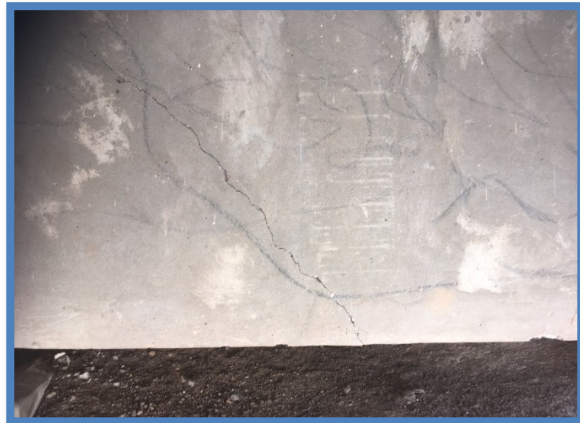
**Figure 18.**3mm wide crack on approach beam

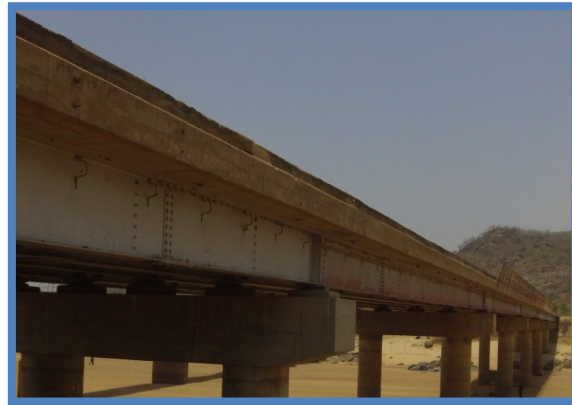
The team also noted that a lot of steel pipe bridge railings were missing, removed by vandals. This has left long distances along the bridge unprotected by any sort of barrier. Shrubs were found to have grown on the bearing seats due to accumulation of debris. It was observed that the channel bed had eroded and this has left some of the pile caps vulnerable to scouring.

**Figure 20.**Missing railings due to vandalism.

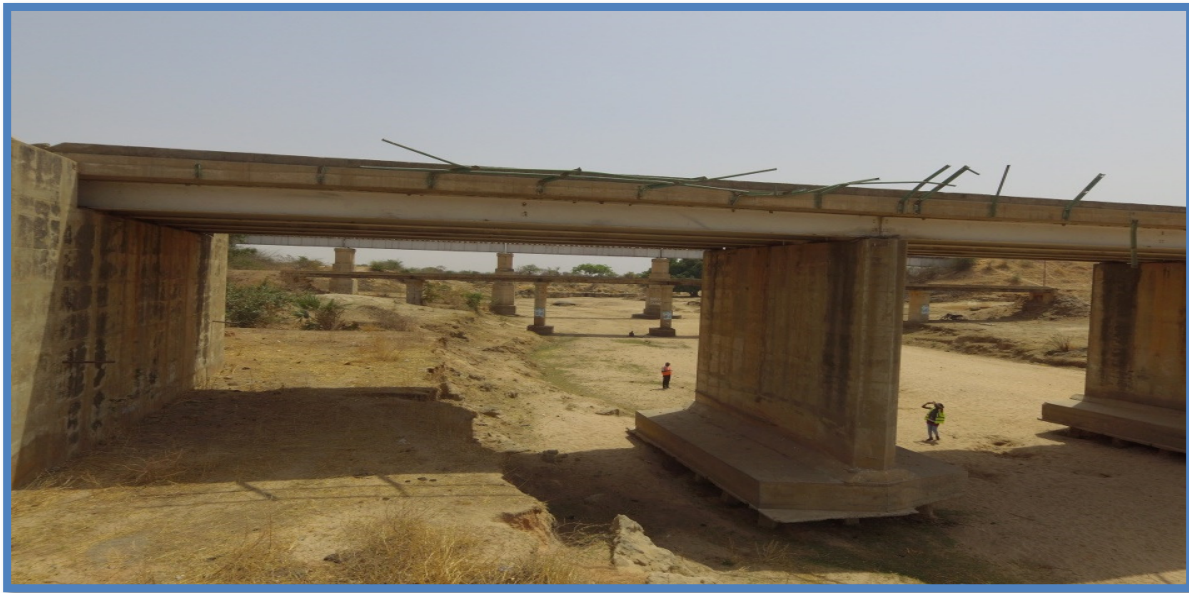
**Figure 24.**Major loss of channel bed to erosion and scouring. **Source: Field Survey 2019**

In conclusion, the Gwaram bridge needs immediate preventive maintenance in order to ensure the safety of road users and property along this route and also to preserve and extend the useful life of the bridge.

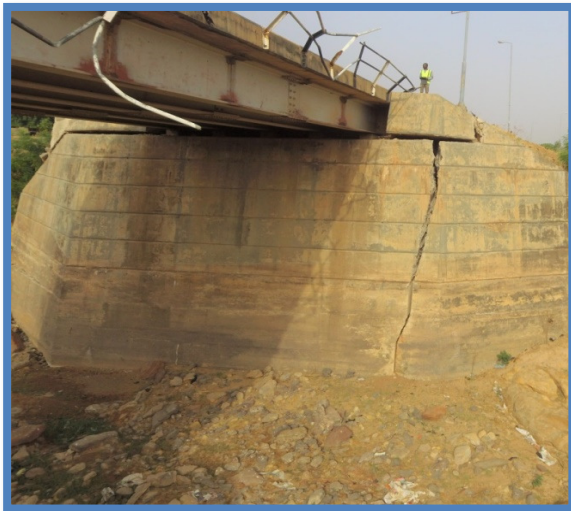
This bridge is located along Gombe-Biu road. The main construction materials are concrete and steel. It has been shut off to general traffic due to its deplorable condition. The abutment from the Gombe approach has literally broken in two directions; horizontally and vertically as seen in figure 26. The team observed that no reinforcements were used in the construction of the abutment: it was just a big mass of concrete with inadequate tensile resistance to loading. The contractor erroneously designed the abutment to be over 1 metre thick, thinking it sufficient to carry out its functions. This can be seen in figure 27.

**Figure 26.**Major cracks on abutment.

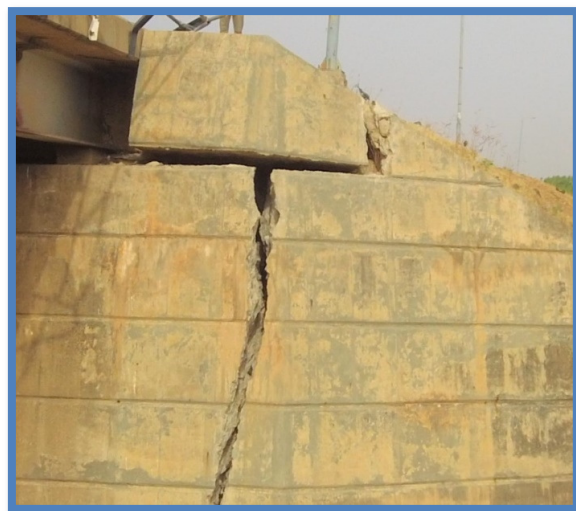
**Figure 27.**Absence of rebars in abutment.
