Post Construction Failure Analysis of Road Pavements in Ghana.

Dr. Francis Achampong^{1*}, Dr Fred Boadu², Peter Klu Agbeko³, Reginald Adjetey Anum.

The current Koforidua By-Pass is a 9 kilometer four lane dual carriageway which was fully funded by the government of Ghana. The road is a major arterial serving communities linking it and providing an alternative south –north connection which avoids the congested Central Business District (CBD) of Koforidua, thereby easing traffic congestion and thus reducing travel time for motorists. This Koforidua highway is a surface dressed wearing course with a vegetative median of 2 meters width. The total carriageway width is 14.6 meters. The north and south bound lanes are 7.3 meters apiece with shoulders of 2 meters on both sides and drainage structures at some selected sections. Four critical intersections on the road have been signalized to facilitate traffic management. Street lights were virtually installed at every 40 meter intervals along the median for safety and security of motorists and pedestrians.

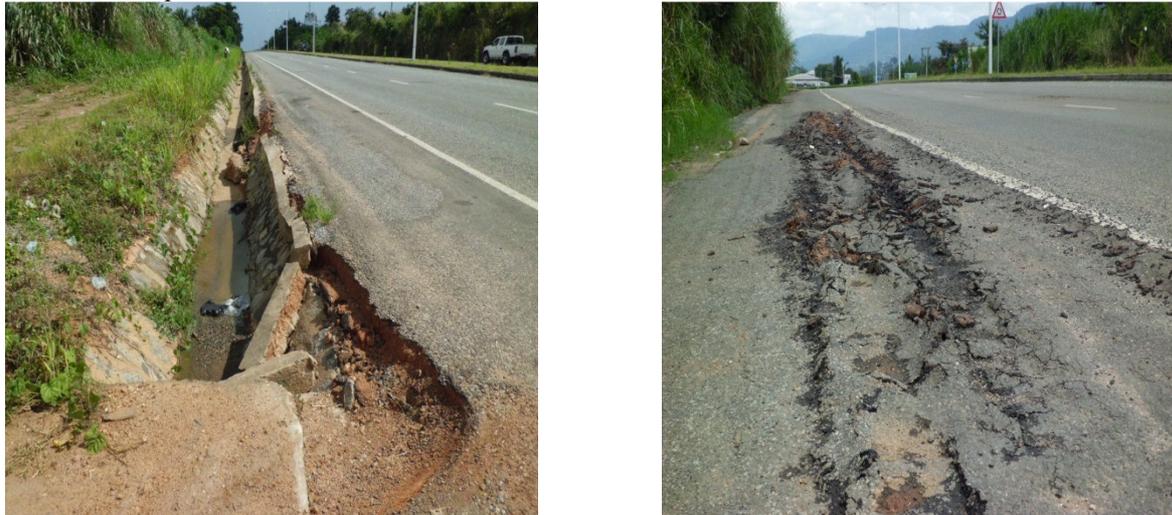
Fig 1: A 3- month old road surface showing poor drainage works and premature road surface failure.

Massive shoving, rutting, depressions and potholes as well as longitudinal cracks were mostly observed on the wheel path of the inner lane of the pavement surface. This lane was adjacent to the median. There was seepage of water from the subgrade and some fractured bedrock to the road surface near the median.

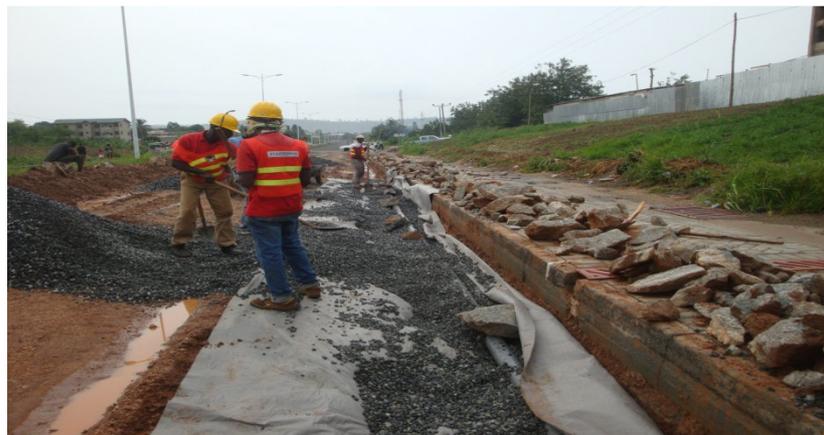
Fig 2: Use of geotextile material at ch 880

Maintenance works started three months after the road pavement was open to vehicular traffic to remedy most of the pavement defects to ensure safety on the roadway. The defective sections on the roadway were excavated to the subgrade formation. Geotextile material was installed at CH 880 as shown the figure 3. 100 mm boulders were placed on the geotextiles fabric. It was then compacted with a 10 ton vibratory roller to a depth of 0.5 meters.

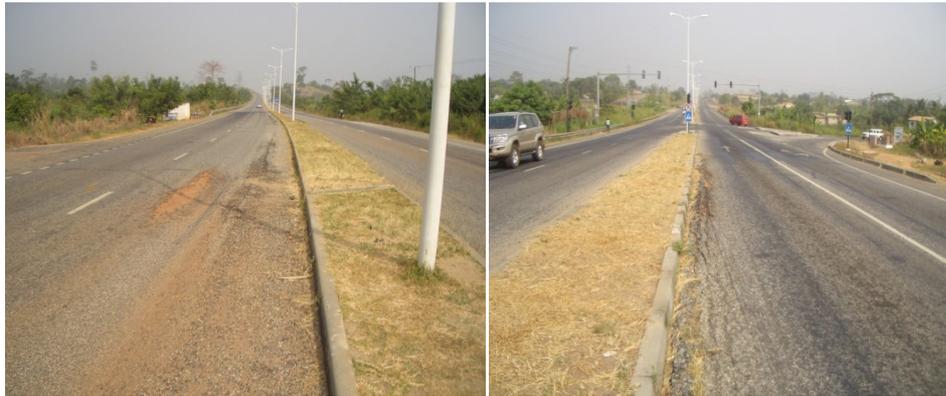
Road defect (pothole) Shoving and Longitudinal grooves

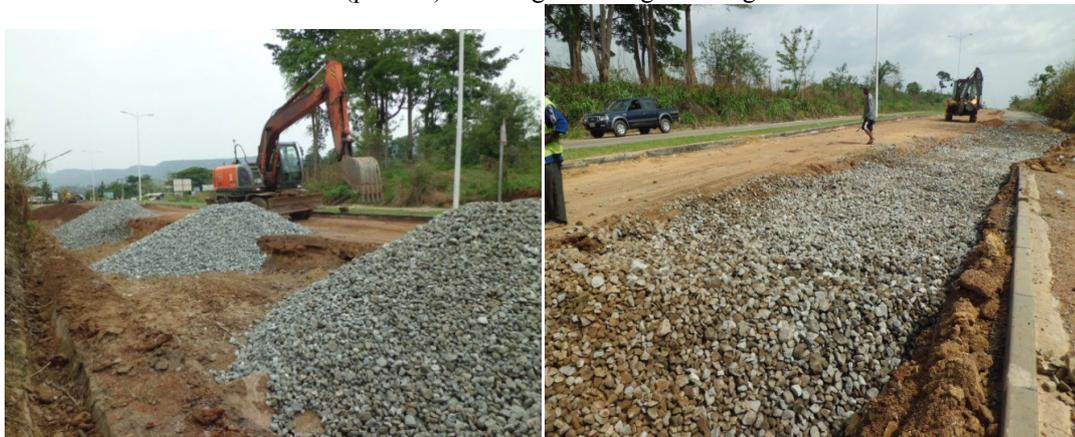
During remedial works (Placement of crush rock base material)

Crushed rock aggregates (0 -40 mm size) were placed on the compacted boulder layer and were subsequently compacted. Crushed granite aggregates mixed with natural gravels were used as a sub -base layer and were compacted to a thickness of 200 mm.

The sub-base materials were stabilized with 10 percent cement to increase its CBR and compressive strength values. The 200 mm thick stabilized material was used as a base layer. Unfortunately the wearing course is still surface dressed instead of hot asphaltic cement concrete layer.
