# Investigations on the Material Efficacy of Failed Helical Gears in a Gear Train

O. O. Joseph,\* O. A. Abidakun, A. O. Aniyikaye, O. O. Folorunsho

Department of Mechanical Engineering, Covenant University, P.M.B.1023, Ota, Nigeria

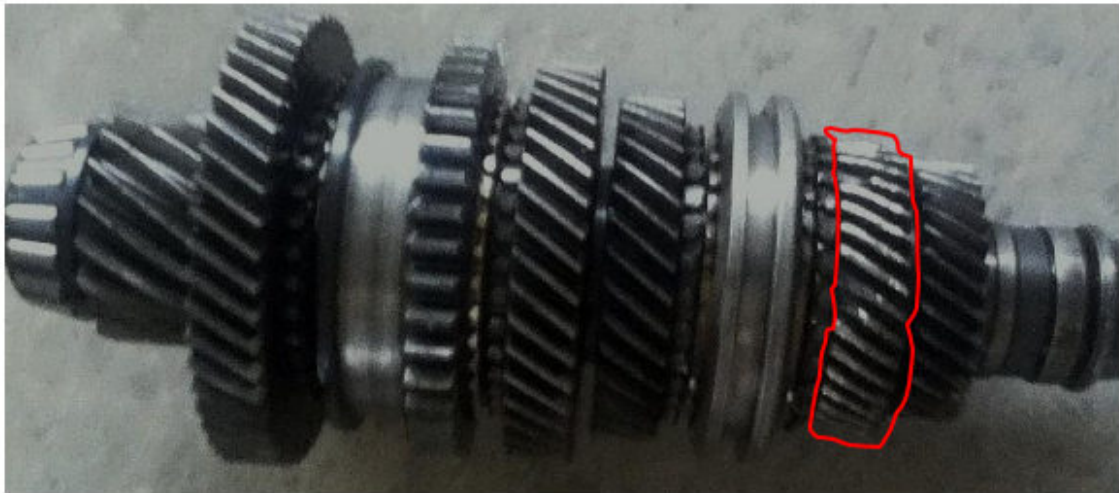
showed several worn teeth and seven fractured teeth (indicated by the red curve) and the remaining five had no visible sign of failure. The appearance of the gear train is as shown in Fig. 1. The helical gear is a five speed manual transmission gear. The passenger car has 202horse power and 6000revolution per minute (rpm) engine power. For the purpose of analysis, two helical gears were randomly chosen as representative samples of the six. The gear showing visible signs of fractures and wear was taken and denoted as Sample A, and another showing no visible sign of failure was chosen as Sample B. Basic data of the representative samples of the failed helical gears is presented in Table 1 and relevant layouts of the gears are shown in Fig. 2.

**Figure 1** Appearance of the gear train.

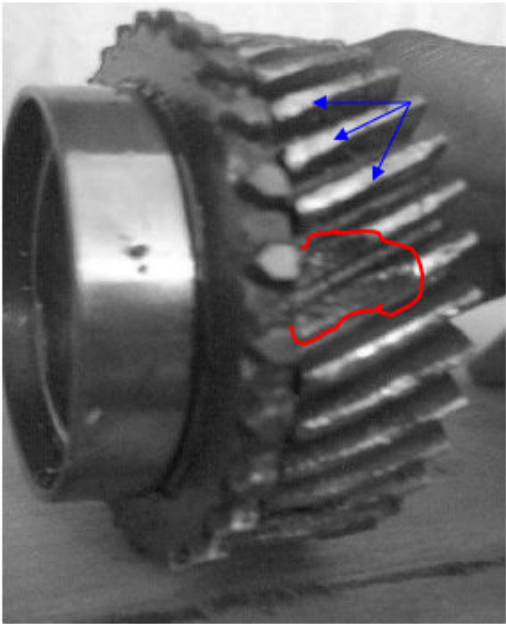
The purpose of which is to ascertain the mode of failure, observation of sample A with the unaided eye revealed surface wear (blue arrow) on nearly all tooth surfaces and tooth fracture (red curve) of seven out of a total number of 28 teeth (Fig. 3). The fractures occurred as a result of wear induced fatigue on the gear teeth. Hence, the failure mode of sample A can be classified as wear failure. This is further confirmed by Fractographic studies which showed cracks propagating from a point on the surface of the metal (which is the origin of crack initiation indicated by the red arrow), upward and downwards along slip planes (Fig. 4).

Figure 3 Unaided view of gear sample A .

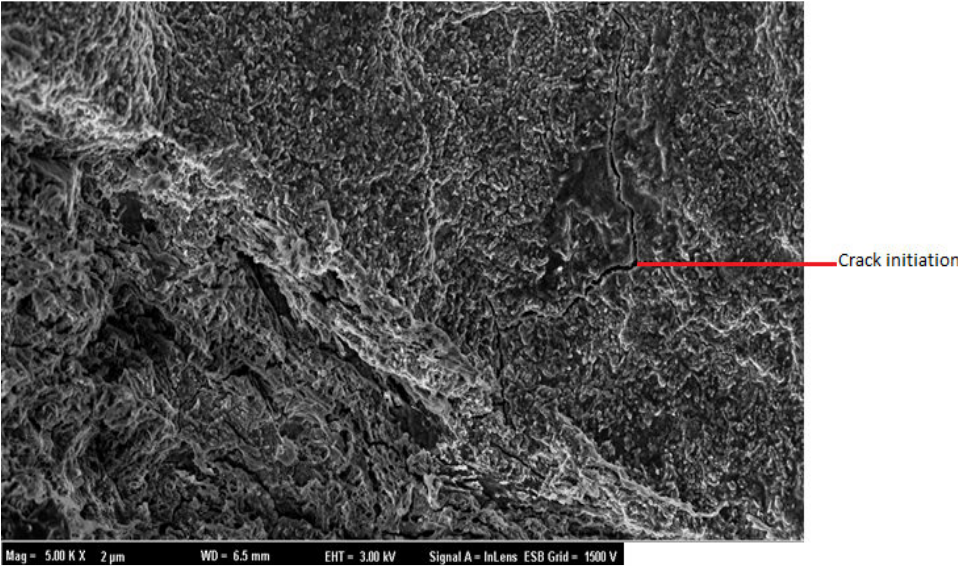
Figure 4 Fractograph of gear sample A.

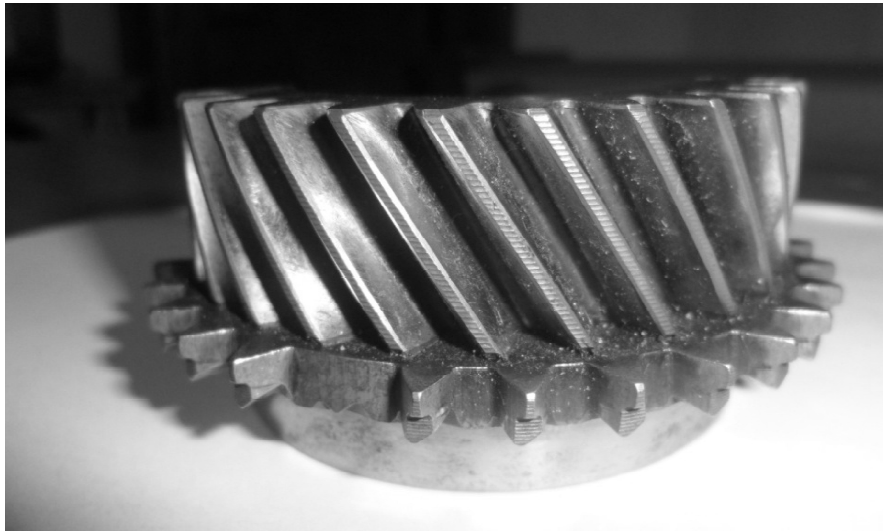
It was observed from the fractograph of sample A that the frictional heat (due to insufficient lubrication) between the rolling gear parts caused re-austenization of pearlite on its surface (lower left), producing as-quenched martensite (upper right) upon cooling, which led to crack initiation in the material. After initiation, repeated rolling contact caused crack growth which eventually led to surface contact damage (spalling). In the case of sample B, visual examination with the unaided eye (Fig. 5) revealed that there was no visible sign of failure. Nevertheless, sample B was subjected to Fractographic examination (Fig. 6). Curiously, developing spalls were observed on the gear tooth of sample B.

**Figure 5** Fractograph of gear sample A.

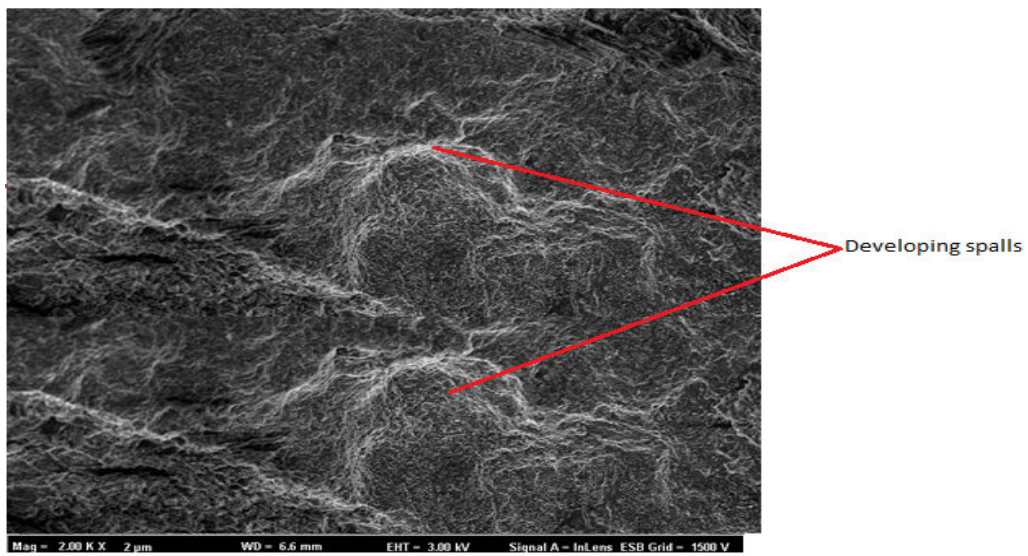
**Figure 6** Fractograph of gear sample B.

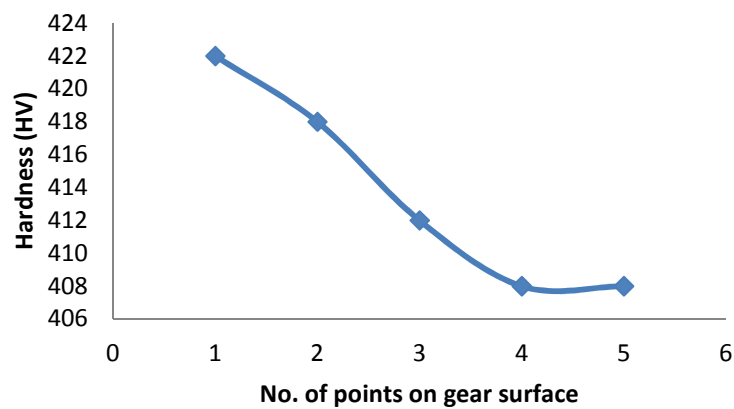
The microhardness distribution of both gears, across the gear tooth was measured using a digital Vickers hardness tester (HVD501 model) with 500kgf load. The results are shown in Figures 7 and 8. The decreasing hardness values from the case of both materials to the core are an indication that the material has been case hardened by carburization which is a normal operation for gear heat treatment.

**Figure 7** Hardness distribution of gear sample A.

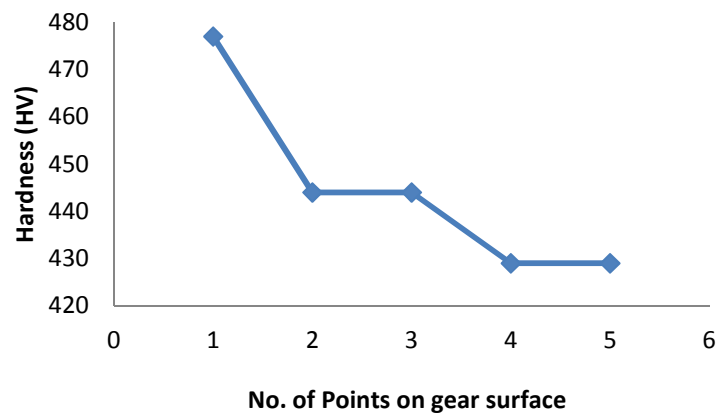
**Figure 8** Hardness distribution of gear sample B

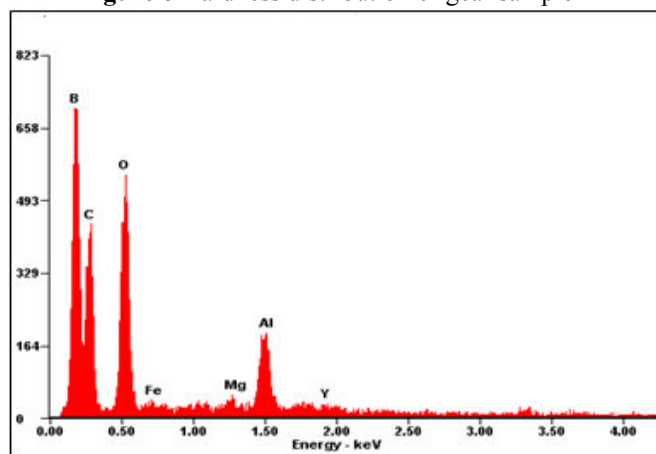
The X-ray spectrum that was generated from a point on sample A and another on sample B are shown in Figs. 9 and 10. EDS of sample A shows high proportions of boron, carbon and oxygen. Boron had reacted with carbon to yield boron carbide which is extremely hard, improving the material's property. On the other hand, it can be asserted that in the absence of sufficient lubrication, the steel being rich in carbide particles, exhibited a low

coefficient of friction which resulted in a high wear rate. Iron oxide, a contaminant, weakened the gear teeth in the presence of frictional heat generated from improper lubrication. The oxide contaminant in sample A was a major contributor to its failure. In the absence of lubrication, wear of the gear metal proceeded by cyclic disintegration of oxide films and subsequent reformation of these films. In other words, oxidative wear occurred. The EDS view of sample B showed the presence of iron, carbon, copper and chromium in the material. There was no indication of contaminants. It is worth noting however, that there is no wear on sample B which is also reflected by its EDS view. These results were further confirmed by microstructural examination.

**Figure 9** EDS view of gear sample A.

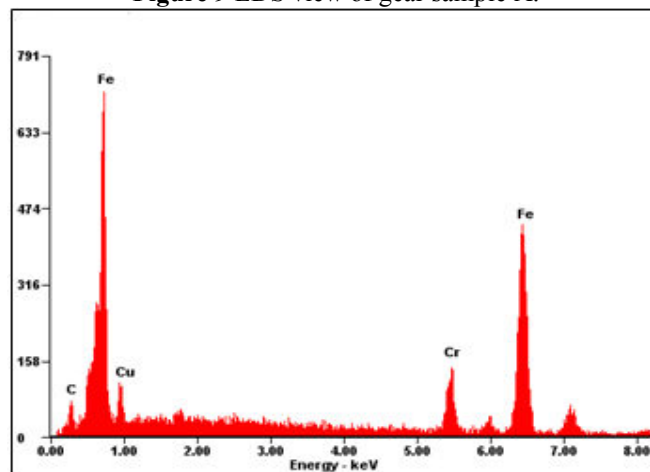
**Figure 10** EDS view of gear sample B.

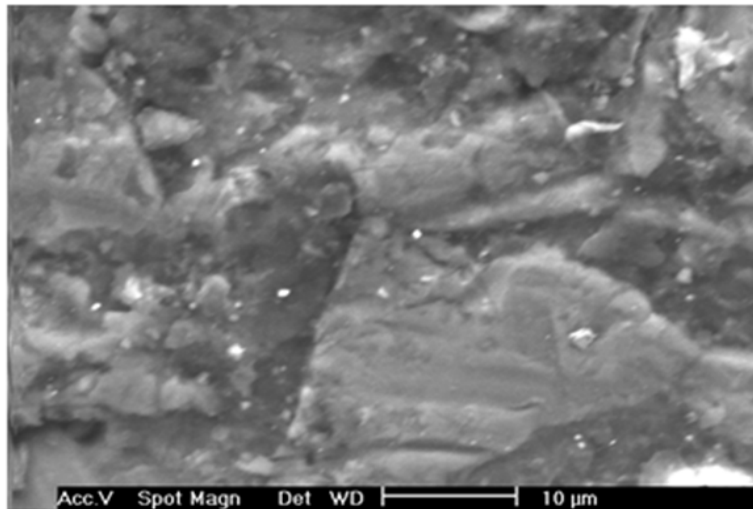
The gear samples were metallographically prepared and observed with a scanning electron microscope under etched conditions. The views obtained are shown in Figs. 11 and 12. Analysis of sample A showed severe subsurface spalling of the gear sample. Subsurface spalls are characterized by oxide inclusions and initiation of contact fatigue cracks (Qiong, 2008). This confirms that actually, there were oxide contaminants in the sample. Spalling of the gear material is a form of subsurface damage which led to crack initiation, crack growth and ultimately, fracture. Carbide precipitates could be seen on the micrograph as well. The unavoidable presence of these carbides contributed to the wear of the material. Hence, the failure mechanism of sample A as seen by the micrograph was by subsurface crack initiated spalling.

**Figure 11** SEM view of sample A.

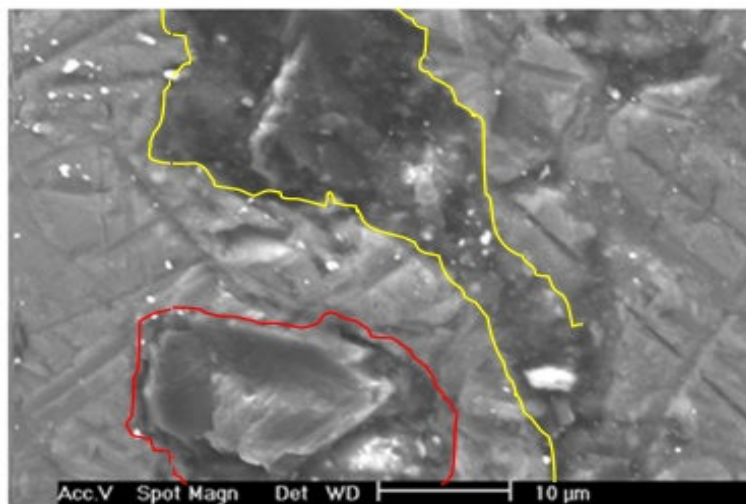
Spalling was observed in sample B. Both modes of spalling (surface and subsurface) were observed. Surface spalling is indicated with the red curve and subsurface spalling with the yellow curve. However, it is noticeable that the surface of sample B remained smooth and lacking in obvious damage, while a few micrometers below the surface, processes culminating in the formation of a wear particle were taking place.

**Figure 12** SEM view of sample B.
