# Assessment of Causes of Land Oil Spills from TANESCO Power Distribution Systems Attributing to Environmental Degradation in Tanzania

**DOI:** 10.7176/JEES/15-5-04

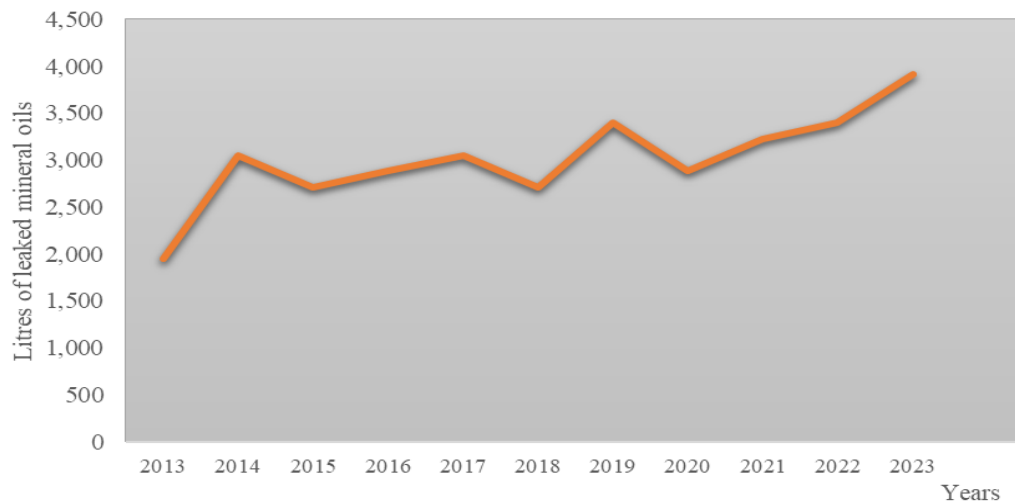
Figure 1. Leaked transformer mineral oil

Other transformer external failure-related causes were noted when the transformer tank was pierced, its cork underneath was removed, and bushing gaskets failed to enable the mineral oil flow out. It could be realized that there was vandalism for the removed or pierced cork prompted by black markets of transformer mineral oil sold as cooking oil for frying potato chips, fuel for vehicles and as medication of wounds (Kirunguru, *et al.*, 2018).

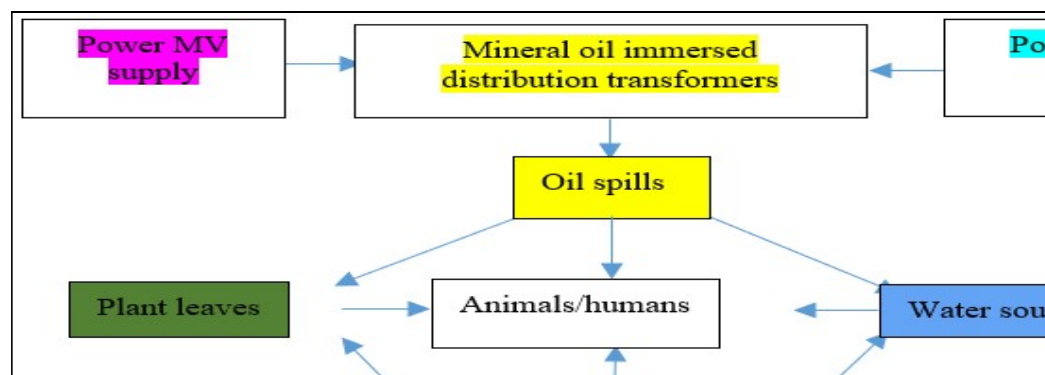
Figure 2: Land oil spills towards animals and humans

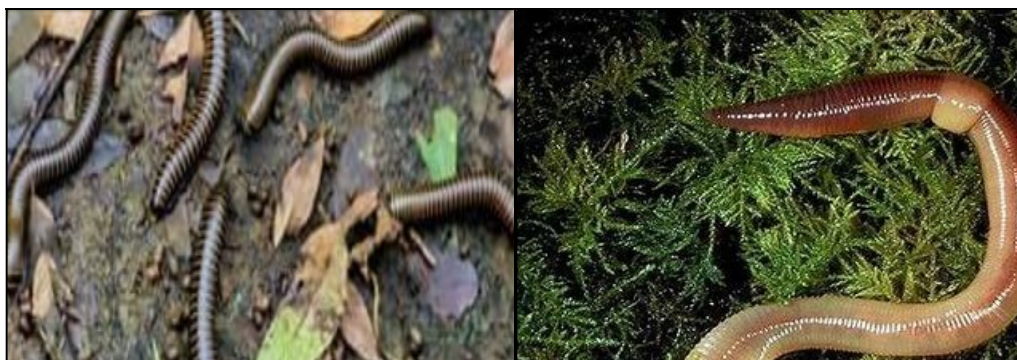
Plate 1: Remains of millipedes on oil spills

Remains of Nematoda from on oil spills
