Cracking of RC School Building Due to Soil Expansion

Omer S. Mughieda¹⁾ and Khaldoon A. Bani-Hani²⁾

ABSTRACT

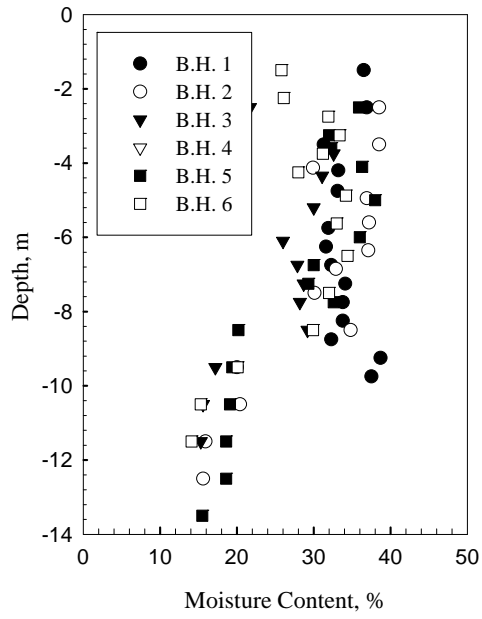
14.8 kN/m³ to 19.4 kN/m³ and 13.7 kN/m³ to 17.6 kN/m³, respectively. The specific gravity of soil solids was around 2.8. Natural water content of the samples varied between 12% and 40%. Figure (3) shows the variation of moisture content with depth for all boreholes drilled. Atterberg limits were determined according to (B.S. 1377: 75, Test No. 2 "A", 3.4) on soil samples extracted from all boreholes. The liquid limit varies from 59% to 84%. The plastic limit varies

Figure 3: Variation of water content with depth.

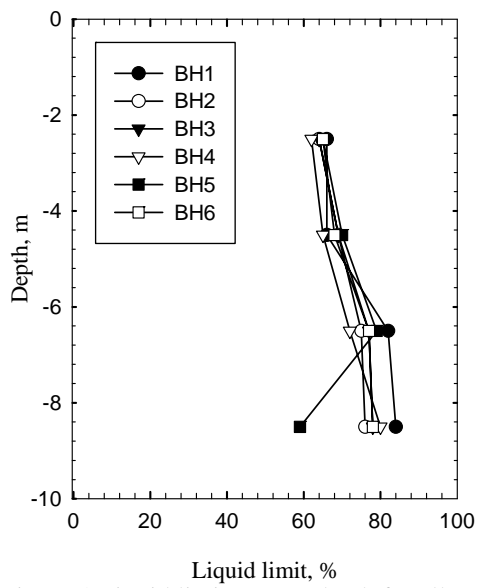
from 27% to 35% and the plasticity index varies from 34% to 49% for all bore holes tested. According to the Unified Soil Classification System (USCS), the soil was classified as high plasticity clay (CH) with a high swelling potential. Also, according to Williams and Donaldson (1980), the soil of concern is classified as having a high swelling potential. Figures (4) and (5) show the results of Atterberg limits; liquid limit and plasticity index.

Figure 4: Liquid limit Versus depth for all soil specimen extracted from the six drilled bore holes

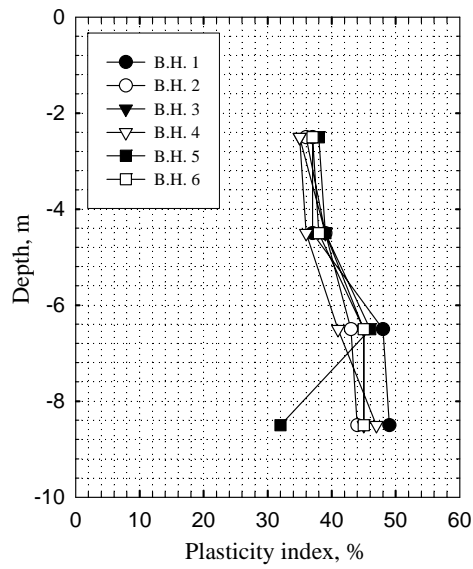
Figure 5: Plasticity index versus depth for all soil specimen extracted from the six drilled bore holes

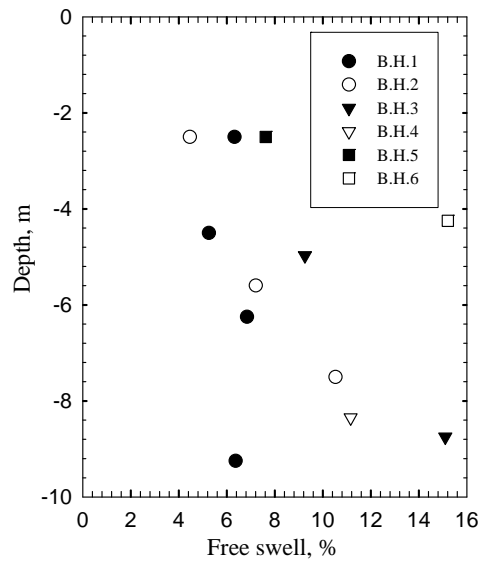
Swelling potential was determined in terms of swelling pressure, and free swell tests were conducted according to (B.S. 1377). The swelling pressure of the tested samples varies from 9.3 kPa at a water content of 35.9 % and 21.3 kPa at a water content of 28 %. Test results of the free swell for tested soil samples extracted from all drilled bore holes are shown in Figure (6).

Figure 6: Percent swell Versus depth for all soil specimen extracted from the six drilled bore holes

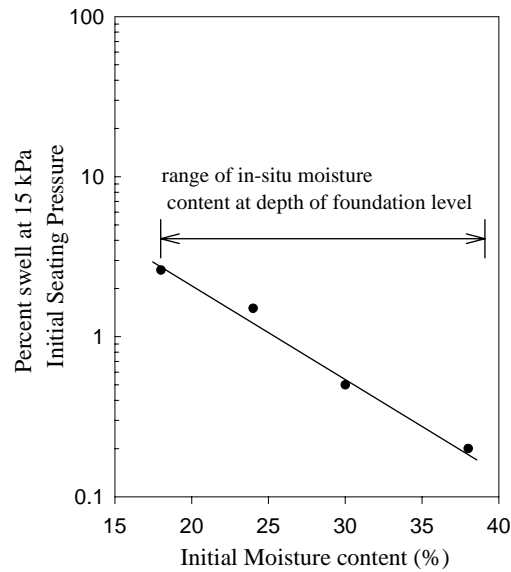
Figure 7: Moisture content versus percent swell obtained from odometer test

swell relationship shown in Figure (7). The data shown were obtained from odometer tests on remolded samples taken from the soil at the foundation level. All samples were tested at a dry unit weight of 1.48 Mg/m^3 . The predicted heave for the silty clay layer under the foundation can be predicted by knowing the initial water content. The water content values varied over a wide range as shown in Figure (3). Soil samples were taken in winter and the values at depth more than 8 m were almost constant at a water content of 18 % in all extracted samples regardless of the borehole location. Therefore, the swelling zone depth was 5.5 m below the foundation level. The 18% water content value can be considered as the summer value while the value of 38 % at the top can be considered as the winter value. By using Figure (7) and taking the effective thickness of clay layer below the foundation level as 5.5 m, the maximum vertical heave under an applied pressure of 15 kPa would be 14.3cm.

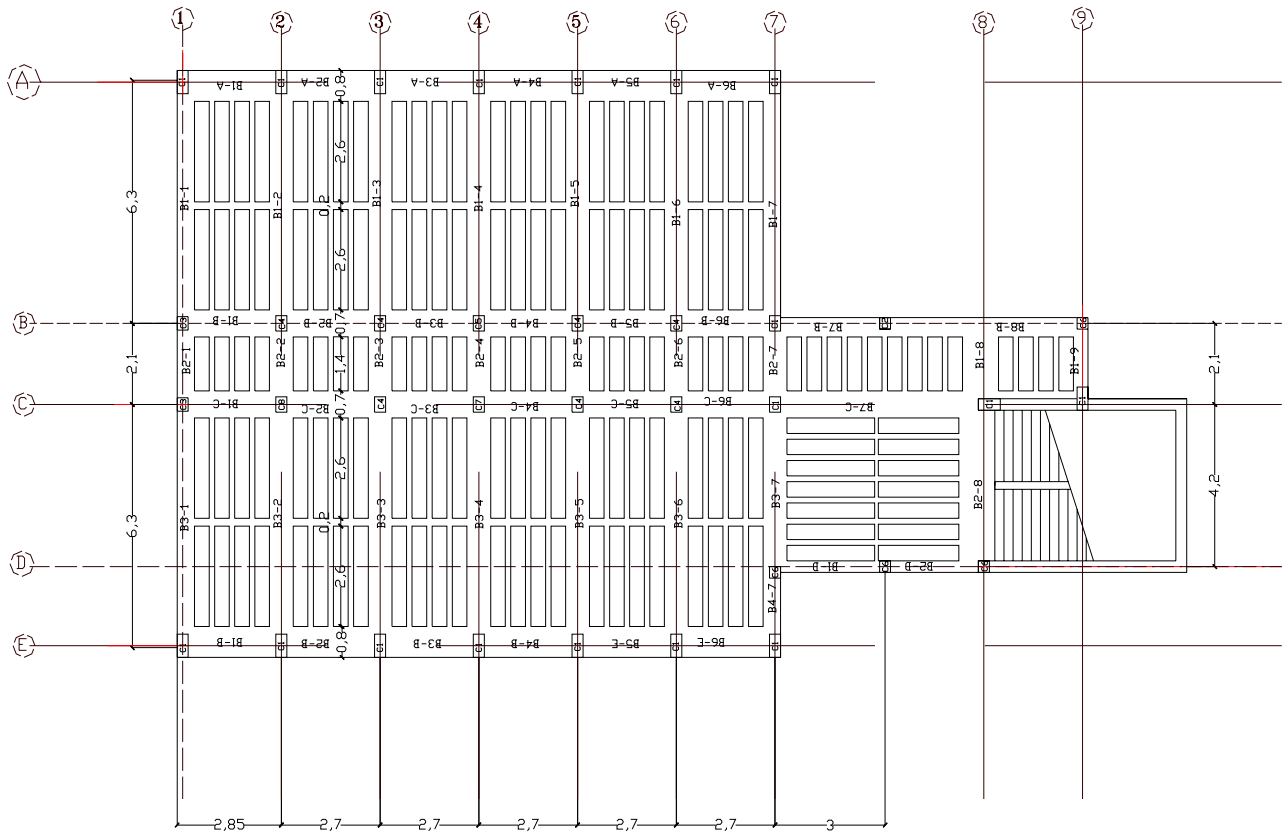
heave and shrinkage of the expansive soil that bears the footings. Additionally, soil investigation showed that the maximum relative soil movement due to drying and wetting can reach up to 7.15 cm. For safety considerations, 10 cm was used in the analysis. Therefore, it has been assumed that the far corner of the structure at (1-1, E-E) axes is settled by 20 cm, the corner at (7-7, E-E) axes settled by 10 cm, the corner at (1-1, A-A) axes settled by 10 cm, and the other columns settled relative to these values up to zero value at the opposite corner at (7-7, A-A) axes as shown in Figure (8). This generated a maximum differential settlement of 10 cm.

Figure (8): The plan-view of the analyzed part with beam numbers and columns used as well as the ribs and the axes.

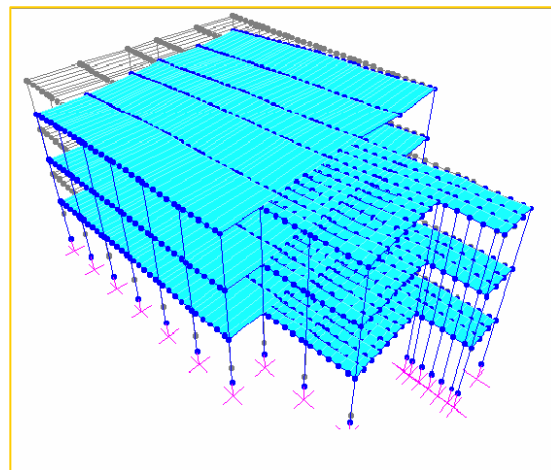
The analysis was performed using several loading cases (ACI 318M, 1995) that are summarized as: Dead load, **DL**, (1.4DL); Dead load and live load, **DLLL**, (1.4DL+1.7LL); Dead load, live load and settlement, **DLLLSTL**, (1.4DL+1.7LL+Settlement). In this study, the Dead Load (DL) value was computed as 7.1 kN/m², the Live Load (LL) was considered to be 4.0 kN/m² and the settlement values were taken as discussed above and shown in Figure (9).

Figure (9): Deformed shape due to (DIII) loading case (the assumed settlements).

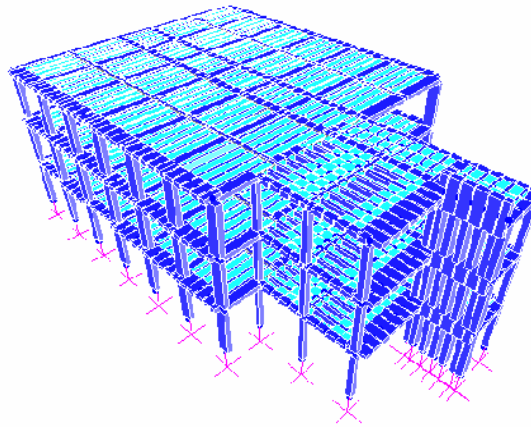
The building under study was modeled as a 3-D model with releases in the end joints of the columns to assure the simple beam action. The 3-D Finite Element Model is shown in Figure (10). SAP2000 code was used to analyze the finite element model. The analyses produced several cases including the most critical case, which was adopted for the design and repair measures. Figure (11) is presented as an example of the bending moment diagram for the **DLLLSTL** case.

Figure (10): 3-D FEM model for analyzed part of the building.

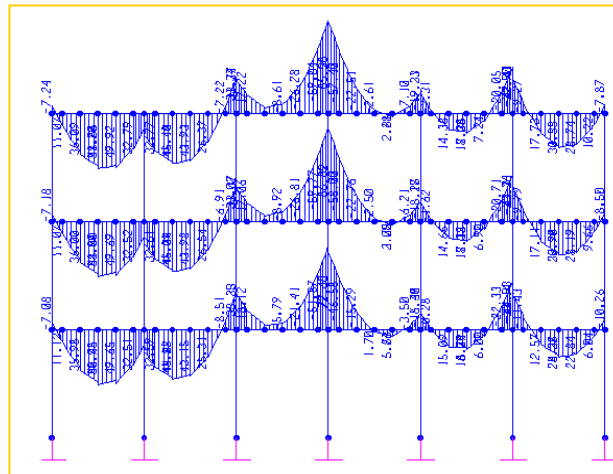
Figure (11): Moment diagram of frame E-E (DIII ST) in kN.m units.
