A STUDY TO DETERMINE THE QUALITY OF BUILDING STOCK AND EARTHQUAKE RISK IN KIRSEHIR

Abstract

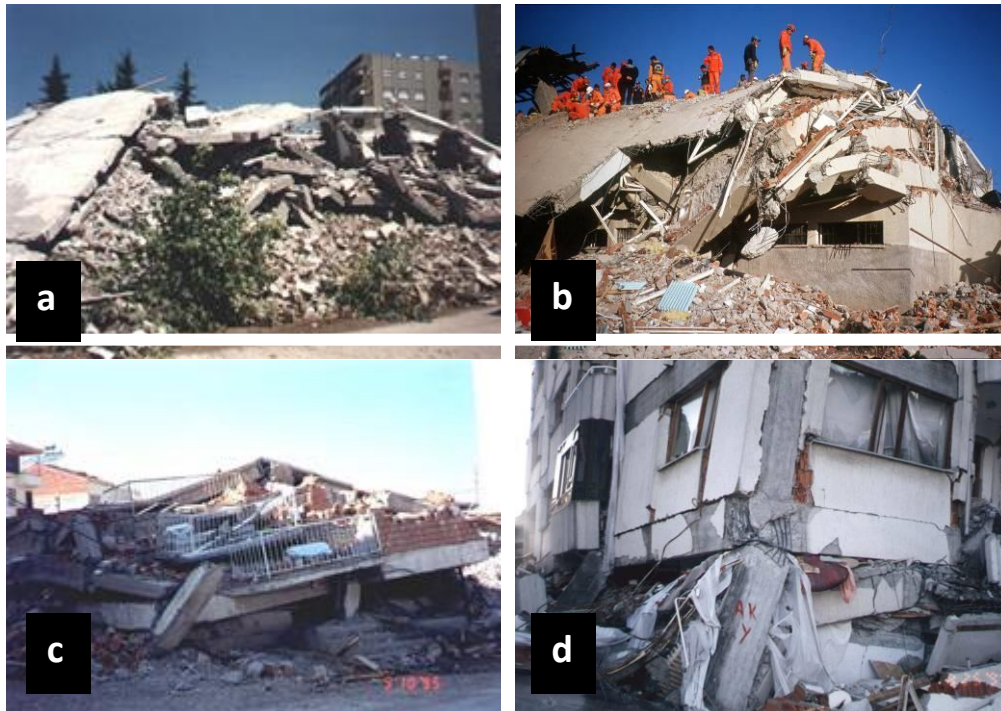
Figure 1. Buildings that were damaged in the earthquakes, a) 13 March 1992 Erzincan Earthquake, b) 1 October 1995 Dinar Earthquake, c) 17 August 1999 Golcuk Earthquake, d) 1 May 2003 Bingol Earthquake

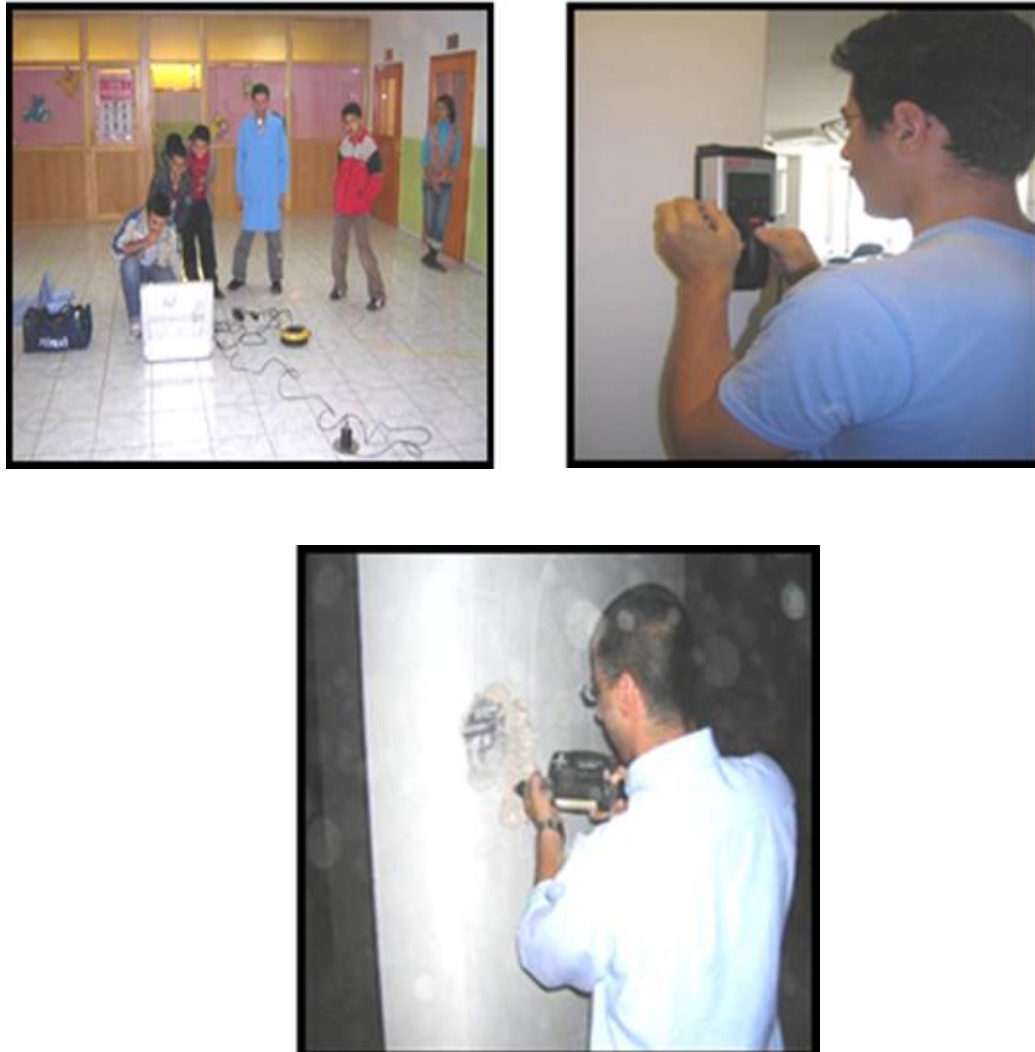
Figure 5. Investigations performed in the buildings

Kirsehir and its close surroundings are one of the regions with a high seismic risk but it is not possible to say anything about the quality of the present building stock until today. In this study, the general structure of the buildings located in Kirsehir and its provinces were sampled and examined with rapid scanning method and 40 reinforced concrete buildings were subjected to a more detailed investigation (Figure 5).

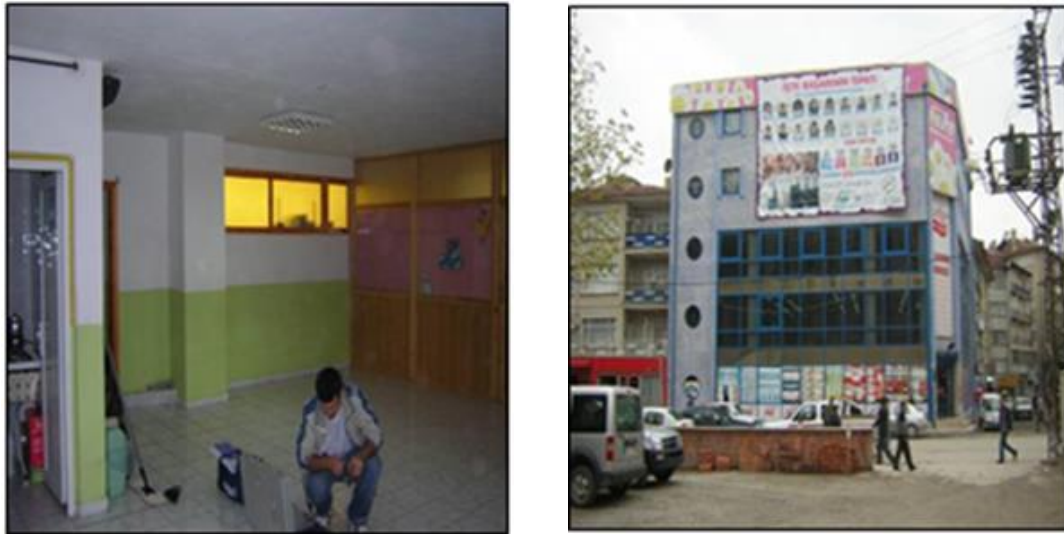
Figure 7. Examples of weak storey, short column, and adjacent buildings

Defects were observed nearly for all buildings. The most common defects among the others are insufficient reinforcement, weak storey, short column effect, and hammering effect during the earthquake caused by different storey levels of the adjacent buildings (Figure 7). Interesting findings were also obtained from the concrete strength detection of the buildings. Minimum compressive concrete strength in the earthquake regions was required as C20 following the change in the Turkish Earthquake Regulations in 1998. The compressive concrete strength value of the sampled buildings constructed before 1998 was determined as 8-12 MPa while this value was determined as 16-22 MPa for the ones constructed after 1998. Corrosion and, accordingly, damage in the structural elements were detected in most of the buildings. The buildings were classified into 4 groups, according to their possible damage (Table 3).

Kirsehir province, like some other provinces, is among the regions where the earthquake region coefficient was changed and the quality of the building stock is rather unspecific. The damage ratio compared to the earthquake magnitude has been unfortunately very high observed from the recent earthquakes. Therefore, the need for the investigation of the Kirsehir building stock, having 42057 buildings in the city center, has emerged. A high ratio, 85%, of the investigated buildings is under risk as observed from the results of the investigations. On the other side, it is possible to state that the masonry buildings, which were not investigated in this study, also fall into this risk group. Thus, retrofitting works should be initiated as soon as possible starting with the buildings at the high-risk group.
