Seismic Performance Comparison of a Building Made with Old Masonry Bayburt Stone According to Old and New TBDY.

Omer Can
Civil Engineering Department, Bayburt University
21 Subat street Bayburt 69010, Turkey
E-mail: ocan@bayburt.edu.tr

In this study, it is aimed to compare the earthquake performance analysis of a masonry structure made with Bayburt stone according to Old (TBDY-2007) and New (TBDY-2018). For this purpose, a technical Vocational High School for Girls building located in the city centre of Bayburt was handled and the survey work was carried out. After moving the measurement to AutoCAD program, the modelling was done with the help of StatiCAD-Masonry Program and performance analyses were obtained and results were compared.

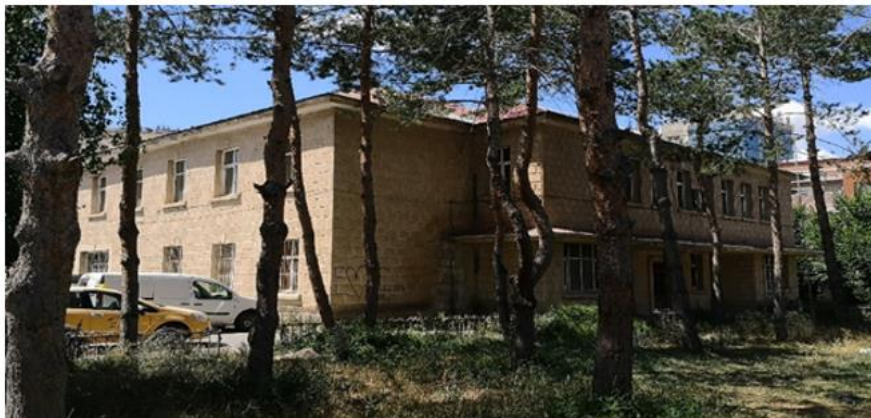
Figure 1. Left View of the Girl's Vocational High School Building (2019)

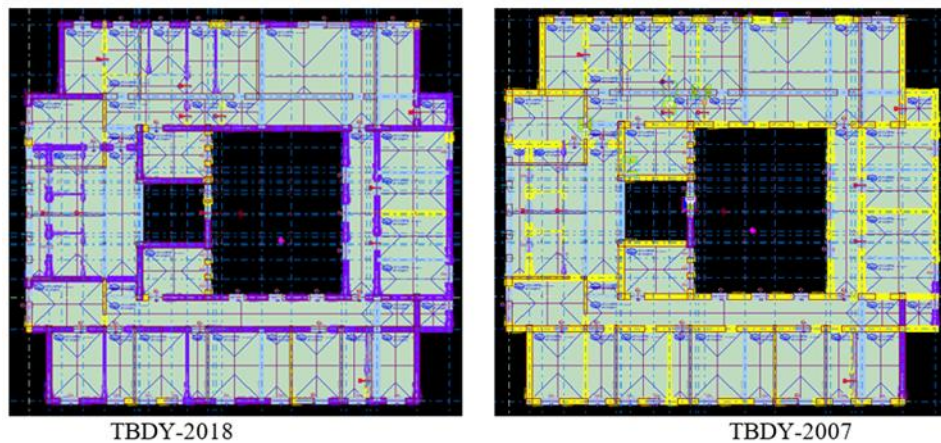
Figure 4. Elements that do not yield pressure and shear stresses on the ground floor as a result of the analysis

- As a result of the analysis of the structure, according to TBDY- 2007, 46 walls were found sufficient in the X-X direction and 6 out of 55 walls in the Y-Y direction were found insufficient. On the 1st floor, all 50 walls in X-X direction were found sufficient and in Y-Y direction, 4 out of 35 walls were found to be insufficient. According to TBDY- 2018, 36 of the 46 walls in the X-X direction were found insufficient in the ground floor, 36 of the 55 walls in the Y-Y direction were found insufficient.

- In the first floor, 41 out of 50 walls in the X-X direction were found insufficient, and 9 out of 35 walls in the Y-Y direction were found insufficient. While 6% of the 101 walls on the ground floor of the building were found insufficient compared to TBDY- 2007, this value corresponds to approximately 72% compared to TBDY- 2018.

- The deficiencies in the walls are shown in different colors in **Figure 4** and **Figure 5**. In the walls indicated with orange color, no pressure stress is provided. Shear stress was not provided on the walls indicated with purple color. Both the pressure and shear stress were not provided on the walls indicated with red color.

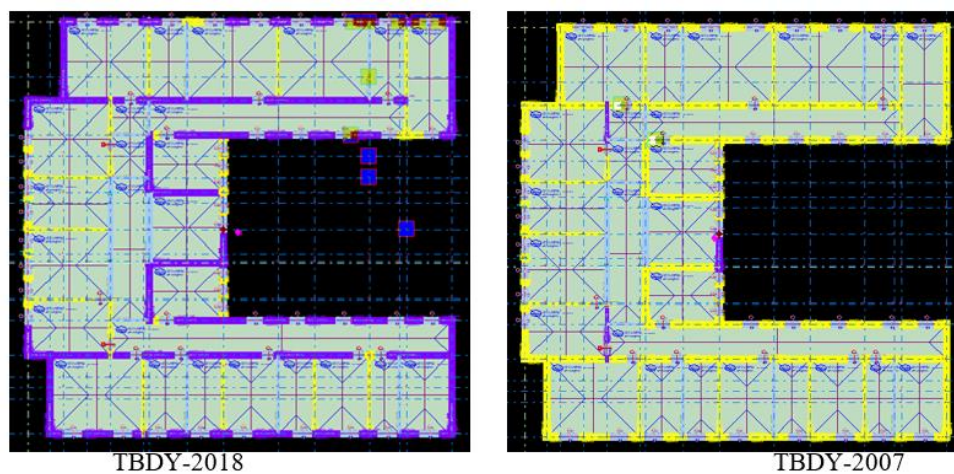
Figure 5. Elements that do not yield pressure and shear stresses on the first floor after analysis

- While 85% of the 85 walls on the first floor of the building are insufficient compared to TBDY- 2007, this value corresponds to approximately 60% compared to TBDY- 2018.
