Impact of Erosion on Street Roads: A Case Study Of Sijuwade

Area Akure Ondo State Nigeria

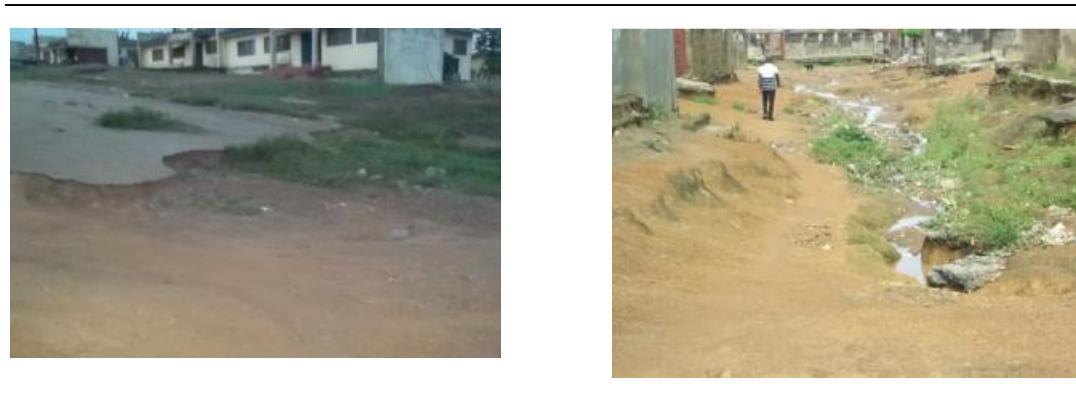
To an extent when rainfall water infiltrates into the existing soils that serve as the foundation for these unpaved street roads and when water input exceed the soil's capacity to absorb water runoff occur. Runoff when improperly channeled lead to erosion. On most of the unpaved roads studied there exist underlying impervious rock layers leading to formation of gully when the loose soil particles that overly these road has been remove. Such a scenario was observed on Yaba Street Idi-AgbaTitun as shown on plate 2.

Particularly, Erosion impact was found to be severe on Yaba Street at Idi AgbaTitun. Also, terrain where underlying impervious layers does not exist, craters were created making such road non motor able. A typical example of such was found at Ifelodun Streets as shown in Plate 3.

Plate 2a: An Eroded Surface of a Paved Road and Gully Erosion at Yaba Streets

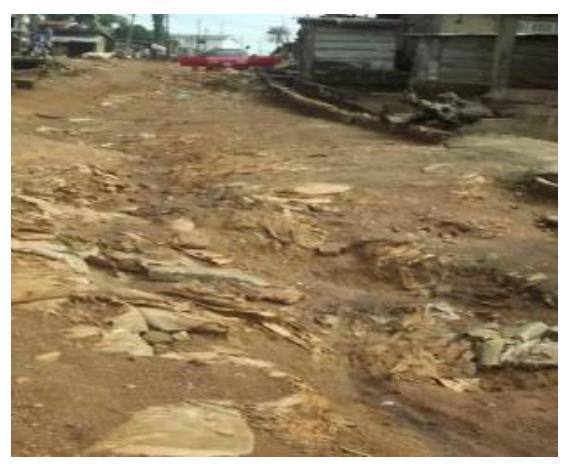
Plate 3: Erosion Problem at Ifelodun Street

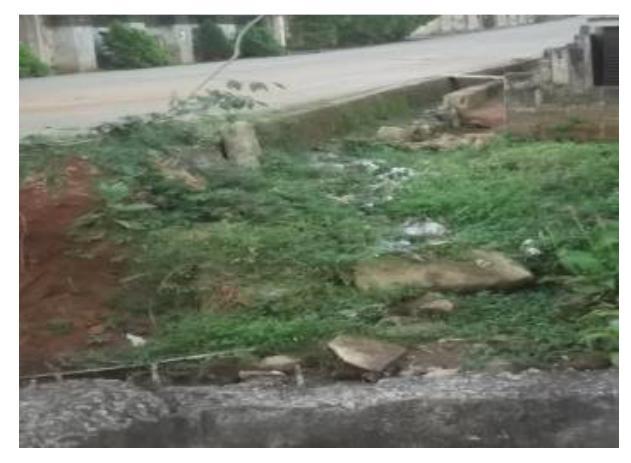
Land use pattern in the areas studied were observed to be terrible. Some of the buildings were observed to be constructed on waterway. Also the way refuses were dumped in the existing drainage limited the way in which drainage performs and when drainages which are expected to be conveying runoff from the road surfaces are obstructed it causes erosion. This often aids in the development of gully on roadway and sometimes flooding which affect both homes and pavement infrastructures as capture in plate 4.

Plate 4: A Typical Example of a Block Drain

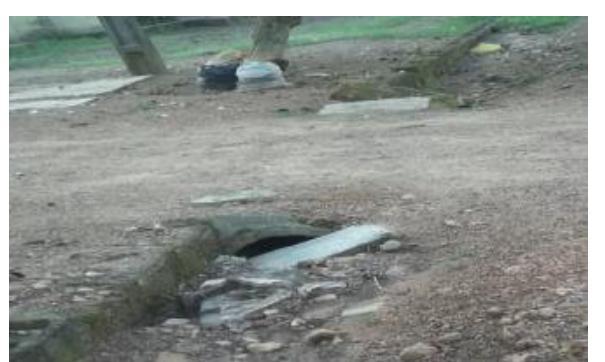
causes roadway flooding. Typical example of this can be found on New Sijuwade Street. In this case, uncontrolled run off and incessant disposal of wastes into the drainage channel often causes flooding when rainfall and this has also lead to carving in of the cross culvert that provide access to other parts of the streets. Typical example of poor maintenance practice was also found on Ala quarter where a damaged drainage was not repaired as shown in plate 5 and 6.

Plate 5: An Improperly Maintained Drainage at Ala Quarters

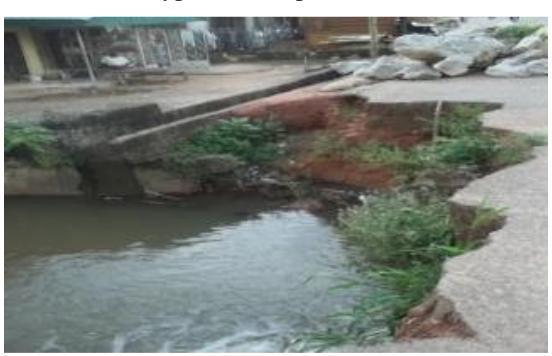
Plate 6: A Caved in Section of Sijuwade Street

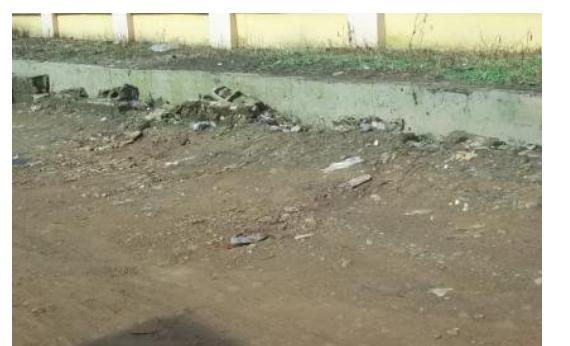
Also improper construction of drainages and culvert were also found to cause road erosion. Drain that was supposed to be constructed using concrete retaining wall at one side and block wall on the other were observed to be constructed using double block wall. Alternate drying and shrinkage of these block wall by rain lead to dying shrinkage and whenever these occur they tend to give way to erosion thereby causing runoff to flow on road surfaces. Typical example can be seen on Plate 7, in this case a double block wall.

Plate 7: A Badly damaged Drain at Dele Johnson Street Due to Improper Construction
