Leakage in Bayer Dam in Jordan: Its Causes and Consequences

ABSTRACT

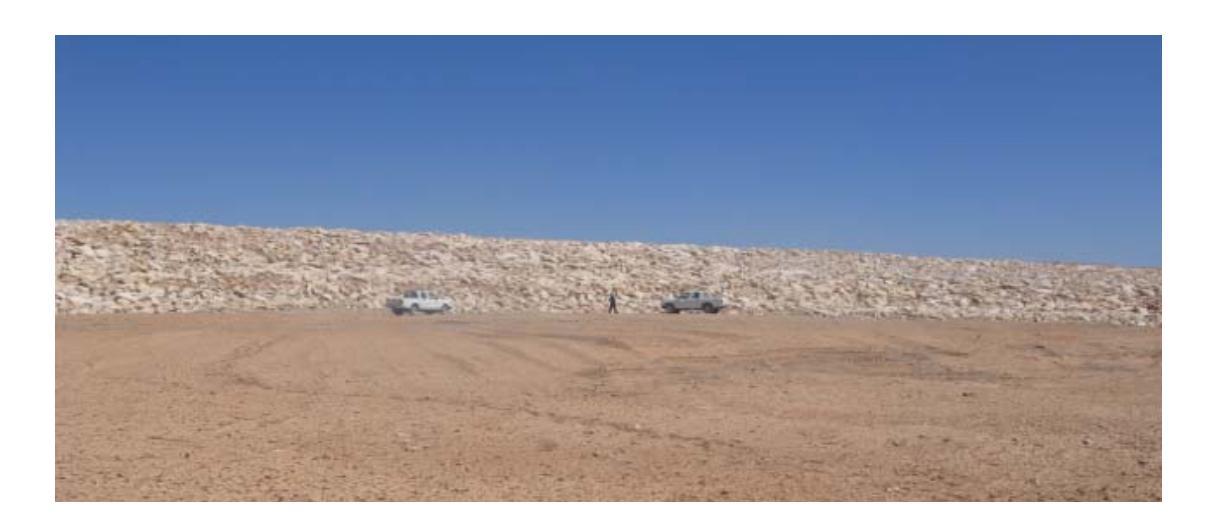
The internal policy of HF tries to reduce expenses as much as possible to widespread projects where it is possible in the country to achieve its aims. Accordingly, Jordan Military Forces with there engineering abilities constructed the dam, building a 6 m high rockfill dam, intersecting Wadi Bayer (Fig 4).

Figure (4): The rockfill and reservoir of Bayer dam.

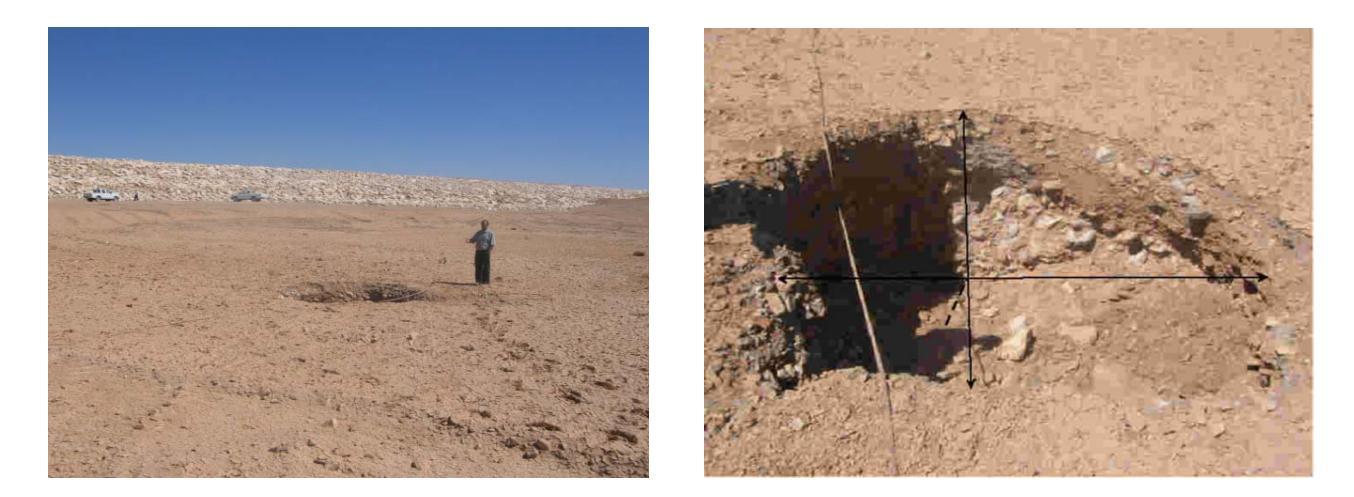
In winter of 2007/2008 the dam has been ready to receive the first floods and was able to collect 0.5 MCM. Some days later, the whole retained water disappeared within only a few hours (as stated by some locals). After the mud got dry, the HF field staff found a newly formed sinkhole in the middle of the floor of the dam, which is unsealed, with dimensions of 4x4 meters, and a depth of 3 meters. This hole caused the water sudden loss (Fig.5: a, b).

Figure (5): (a) Location of the sink in the reservoir of the dam, and (b) The dimensions of the sink.

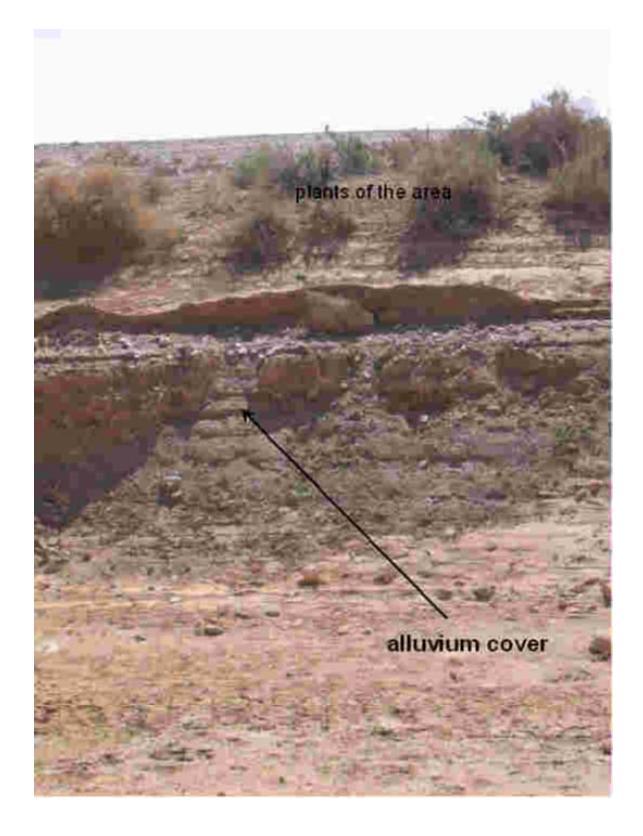
Figure (6): Alluvium covers in the study area.

The study area which is a flat one mostly consists of hard carbonate rocks from Upper Cretaceous to Lower Tertiary, with no major and active faults. A three meters thick layer of alluviums (coming with floods) covers the rock formations all over the area (Fig. 6). Only in lower floodplains, the upper geological formations can be outcropped. Several features of karst have been registered, including sinkholes of recent and old ages, with diameters between 2-8 meters and depths of a few meters (less than 4 meters) (Fig. 7). Land collapse was registered also in the body of the dam. Collapse sinkholes form when an underlying cave passage collapses forming a depression on the upper surface. These sinkholes are actually quite rare, as caves are generally stable.

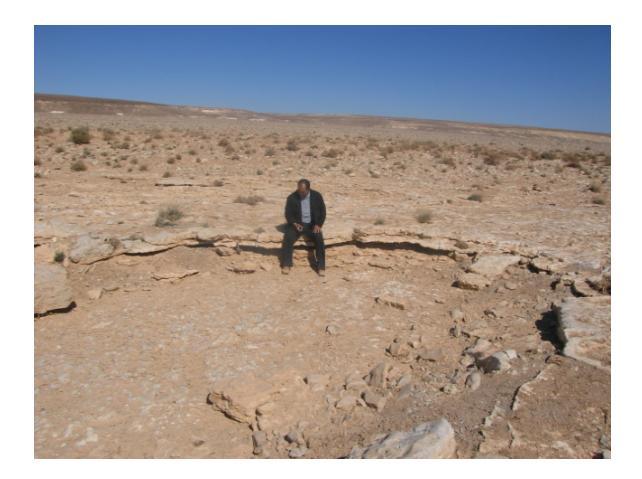
Figure (7): Sinkhole in the study area.

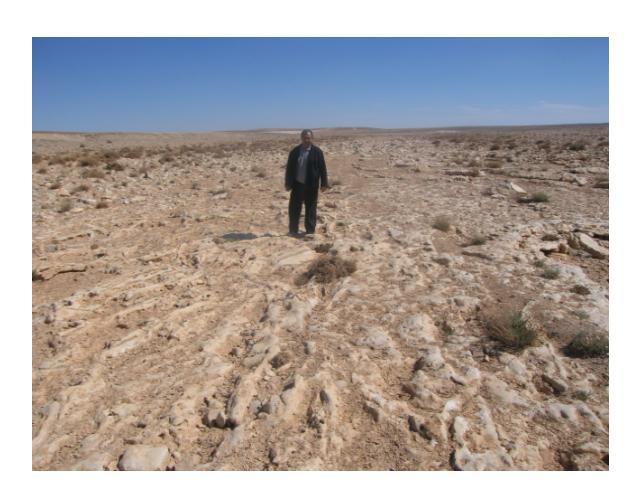
Figure (8): Dissolution along joints.

Dissolution of rocks was found along joints and bedding plains, which in turn led to widening of these joints and plains to some centimeters (Fig. 8). The rocks are highly jointed and take two major directions; 10 and 130 degrees.

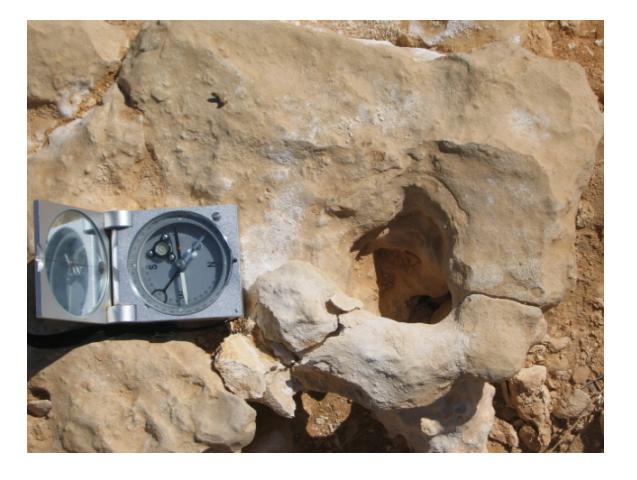
Figure (9): (a) Dissolutional pipes in the rocks.

The rocks show dolines, connected dissolution channels and pipes. The named features are branched and extended (Fig. 9: a and b).

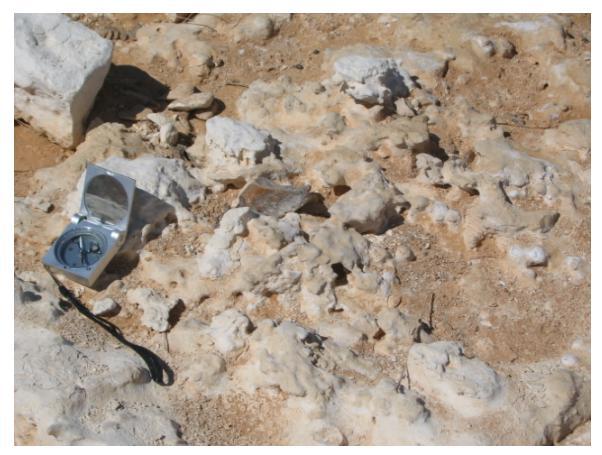
Figure (9): (b) Severe dissolution in the rocks.

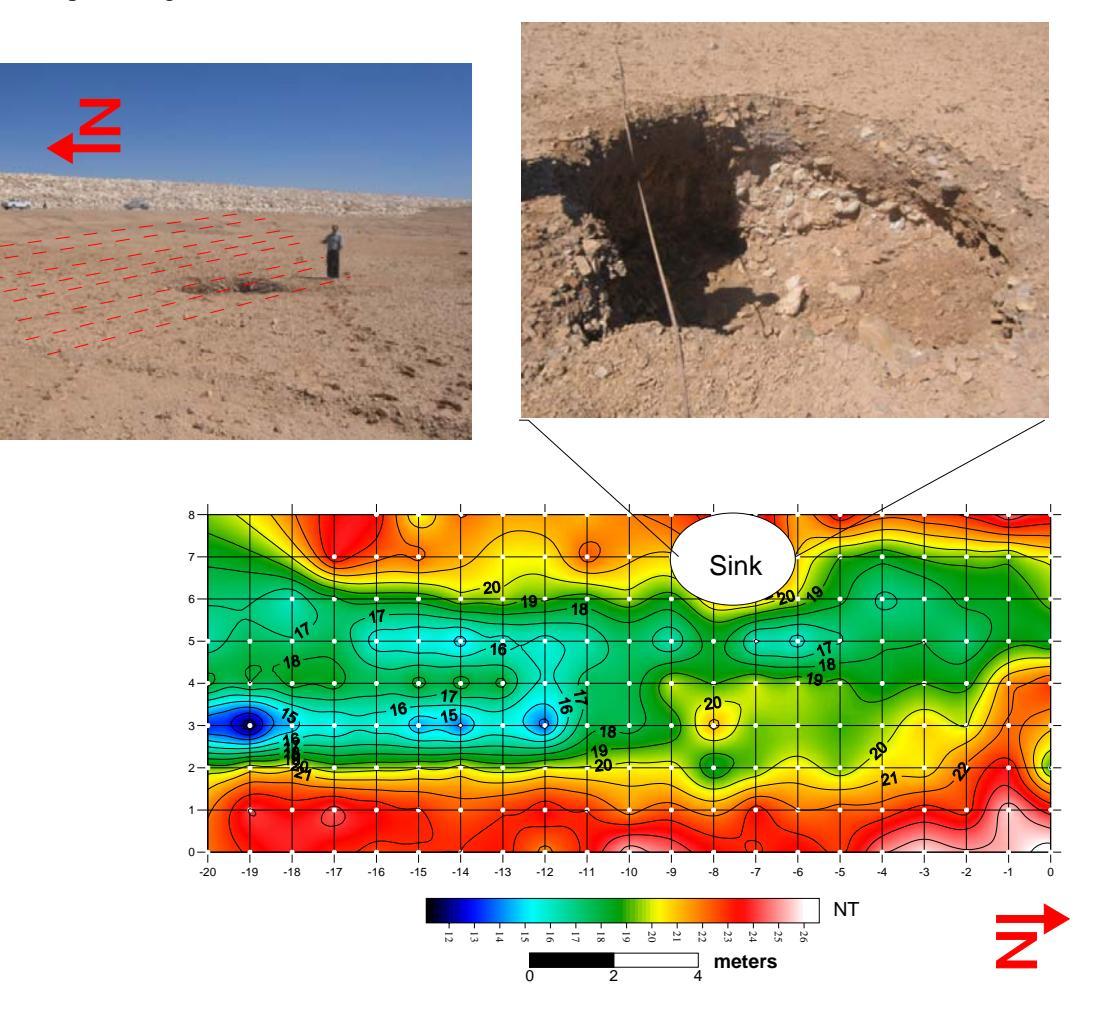
Figure (10): Location and extension of the geomagnetic profiles and the resulting map.

The obtained results have the following statistics: number of values 176, minimum 11.1, maximum 26.6, mean 20.14 and standard deviation 2.934. Figure 10 illustrates the field survey in directions, locations and results. Units of survey are in NT (nano Tesla).

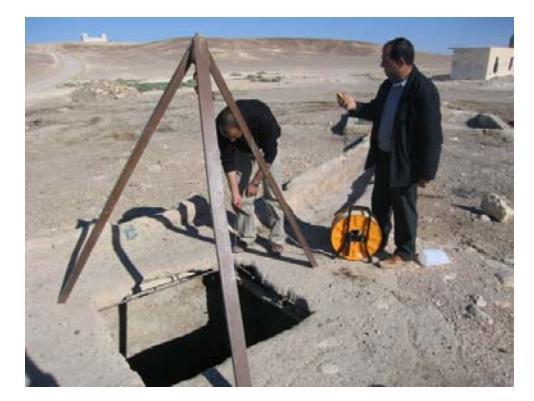
Some shallow dug wells (20-30 m deep) are available in the wadis overlooking the dam. But they seem to be dry since along time before the dam leakage (Fig. 11). The only available deep well is that which was drilled by HF. Two shallow wells and the deep well have been sampled. The water samples have been exposed to chemical analysis. The results are listed in Table 1.

Figure (11): An ancient well in the study area.

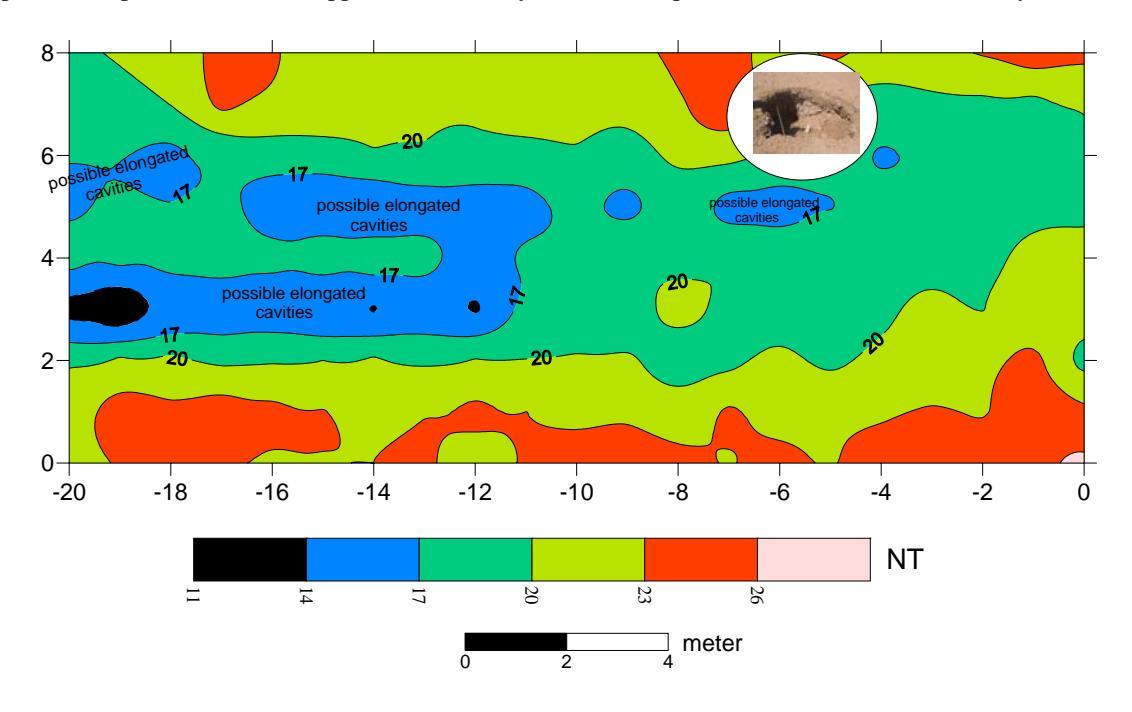
Figure (12): Resulting map from the geomagnetic survey, showing the extension of the caves and dissolution features.

The map in Figure (12) has resulted from modeling of the geomagnetic study. It shows the potential locations of some near subsurface cavities and holes, in addition to extended dissolution pipes in the rocks beneath the lake of the dam. It is obvious from the map that the low values point to the presence of subsurface cavities and tunnels of dissolution. They take directions parallel to the major directions of the joints in the area (10 and 130 degrees). The revealed shapes of the cavities show that they are connected. They can reach more than 8 meters in length. Normally, they are located at depths of around 5 meters.

The study recommends the dam to be used for recharging purposes for the shallow groundwater aquifers in the downstream. Intensive geophysical investigations of high resolutions should be carried out to investigate the near surface geology of the wall of the dam, to check for the presence of cavities, to avoid the risk of sudden collapse and to delineate seepage paths in the karstic
