Landslide Hazards: Geotechnical Aspects and Management Policies

Yousef M. Masannat

ABSTRACT

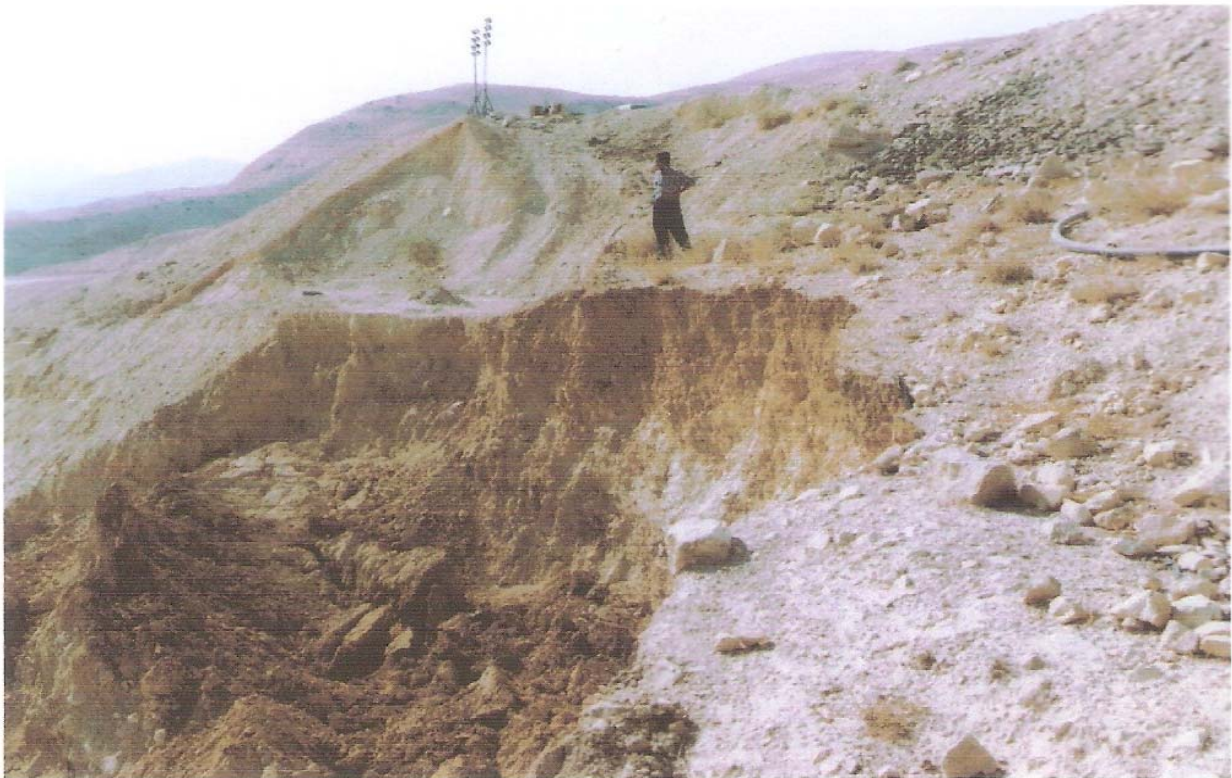
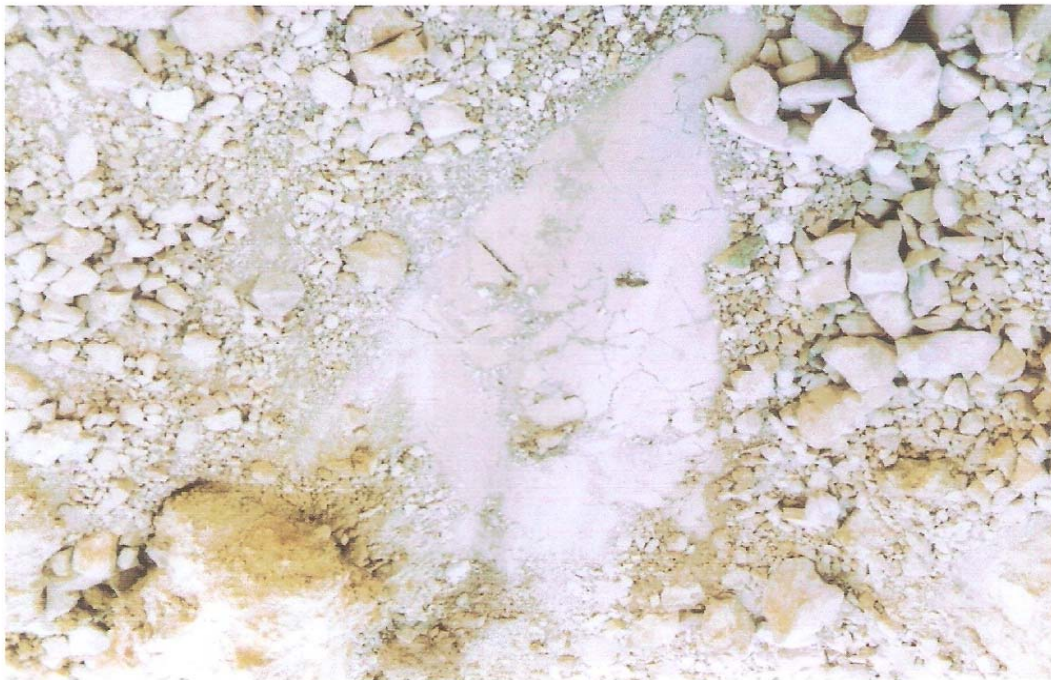
Figure (1): A landslide on the left abutment of Al-Mujib dam

A) The escarpment of the slide in the talus material

B) The slickenslide surface in the underlying mud layer

-Slope failure in the left abutment of Al-Mujib dam caused by the daylighting of a 0.4 to 1.0 m thick wet plastic mudstone layer overlain by porous loose colluvium that allowed the percolation of rainwater towards the mud layer that was dipping steeply towards the excavation (Figure 1).

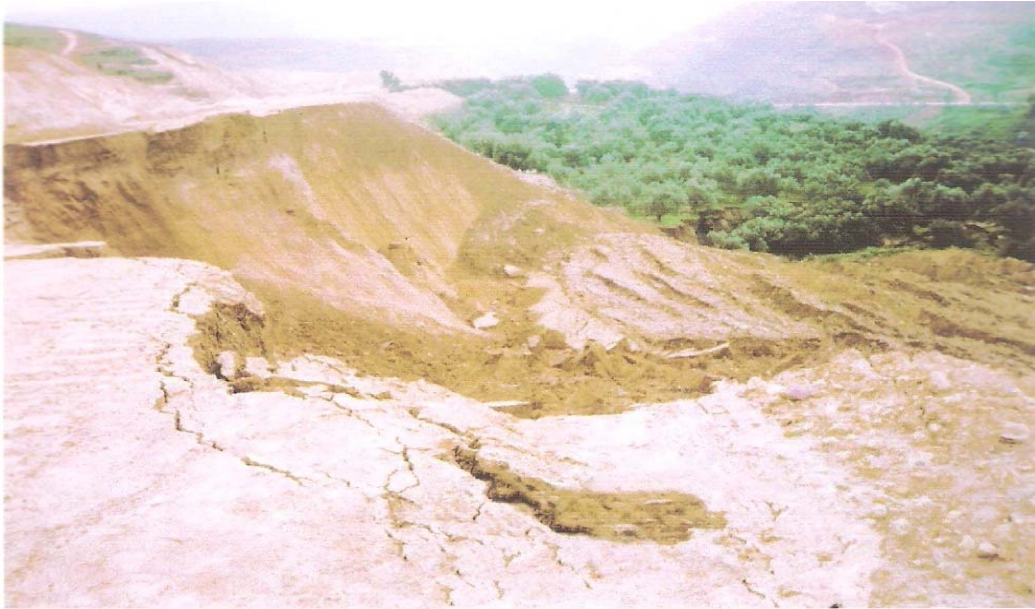
Figure (2): Failure of a 16 m high highway embankment founded on a thick layer of colluvial deposits along Amman-Jerash highway at St. 38+600

-Failure of a 16 m high highway embankment on Amman-Jerash highway founded on thick layers of loose wet colluvial deposits that already existed in a critical state of stability (Figure 2).

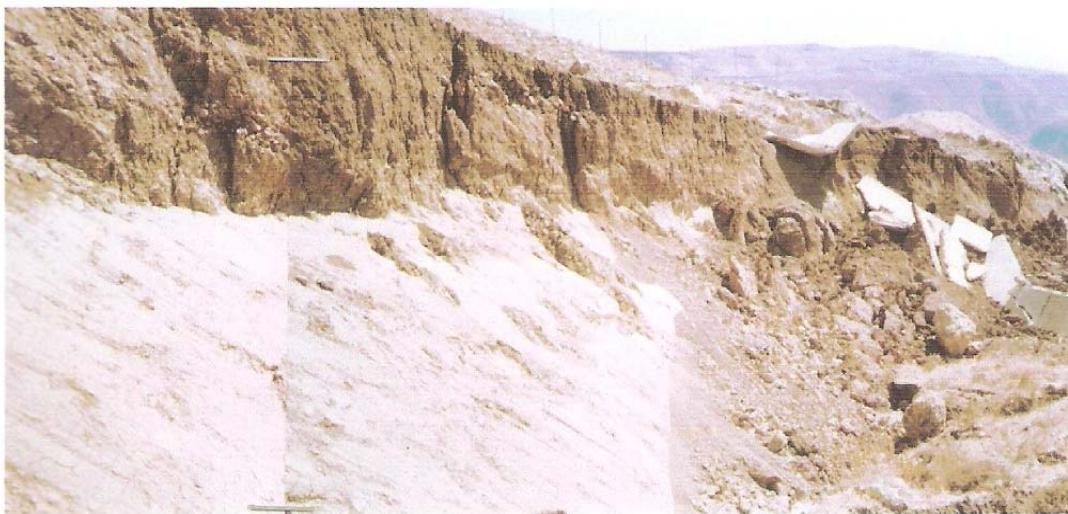
Figure (3): The sliding surface at the top of clayey marl bed in Wadi Es-Sir Sewage Treatment Plant. Note the jointed cliff of the limestone overlying the marl that belongs to Naur Formation (A1/2)

-Four failures in Wadi Es-Sir Sewage Treatment Plant in the period from September 8,1993 to February 23,1997 in spite of the continuous flattening of cut slopes from 1V:2H to 1V:4H. The failures occurred along slippery planes of wet plastic clayey marl in an area that experienced many old landslides and is

characterized by poor drainage conditions as shown in Figure 3 which shows the sliding plane of the failure that occurred on July10, 1995.

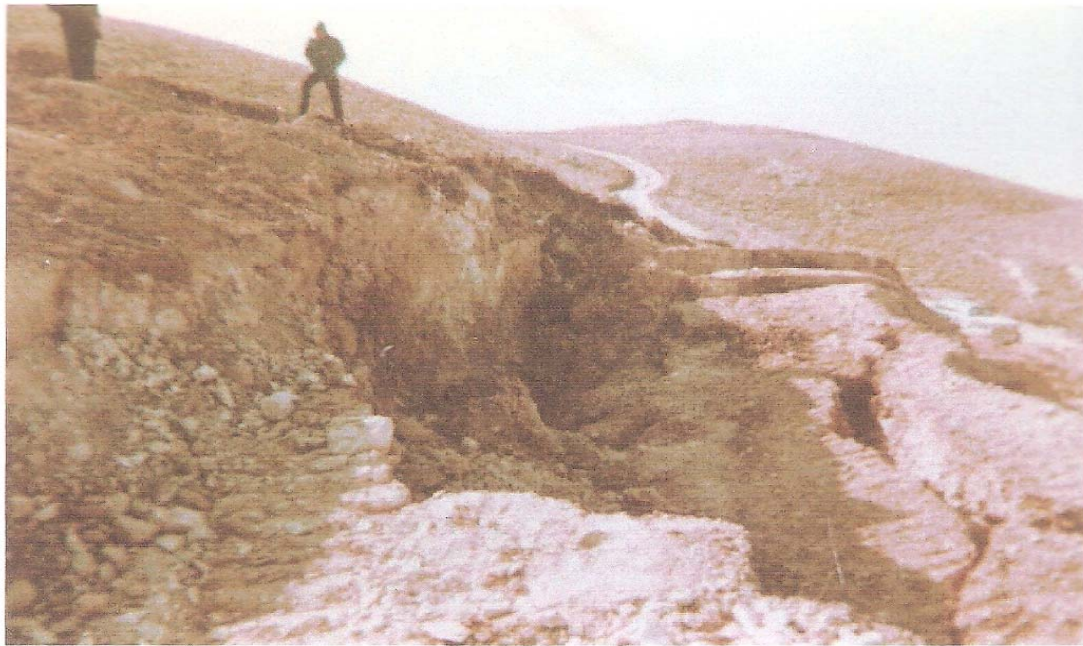
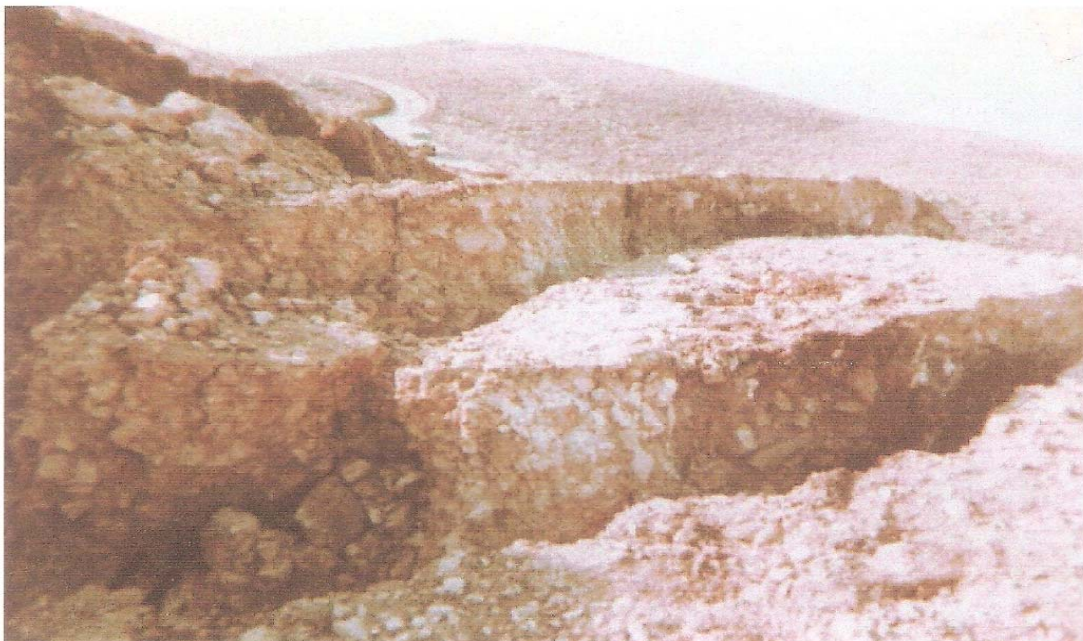
Figure (4): The slide at pump station no. 3

- A) Wide and deep cracks extending to more than 30m beyond the crest of the slope**
- B) The main scarp and failed benches**

-Slope failure at pump station no.3 along the route of the pipeline of pumped water from Deir Alla (Jordan Valley) to Dabouq (west of Amman). The failure occurred due to the daylighting of 0.4 to 0.6m thick layer of wet plastic clayey marl dipping unfavourably towards the excavation (Figure 4).

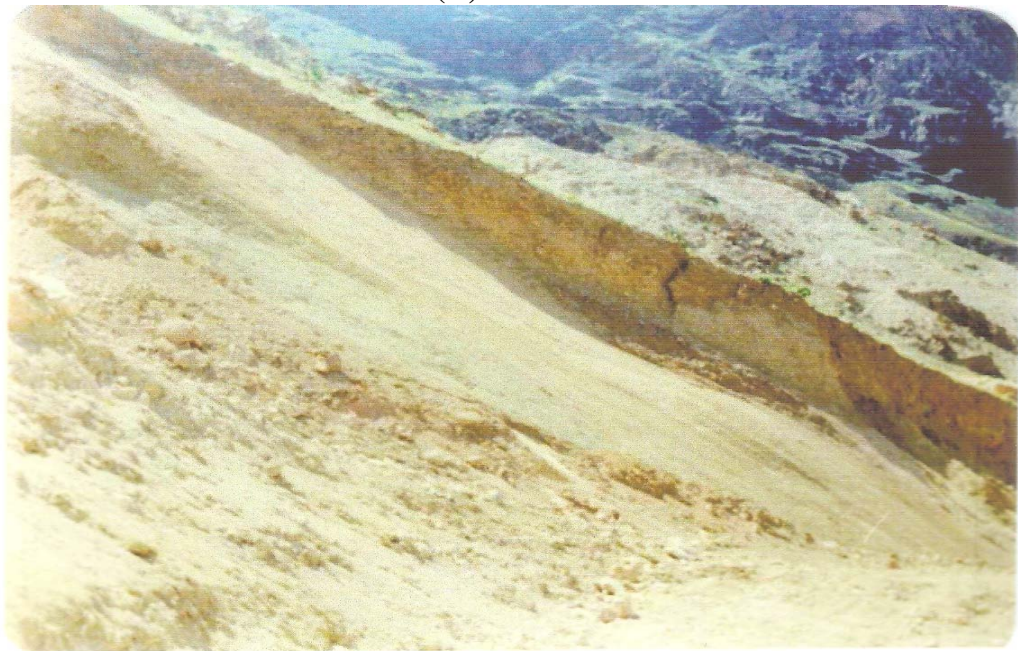
**Figure (5): (A) The cracks on the crest and the sides of the slope overlooking the approach road to the main hotel at Ma'in SPA complex before failure
(B) The smooth sliding surface in the clay marl after failure**

-Slope failure in Ma'in SPA complex main entrance road due to the excavation at the toe of a steep slope composed of wet moderately plastic marl. The failure occurred 4 months after the first appearance of the cracks at the crest and the sides of failed slope (Figure 5).

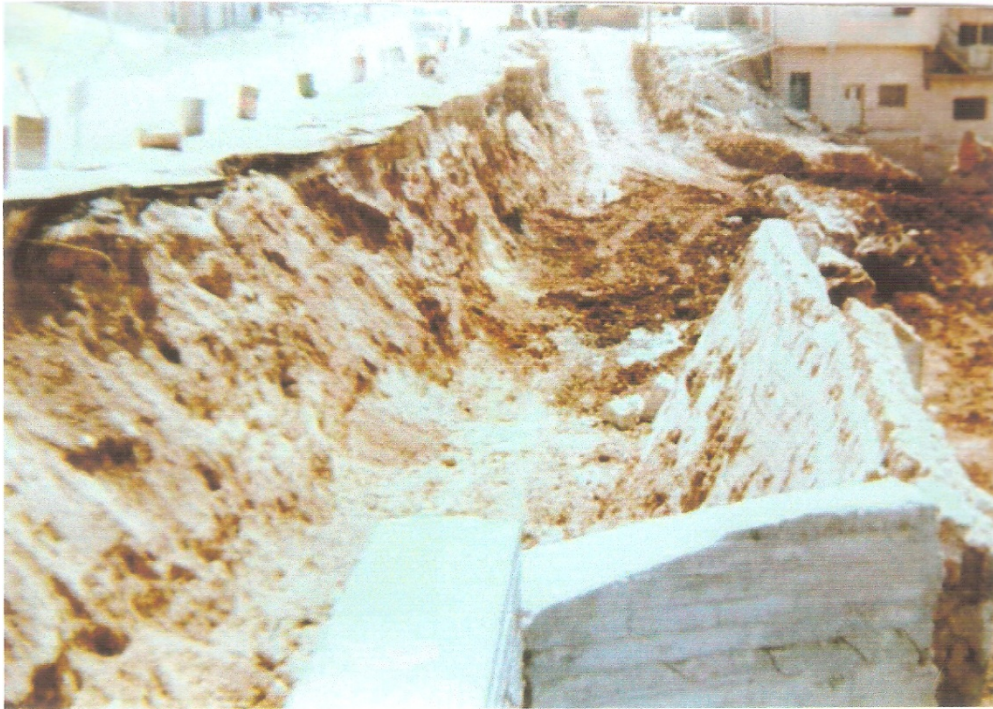
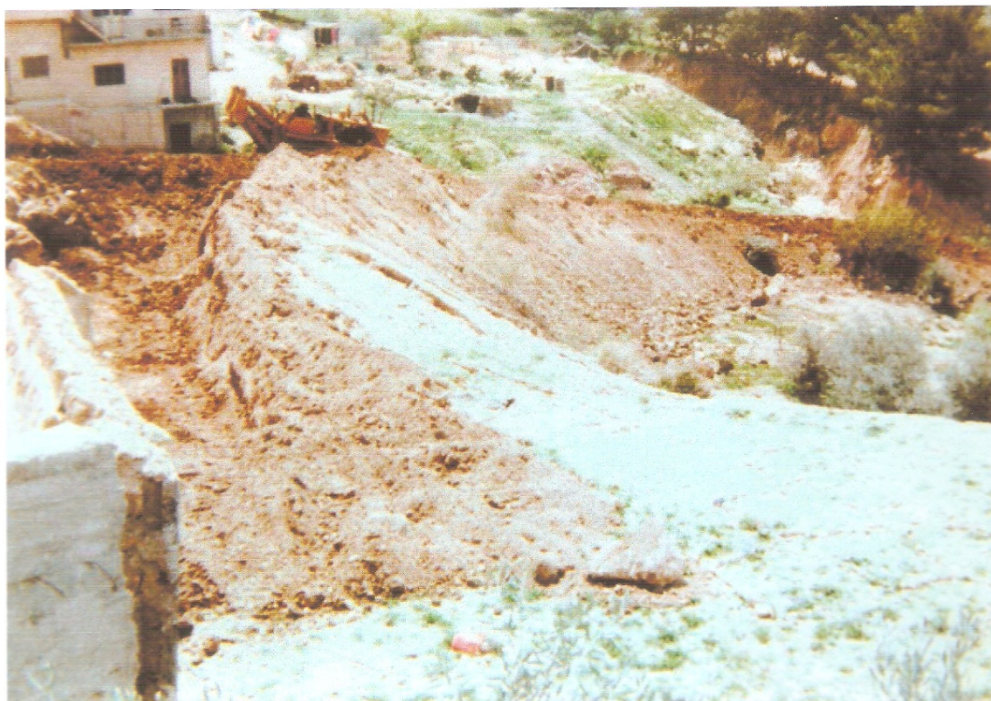
**Figure (6): (A) The displacement and overturning of retaining wall on Wadi Zaid in Tafila
(B) The displacement of slope material beyond the failed wall**

-Failure of concrete retaining walls constructed near Wadi Zaid in Tafila. The failure is due to the low bearing capacity of the very wet plastic clay marls on which the retaining walls were founded. The problem was further exacerbated by the poor quality of backfill material and poor drainage conditions (Figure 6).

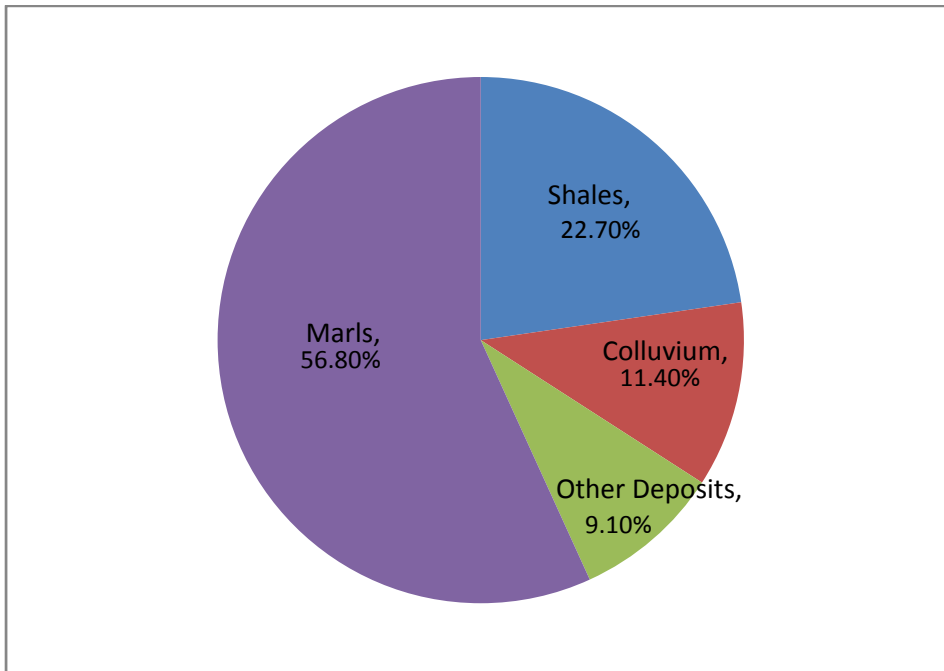
Figure (7): Frequency distribution of the dominating materials in 44 landslide areas

It has been noticed that most of the landslide areas are dominated by highly plastic marls and moderately plastic shales as shown in Figures 7 and 8. Most of the formations that contribute to landslides in Jordan belong to Ajloun Group of the U. Cretaceous and to the Kurnub Sandstone formation of the L. Cretaceous as shown in Figure 9. Also, most of the landslides occurred in the years that witnessed high rainfalls, particularly in the winter season of the years 1991/1992 when the total annual rainfall exceeded 900 to 1000 mm in the highlands of north and west Jordan as shown in Figure 10.

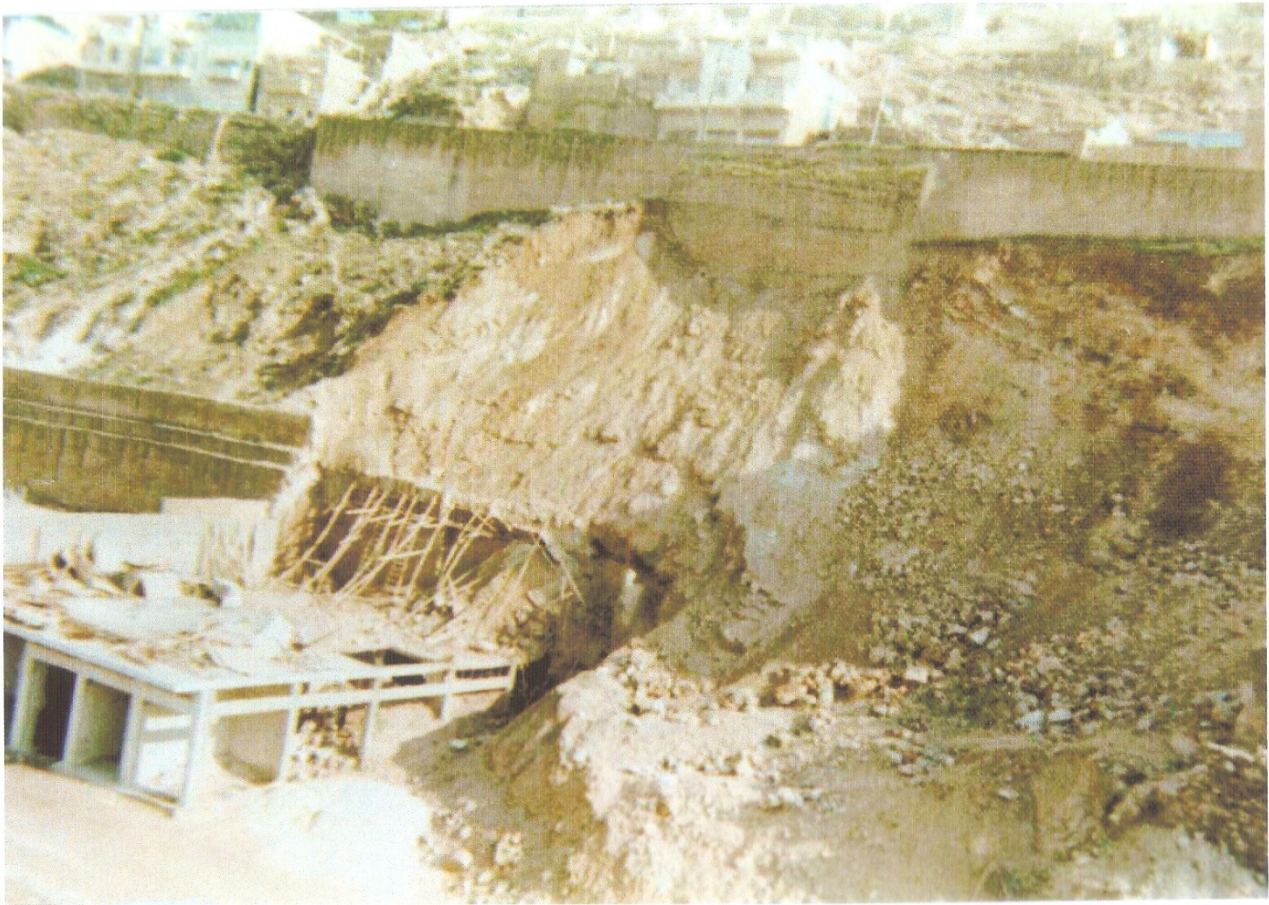
Figure (11): The construction activities at the toe of Jebel Jofeh that led to slope failure and closure of the upper road

Leakage of water from pipelines and ground reservoirs, accumulation of surface runoff in depressions with slow but continuous deep percolation through ground strata and steep cutting of slopes often lead to slope failures as shown in Figures 11 and 12. In Figure 11, the construction activities at the toe of Jebel Jofeh involving excavations and removal of debris from a previous landslide and the leakage of water from corroded pipelines resulted in reactivation of slide and failure of the above retaining wall and the street behind it. Figure 12 shows slope failure on Amman-Jerash highway due to the poor drainage conditions and daylighting of wet plastic marls due to nearby deep steep excavation. These failures resulted in the closure of a main road in Jebel Jofeh, destruction of many houses along Amman-Jerash highway and deportation of people from their damaged homes to safer ones. The placement of a thick embankment fill along Jordan

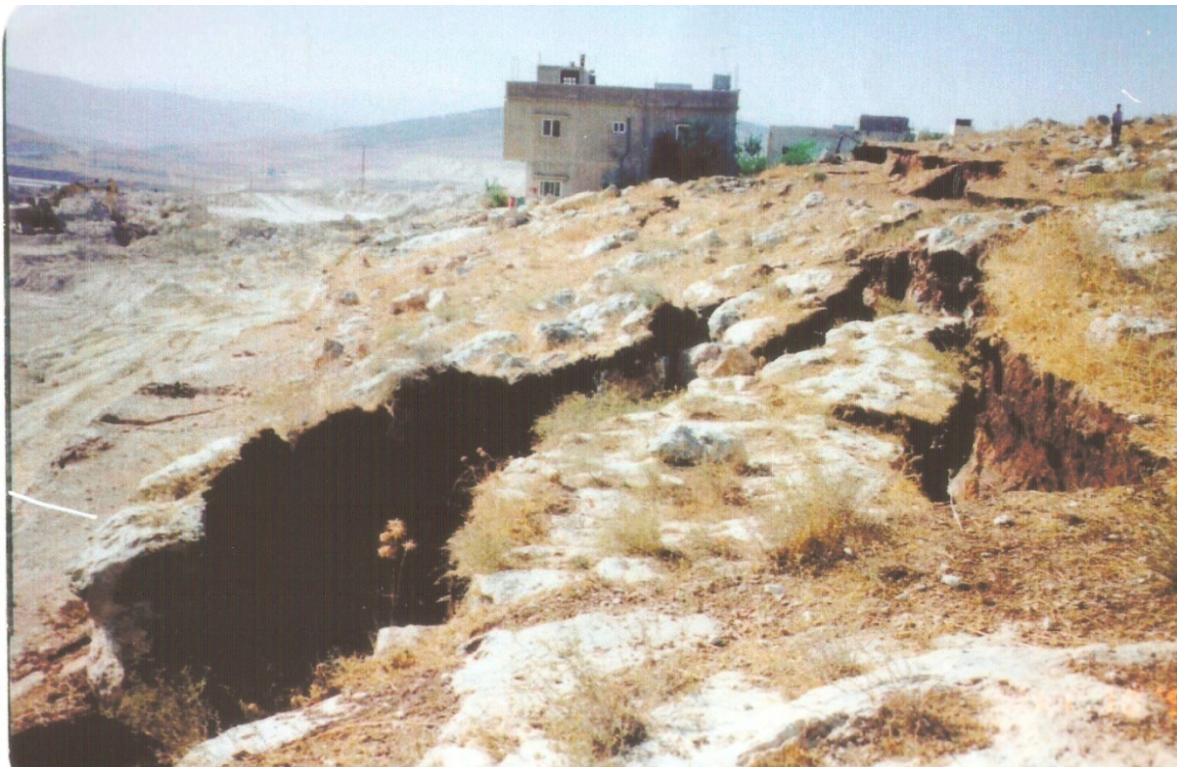
Figure (12): Failure along Amman-Jerash-Irbid highway due to the daylighting of the wet plastic clayey marl that resulted in the collapse of the houses near the edge of the excavation

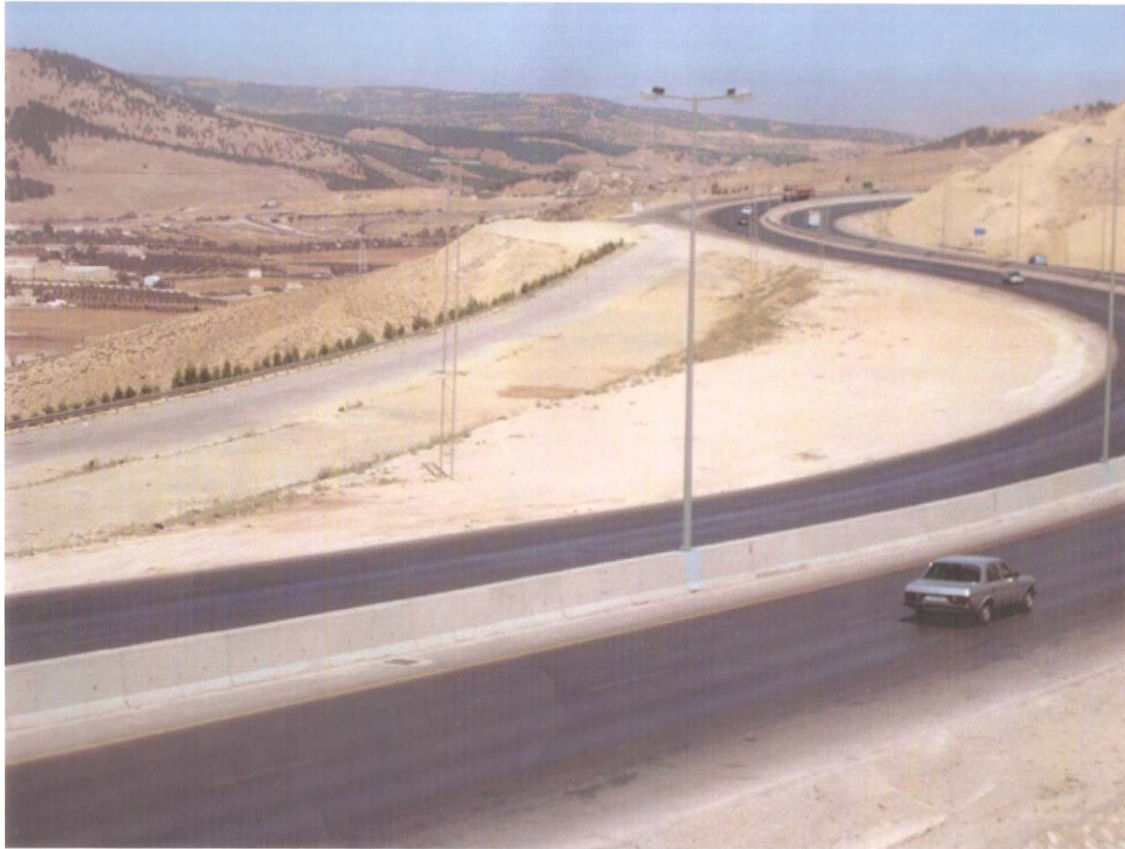
Figure (13): Shifting of a section of Jordan Road due to a continuous creep movement of the road embankment constructed in an area that suffered from an old landslide

road on a pre-existing slip plane in an area that suffered from an old landslide resulted in a creep displacement that caused drop and cracking of the asphalt road. The

only feasible solution was to shift this section of the road towards the hill side as shown in Figure 13.

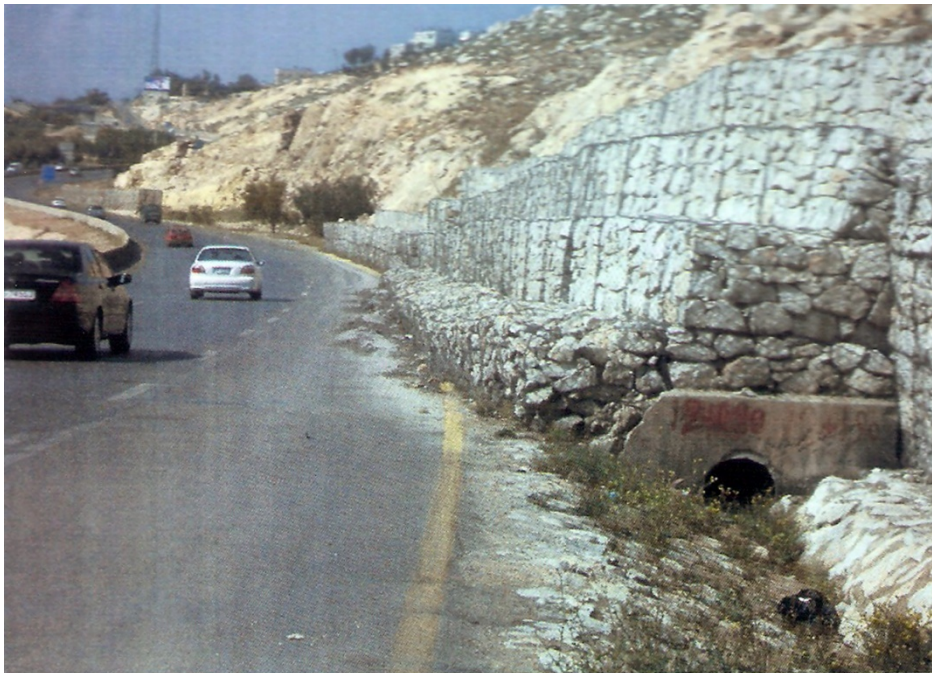
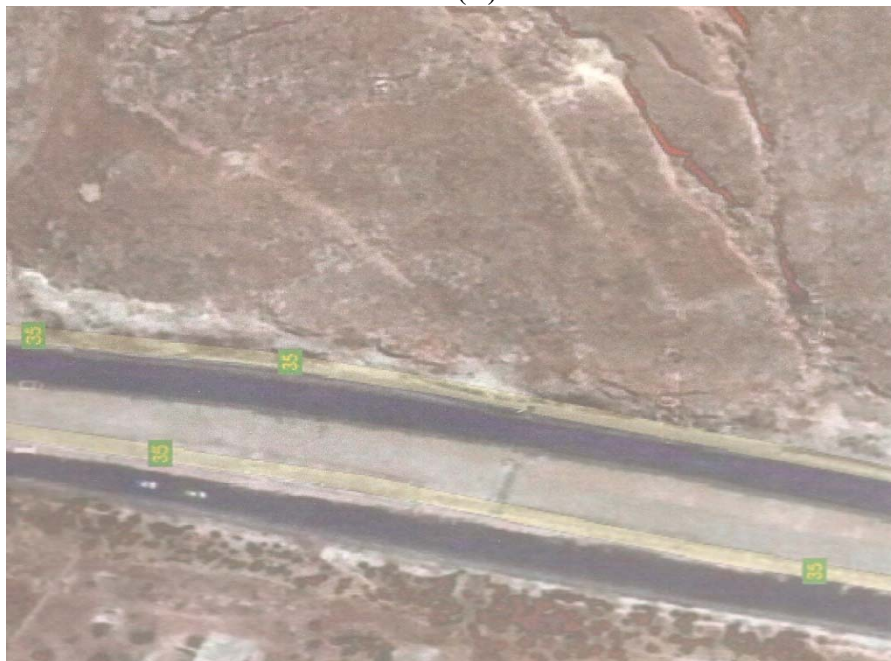
**Figure (14): (A) Severe damage in the gabions and the asphalt of Amman-Jerash highway due to the creep displacement of the failed slope along the wet plastic marl sliding surface at St. 56+600
(B) Satellite image of the landslide**

The daylighting of a layer of a disturbed reworked plastic clayey marl under a succession of limestone and marly limestone beds at Station 56+600 along Amman-Jerash highway resulted in a major landslide exceeding 120,000 m³. This resulted in the adoption of a split-level design of the highway. In spite of the construction of gabions at the toe of the sliding mass continuous creep of this mass resulted in the last 18 years in excessive distortion of the gabions and the asphalt road as well (Figure 14).

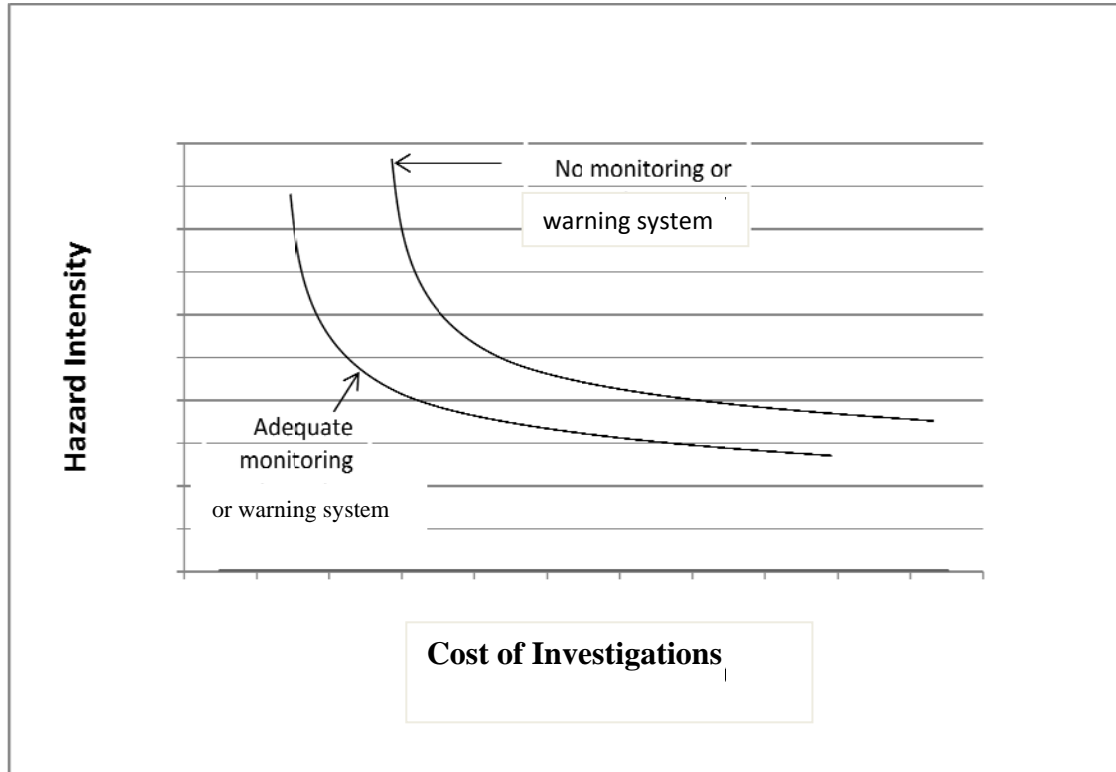
Figure (18): Cost of investigations vs. hazard intensity

The significant role of early warning systems stems from the fact that the number of fatalities due to natural hazards is much lower in the developed countries which use adequate monitoring and warning systems than in the underdeveloped ones which lack such systems (Figure 18).

through metastable hilly areas These aim at reducing the cost of hazard reduction measures as shown in Figures 18, 19 and 20.

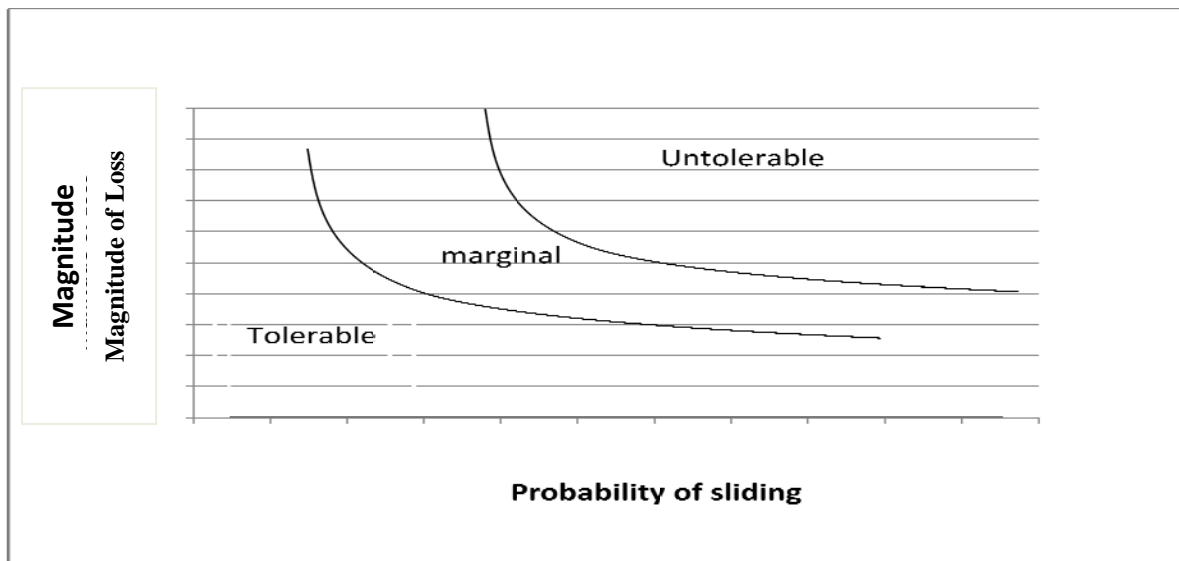
Figure (19): Effects of probability of sliding and magnitude of loss on the tolerance level of sliding

Due to the exponential growth of population who seek settlement in the major cities located in the hilly and rugged terrains, landslide and rock fall hazards continuously increase. Prevention of all landslides and rock falls often entails prohibitive costs that many countries cannot afford. Some minor slides could be tolerated depending on their probability of occurrence and the associated magnitude of loss as shown in Figure 19.
