Mural Restoration as an Effort to Restore the Originality of a Cultural Heritage Building at Santa Ursula Chapel in Jakarta

Abstract

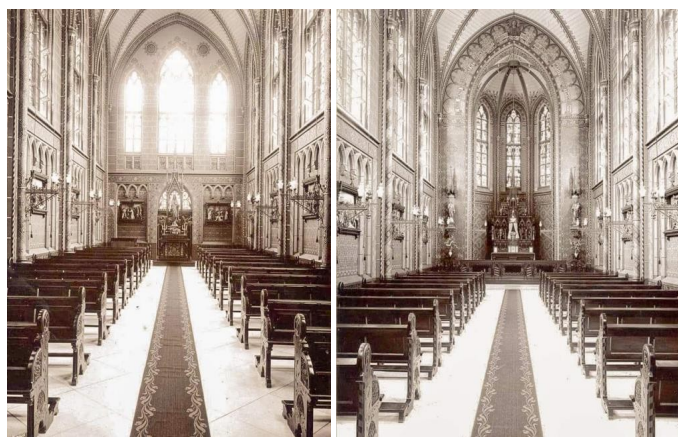
Figure 1. Existing Design (Phase 1) - Santa Ursula Chapel

A. Dijksmans had attended a course in ecclesiastical architecture in France and had built two churches in the Netherlands. This Jesuit father designed and built a chapel in the Ursuline nuns of Jl. Pos no.2 before 1888 [2]. This is one of the Neo-Gothic styles in Batavia until now. Design P. Dijksmans shows subtle early French Gothic influences. People's room with rows of special benches for the officials on the left and right walls, it is slender patterned with a high ceiling in the form of a cross-ribbed vault, which is a ceiling formed by four ribs that meet at a keystone in the middle.

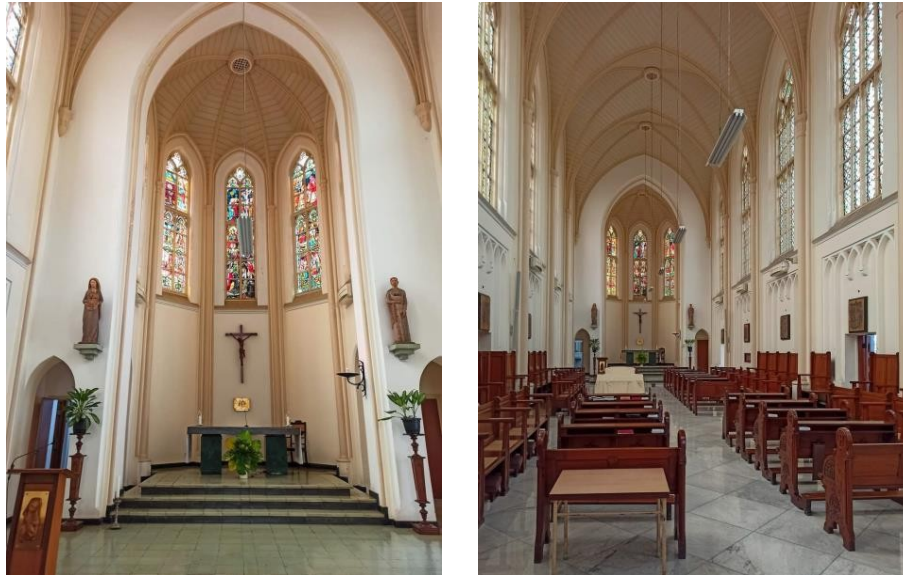
All the long windows lead to the pointed arch above and are filled with stained tin glass patterned with simple geometric motifs. The five windows in the altar area are more strongly colored showing events from the gospels as well as the accounts of saints, especially from the legend of Saint Ursula. Renovation was carried out by closing all mural decorations based on the policy of the Second Vatican Council in 1962-1965 which prioritized simplicity so that the church became more populist.

Figure 2. Design Renovation (Phase 2) - Santa Ursula Chapel

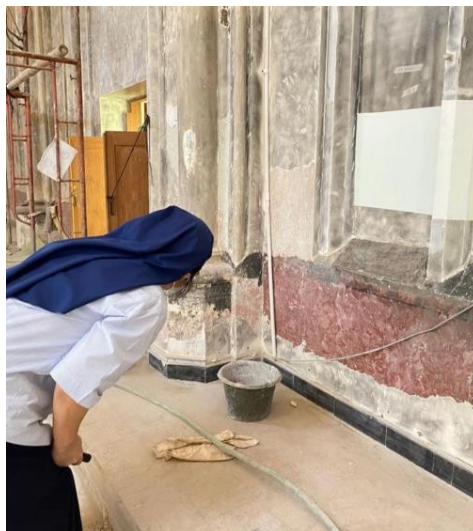
Based on the importance of building maintenance, renovations were then carried out again in 2021. In the renovation, the original mural was found which was applied to the chapel in 1888.

Figure 3. Wall Exfoliation Process - Santa Ursula Chapel (Phase 3)

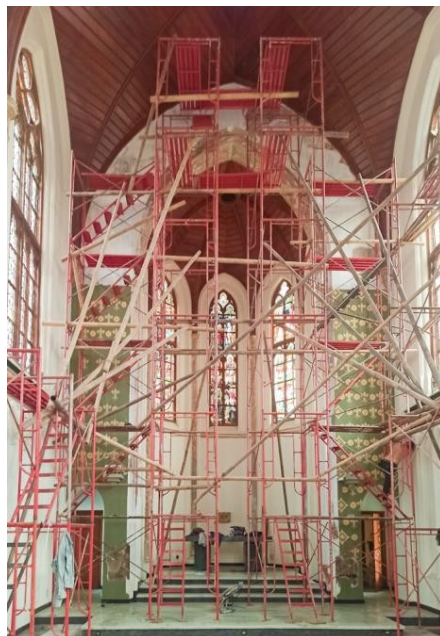
With the discovery of the mural, restoration was carried out on the heritage building as an effort to restore the originality of the motif. The restoration was carried out by the team of Han Awal and Partners by peeling off the wall paint and restoration the mural motif.

Figure 4. Restoration Process - Santa Ursula Chapel (Phase 3)

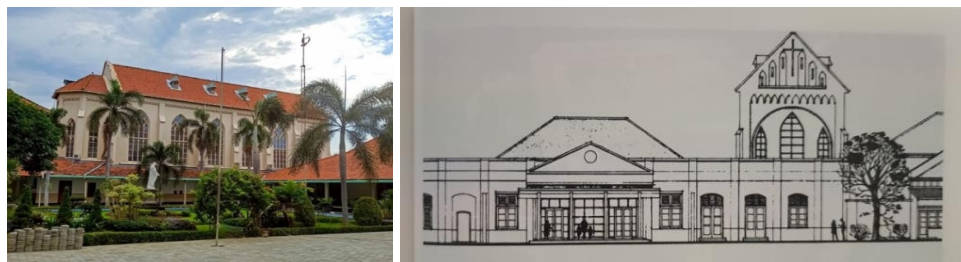
Figure 7. Front and Side Building - Santa Ursula Chapel

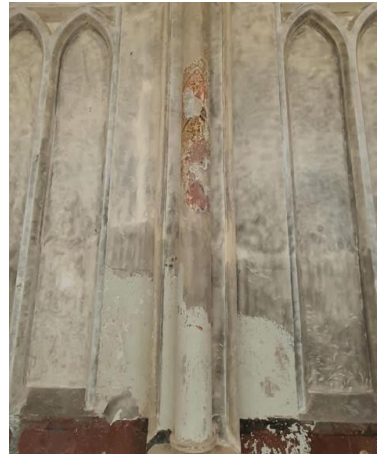
In the renovation process carried out in 2021 on the Santa Ursula Chapel Heritage Building, original motifs were found after peeling off the walls.

Figure 9. Wall Restoration Process Santa Ursula Chapel

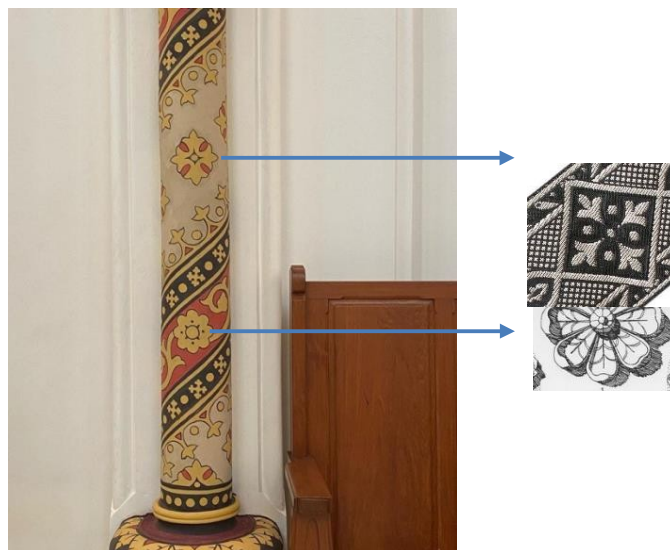
After reconstruction, the mural motif was redrawn as a form of restoration in an effort to restore the condition of the heritage building accurately according to its authenticity by removing additional elements / components and materials (in this case wall cladding paint) and replacing missing elements / components to become their previous form in the initial design period in 1888 when the Santa Ursula chapel was first built.

Figure 10. Colom Mural Renovation Process, Neo Gothic Motif Applied

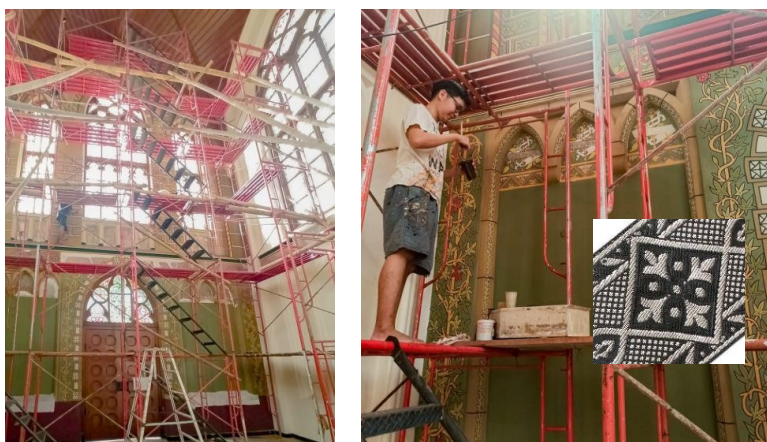
This restoration effort was carried out for 2 years by peeling off all the covering paint until the initial mural base was found on all the walls and architrave of doors and windows of Santa Ursula chapel. In addition to murals, restoration was also carried out on most of the interior elements of the Santa Ursula chapel such as the ceiling, walls and columns in the interior of the chapel.

Figure 11. Wall Mural Restoration at Santa Ursula Chapel
