An overview of nitrates-induced corrosion of reinforced concrete structures: case studies, laboratory investigations and corrosion mechanisms

Abstract. The paper presents the results of the research on the long-term corrosion behaviour in service of the reinforced concrete structures located in nitrates-based industrial environments. Two representative types of reinforced concrete structures were investigated: industrial multi-storied buildings of fabrication and granulation towers of nitrates-based products. The case studies revealed the existence of severe nitrates-induced corrosion damage affecting the resistance, stability and durability of structures in these aggressive environments. Laboratory investigations performed on a large number of concrete and steel reinforcement samples, which were extracted from the corrosion affected elements, underlined the complexity of the corrosion process of reinforced concrete in nitrates-based environments affecting concrete and steel reinforcement by different mechanisms. The degradation of concrete consists in some decalcification and expansion phenomena which lead to cracking and, finally, to a rapid concrete destruction. The stress corr

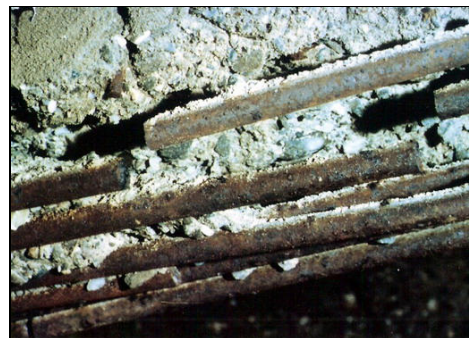
The reinforced concrete beams and arches presented severe local damages due to corrosion, which led in the end to a significant reduction or loss of bearing capacity of some elements (figures 1 and 2). Mainly, these damages consist in:

- concrete cracking by corrosion under the action of nitrates, especially at the bottom of the beams/arches, followed by spalling and corrosion destruction of the concrete cover and by uncovering of the reinforcements; local reduction of the elements cross-section due to corrosion of the concrete in its depth;

Fig. 1. Beam: corrosion destruction of concrete cover; fragile fractures of the longitudinal and transversal steel reinforcements by stress corrosion cracking.

- fragile fractures, without reduction of the cross-section, of the longitudinal and transversal steel reinforcements, in some areas, caused by nitrates-induced stress corrosion cracking; localized (pitting) and generalized corrosion phenomena of the reinforcement steel were also observed;

Considering the advanced corrosion damage state of some structural elements, which affects the resistance and stability of the investigated structures, intervention measures regarding the repair, strengthening or replacement of the damaged elements were proposed [5].

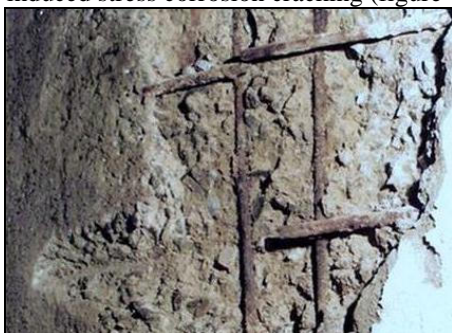
The reinforced concrete walls of the granulation towers presented advanced damages by corrosion, visible on the exterior of the towers, in areas disposed on their entire heights, in the shape of swellings, cracks and local spillings of concrete, with reinforcements uncovering and fragile fractures of the steel reinforcements by nitrates-induced stress corrosion cracking (figure 4).

Fig. 4. Wall: local spalling of concrete cover; fragile fractures of the steel reinforcements by stress corrosion cracking.
