## Assessment of Metals Accumulation in Selected Dumpsites of Oyo Township, Southwestern Nigeria

Adegbola, A. Adedayo<sup>1</sup> Adewoye, A. Olufunmi<sup>2</sup>

1. Department of Civil Engineering, Ladoké Akintola University of Technology, Ogbomosho, Oyo State, Nigeria
2. Department of Earth Sciences, Ladoké Akintola University of Technology, Ogbomosho, Oyo State, Nigeria

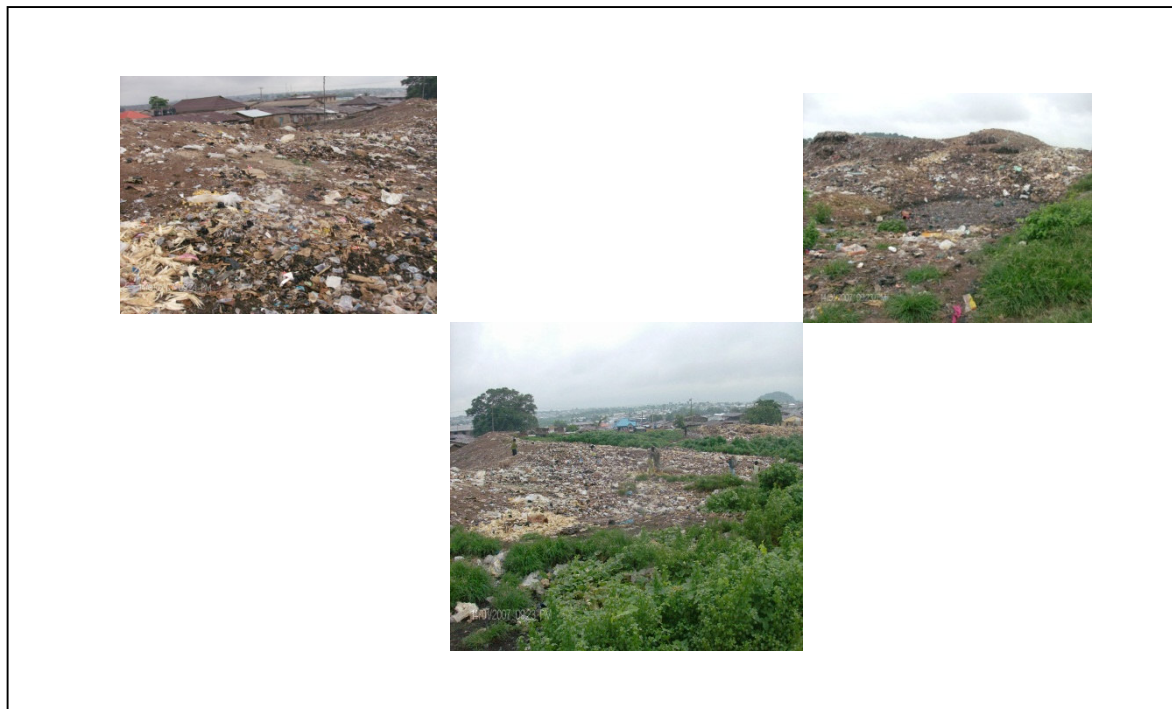
**Plate 1: Disposal of Wastes close to Residential Areas in Oyo Township**

Solid wastes are all the wastes arising from human and animal activities that are normally solid and are discarded as useless or unwanted. The indiscriminate dumping of municipal wastes are common in Oyo town. (Plate 1). The Oyo waste dump sites have been in use since 1940s and illegal local dumping of mostly market wastes is still continuing till date. Sabo waste site is surrounded by residential buildings to the southeast and northwest. The general trend of this waste generation in Oyo is increasing each month. The solid waste composition is highly biodegradable mainly composed of an organic fraction with moisture. Food waste, plastic, paper, rubber, leather, wood, glass, metal and textile are the common waste components.
