Assessment of the Use of Solid Concrete and Interlocking Stones in the Construction of Walkways in a Tertiary Institution

Keywords: Construction, Interlocking stone, Pavers, Solid concrete, Walkways.

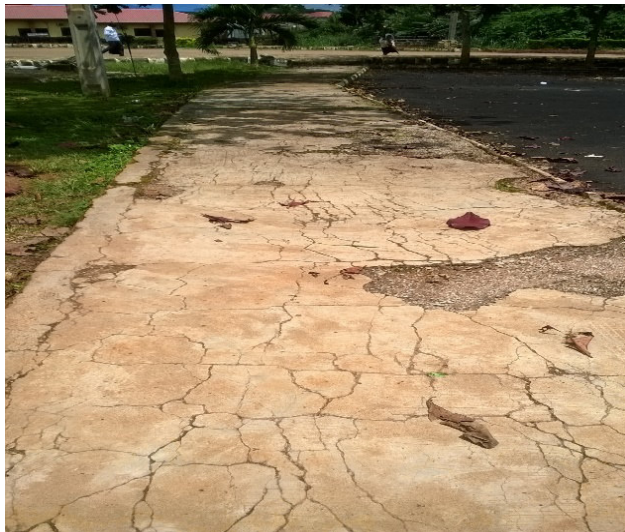
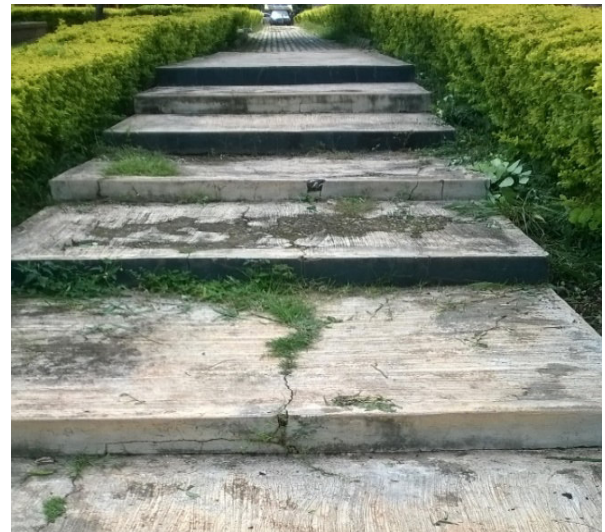
Cracking of walkways which is basically as a result of absorbed heat from the sun leading to gradual disintegration of the particles making up the solid concrete. Nevertheless, some can be attributed to poor usage and maintenance.

Breaking of walkways which is the aftermath of cracking of such walkways. This is majorly found along student affairs walkway, School of Environmental Technology, and the two male hostels in both campuses. The breakage in these walkways has however led to the presence of vegetative growths in such areas of breakage

as seen in plate 2.

Plate 1 and 2: Showing cracks, breakage and vegetative growth in solid concrete walkways within the institution.

The study therefore recommends that performance of solid concrete walkways and interlocking stones can be improved if adequate maintenance can be done. This involves continuous weeding of plants that grows around voids through the use of herbicides and scrubbing of interlock surfaces decaying as a result of presence of spirogyra plants. The use of vacuum pumps can be adopted for better result. Also, the use of under drains beneath sub soils can be used to allow proper draining of absorbed water and this prevents weakening and loosening of interlocks. Shading of concrete walkways through use of light weight covering where applicable should be encouraged to reduce cracks, while proper filling, compaction and slope be taken during construction in under to avoid underground settlement which can lead to undulating nature of walkway and even removal of walkway materials.

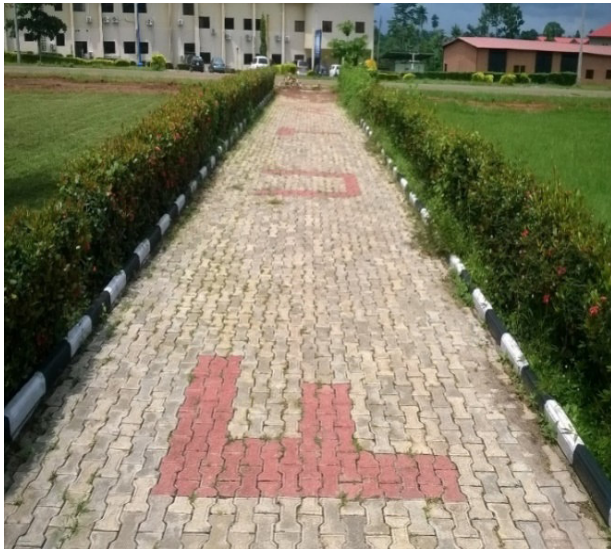
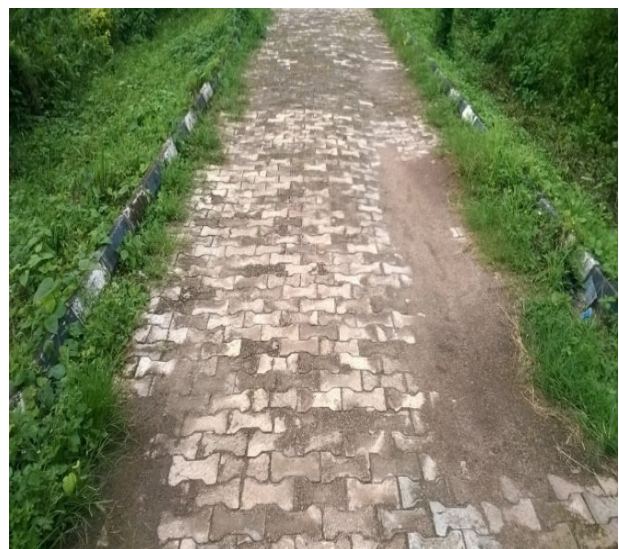
Presence of vegetative growth in between voids and spirogyra on interlock surface which is as a result of seepage of water in between voids of interlocks leading to continuous watering of the subsoil underneath them and this in turn as promoted the growth of plants as seen in plate 3 and 4. Also, the effect of spirogyra on surfaces of interlocks has become another issue worth discussing. This is sometimes due to poor drainage leading to stagnancy of water and this creates an avenue for development of spirogyras. The issue of vegetative growth is evident on walkways along post graduate laboratory linking the 3 in 1 lecture theatre and the walkway around the 2 in 1 lecture theatre.

Undulating nature of existing walkways which can be as a result of continuous downward pressure exerted on them by the feet during usage or as a result of improper ramming of the subsoil before installation of the interlocks. This is evident along middle belt road, 2 in 1 lecture theatre, research laboratory road, post graduate laboratory walkway linking the 3 in 1 lecture theatre and new undergraduate boys' hostel. This undulating nature sometimes leads to stagnancy of water and in turn leading to presence of spirogyra on surfaces of interlocks.

Plate 3 and 4: Showing the vegetative growth and undulating nature of an interlocking stone walkway within the institution.
