# Assessment of the Hydraulic Performance of the Drainage System in Dire Dawa Town

Moges Tariku

College of engineering and technology, Wolkite University, PO box 07, Wolkite, Ethiopia

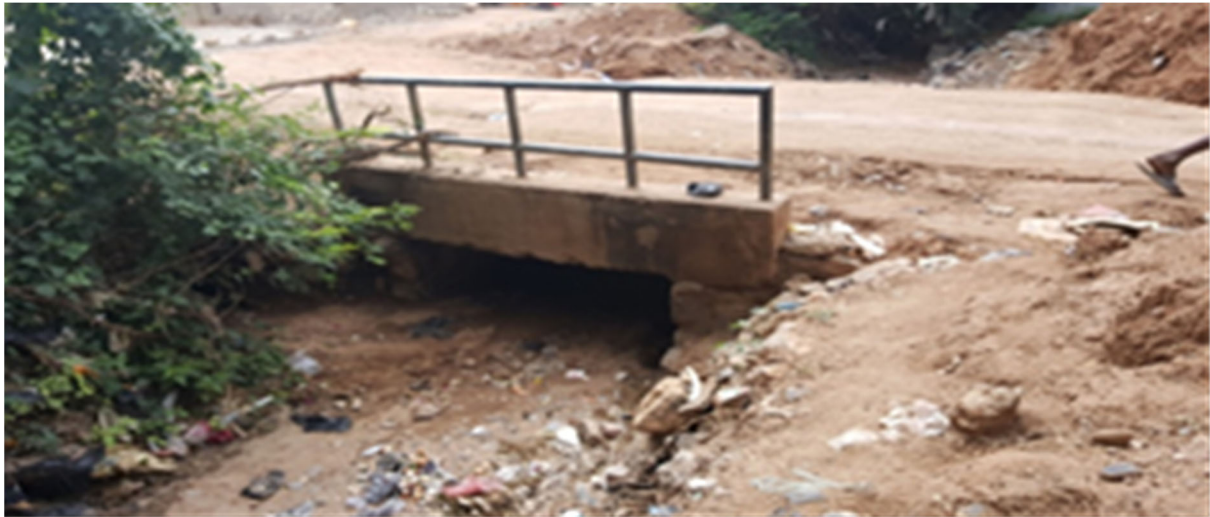
Figure 3: Almost all filled with the sedimentation of side ditches

From personal observation of the site the drainage system of the town was highly used the rectangular open channel without covering the top part of the channels this leads the channel to filled with wastes, commercial residues, and the community itself use the channel as a means of the trade area. Those activate create reducing the size of the drainage structure and immediately it creates an overtopping of channels and flow on the roads also some portion of the drainage blocked with waste crates water stagnation for long period of times.

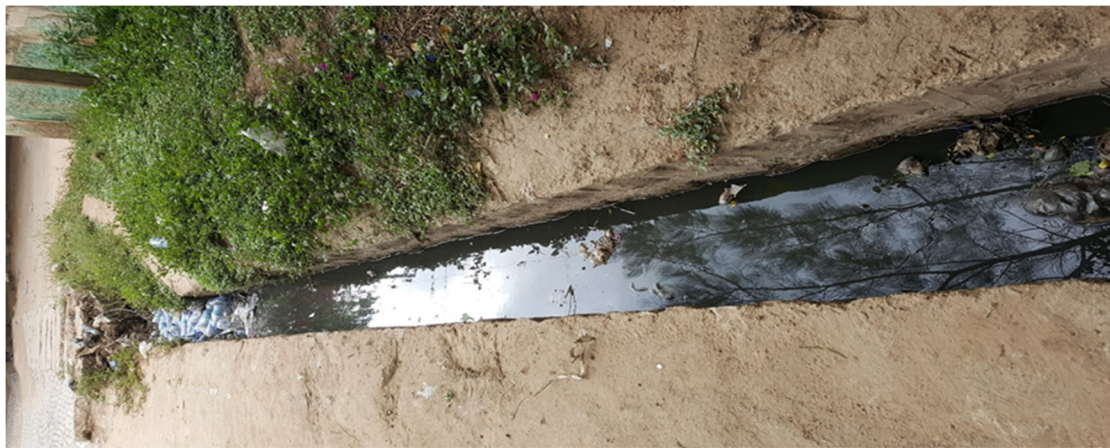
Figure 4: Solid waste and dust accumulation in the drainage system and creates water stagnation in the side channel

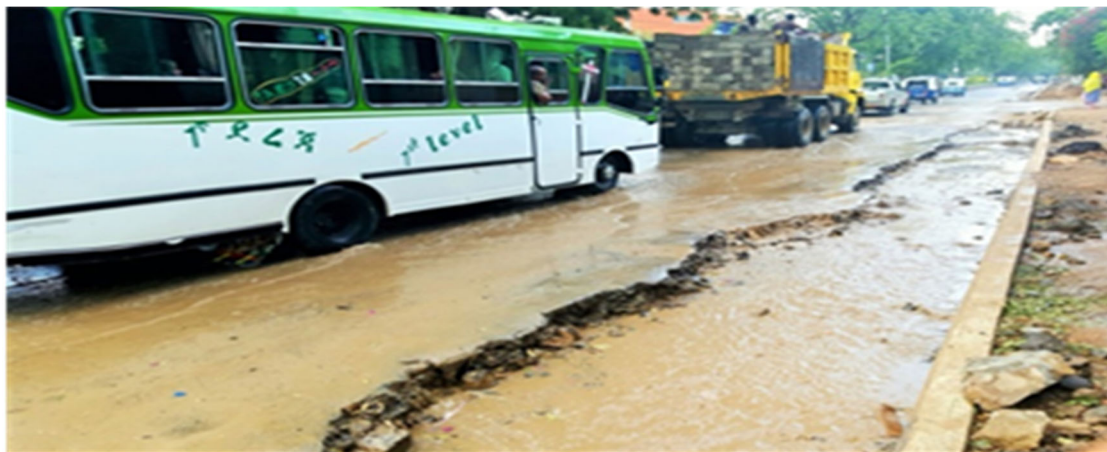
Figure 5: Flooding to both the right and left side of the drainage system

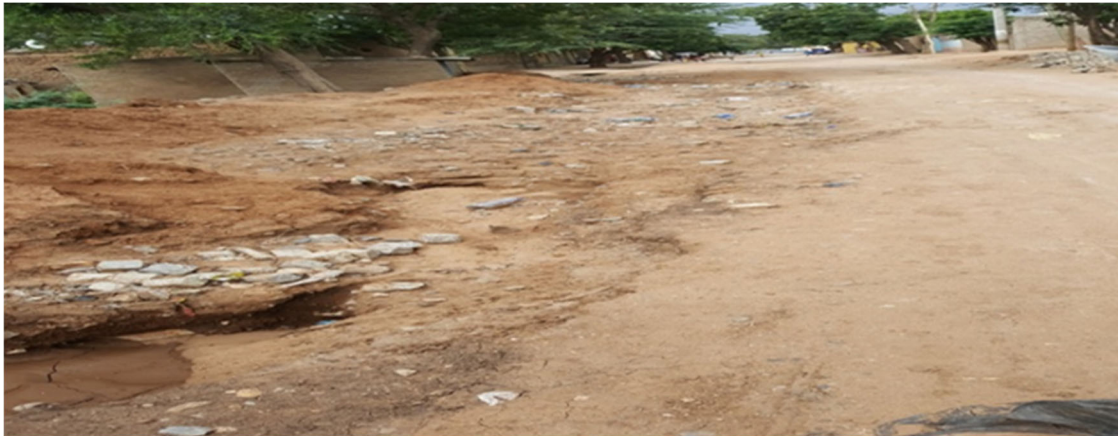
The roads at station S.CM\_5, station 1+600.311 has been eroded and formed gullies due to the absence of side ditches the runoff directly flows over the road and distracts the road service to the community and requires high investment cost for maintenances.

Figure 6: Eroded roads and gully formations due to lack of side ditches

Still, areas without drainage channels construction exist and the flow from those places create an overflow on the road and deteriorates the side of the roads highly this happens due to poor drainage alignment system with the roads.
