Evaluation of WA Township's Public Toilet Management and the Adequacy of Services Provided to Commuters and Households without Toilets

Abstract

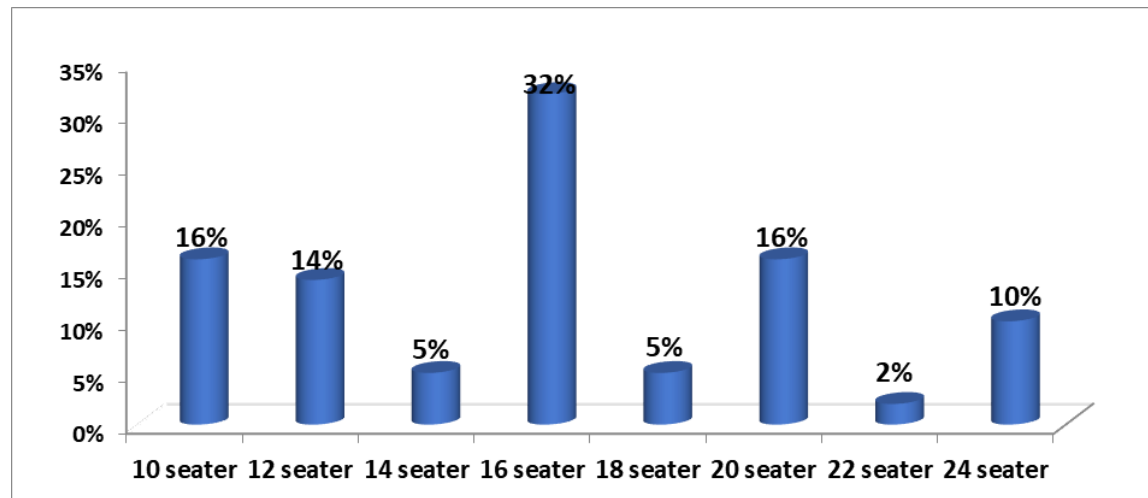
Figure 1.2: Wa township Public Toilets Sitting Capacity

All PTs in the city have between 10 and 24 squat holes. The capacity of the toilets is shown in Figure 1.2.

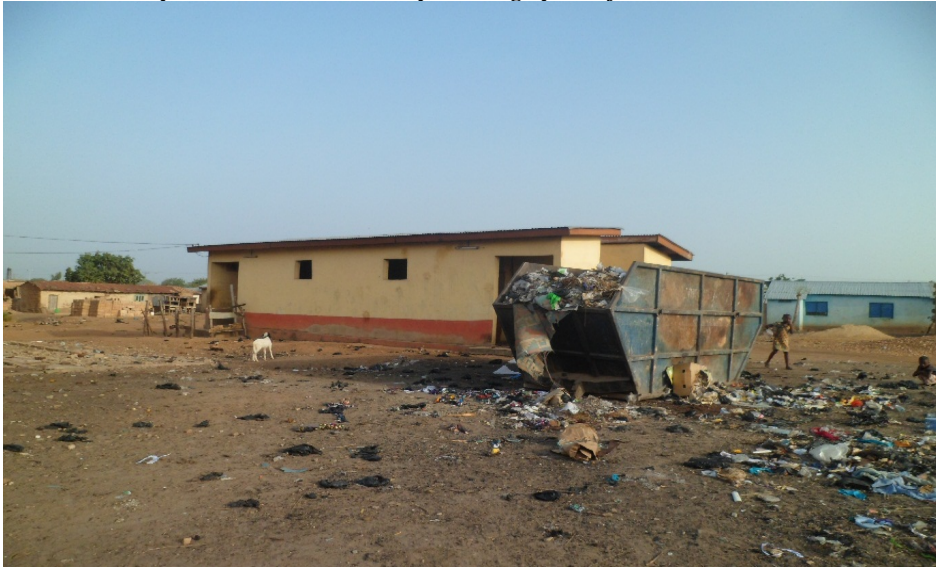
Plate 1.0 shows the rubbish and filth that had engulfed the surroundings of a MAPT at Kambale area within the Wa township. It also shows children practicing open defecation around the toilet.

Based on these findings, the following recommendations were made. More private business individuals should be allowed to construct and manage PTs, especially in high-demand, low-income, and commercial areas. MAPTs should be privatized entirely for efficient and effective management by the private sector. This will reduce the management crisis that arises anytime there is a change of government. The government should increase the number of cesspits emptying trucks to ensure that they meet the increasing demand from public toilet operators and households. All public toilets should be connected to boreholes, pipelines, or wells to ensure a constant water supply for cleaning. Operators found using manual labor to dislodge the fecal sludge and throwing them inappropriately without a permit should be arrested and prosecuted. Law enforcement agencies should arrest and punish house owners who build houses without toilets. This will eliminate households without toilets within the town and subsequently reduce open defecation. Again, tenants in these houses without toilets should be encouraged and motivated to report house owners who are not complying with the Local Government Act 1993 (Act 462). The process of reporting and prosecution should be streamlined, such as the protection of the identity of the whistle-blower and a quite simple and convenient reporting procedure.

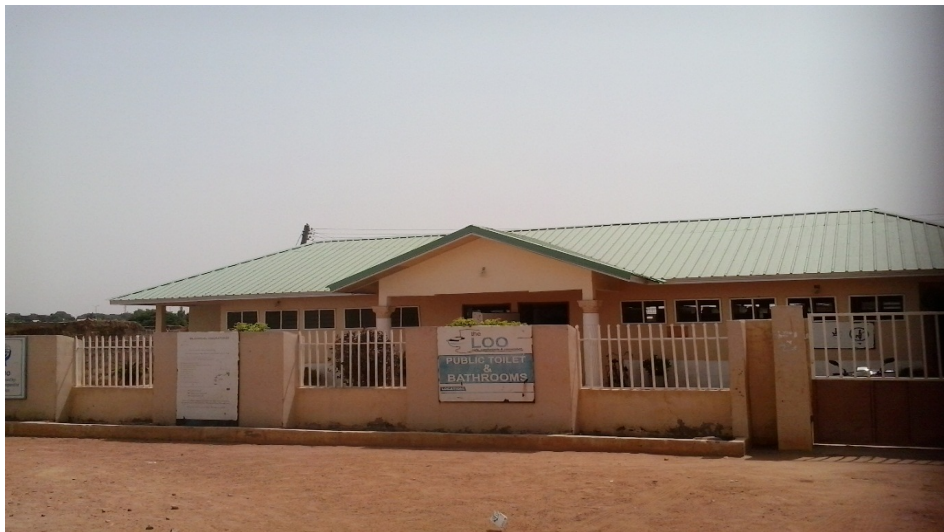
The POMPTs had clean sinks, tiles, and hand washing facilities for clients to use. In contrast, most of the MAPTs toilet cubicles looked dirty, smelling, and worn out, walls were cracked and damaged, doors were loose or hanging down, and 95% (40) of the MAPTs structures had open faeces, and overgrown weeds around them. Children came around them to defecate openly around the building. There were also piles of rubbish around the toilets and overflowing bins close to the facility. Human faeces could be observed everywhere. About 74% (31 PTs) of the MAPTs were in such poor condition that they could be considered a death trap. Maggots were also found crawling inside and outside the building. Men patronizing the place had to remove their clothing before entering the rooms to reduce the smell on their bodies after using the toilet. Plates 2.0 and 3.0 shows the clean environment of the Kpaguri Ganya POMPT.

Plate 2.0 Shows PT (WC toilet) constructed, managed, and owned by a private individual at Kpaguri Ganya community within the Wa township. The surroundings are clean and tidy.

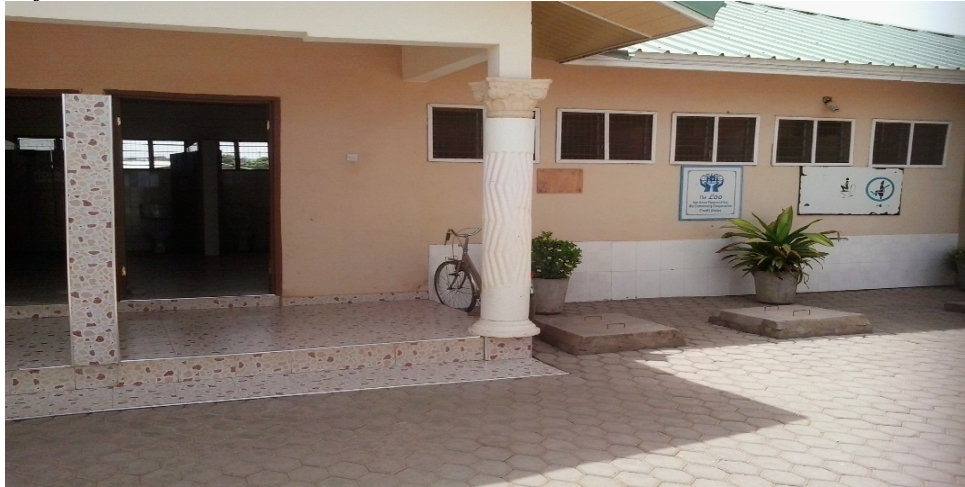
Plate 3.0. Shows the clean entrance of a POMPT (WC toilet) in Kpaguri area. The floor tiles are clean with no flies.

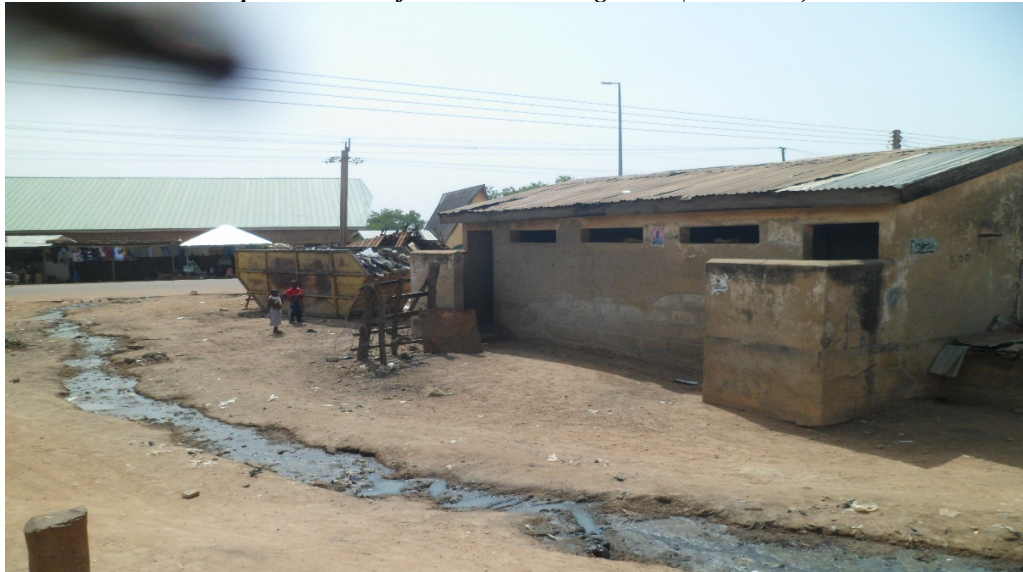
Plate 4.0. Shows the deplorable state of MAPT at the Zongo area (KVIP toilet)

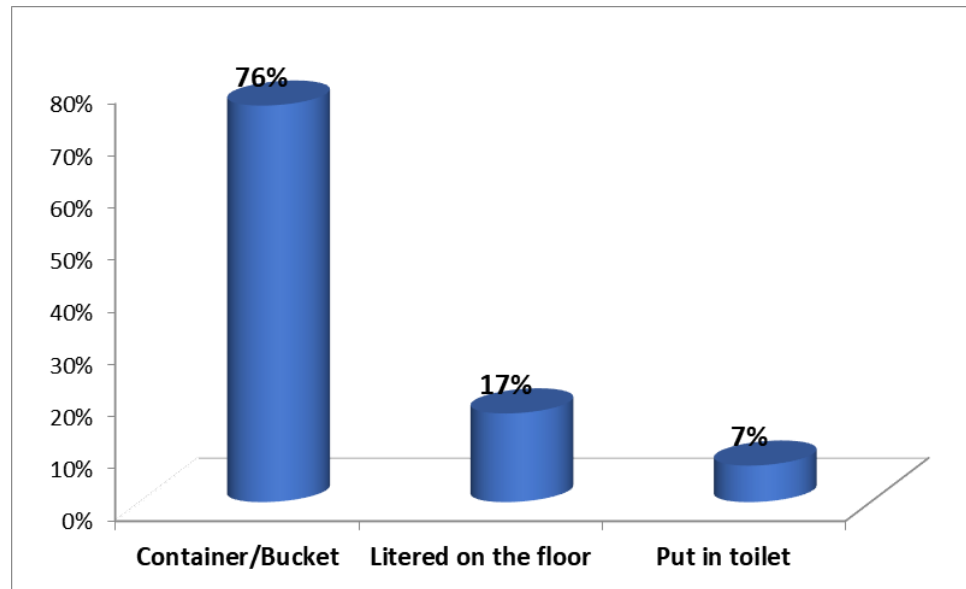
Figure 1.4 Public Toilet usage and management of Toilet Roll and Paper

The study found that 92% of PTs operators issued old newspapers to clients, 5% issued toilet paper (tissue), and 3% relied on water to clean their anus. The survey also found that 76% of public toilets had bins where customers dumped used newspapers and toilet paper, while 17% of public toilets did not have bins. This contradicts the toilet technology principle that only soft materials (toilet paper) should be used and dropped into the toilet hole. However, the investigation showed that newspaper is cheaper than soft materials (tissue paper). The study also found that all anal cleansing materials dropped in the container or collected were either burnt or disposed off in a publicly accessible waste container. However, about 61% of the bins provided inside the PT were not in good condition. They did not have covers, and this attracted flies and other insects. Anal cleansing products should NOT be stored in a waste bin as they attract flies and other insects.

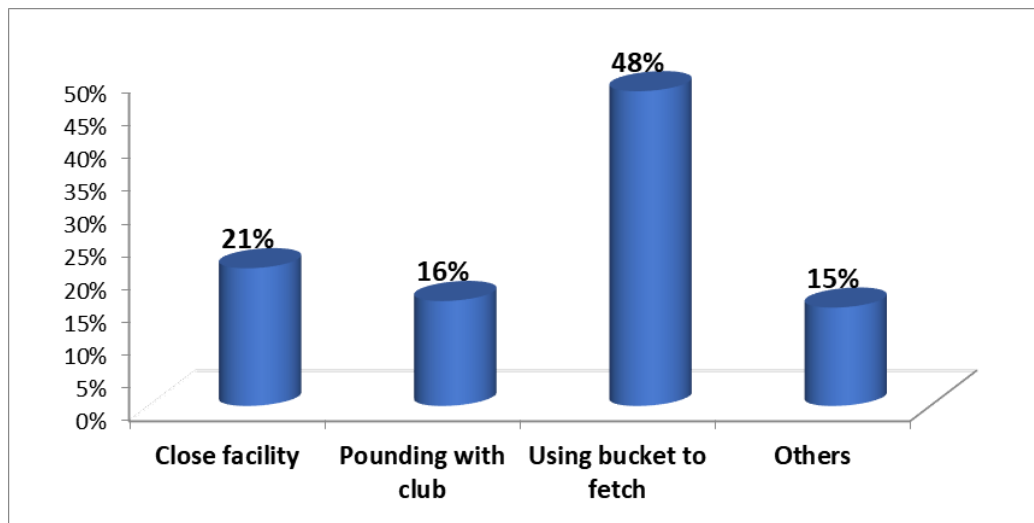
Figure 1.5: The absence of mechanical cesspit emptier truck in various methods for fecal sludge disposal

Manually emptying a septic tank is preferred because once the tank is full, it becomes difficult for the truck to siphon the fecal sludge because it becomes very compact, dry, and solid. The survey found that 48% of public toilets disposed of sludge by collecting it from the septic tank into a bucket and pouring it over the edge of the building. In addition, 21% of respondents reported that if the facility is overloaded and there is no septic tank cleaning crew, the facility is temporarily closed until the sludge is removed. The analysis also showed that 16% of respondents used a sludge stick to hit to reduce the dry sludge and make room for later use of the pit. In comparison, the remaining 15% collected sludge manually and took it to the nearest landfill for disposal.
