Effects of Bad Drainage on Roads

Abstract

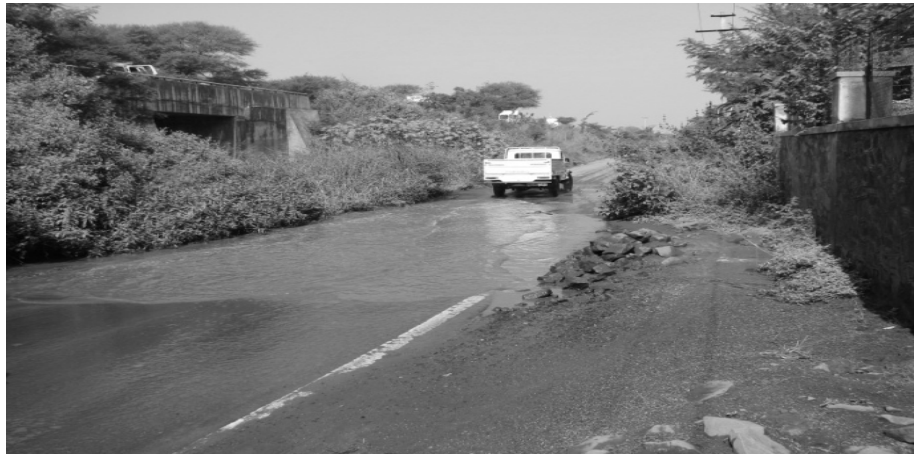
Figure 1: Road under water near Punawale village

The construction of Mumbai Pune Expressway was carried out in 2004. The drainage conditions of this road are getting damaged by the passage of time. The service road provided to this Expressway is mainly getting affected by the poor drainage conditions. The blockage of drainage by derbies and vegetation causes the drain water to flow on the surface of the road (Fig.1 and Fig. 2).The condition remains same throughout the year. This causes the failure of pavement due to stripping of bitumen from aggregates. Fig. 3 and fig. 4 shows the detachment of bituminous pavement layer due to continuous contact of water. The pattern of failure is getting repeated at every 200 m distance on the service road.

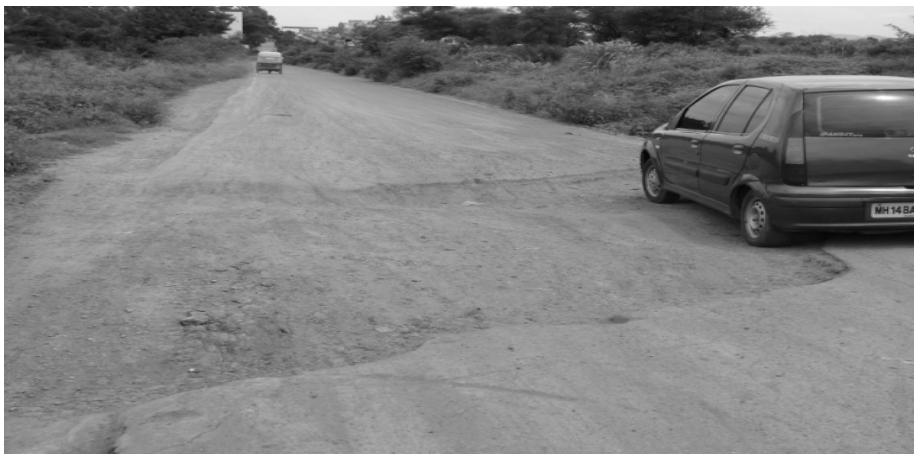
Figure 2: Cuts in road due to water

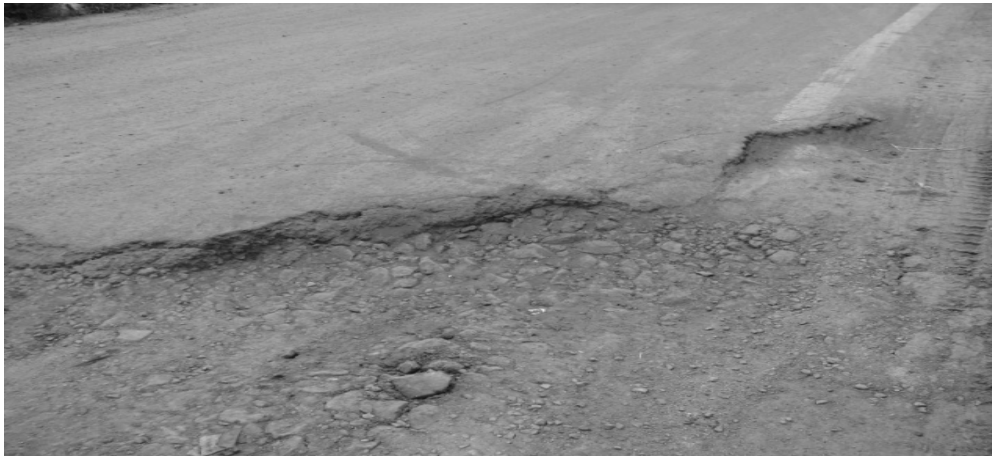
Figure 3: Stripping of bitumen

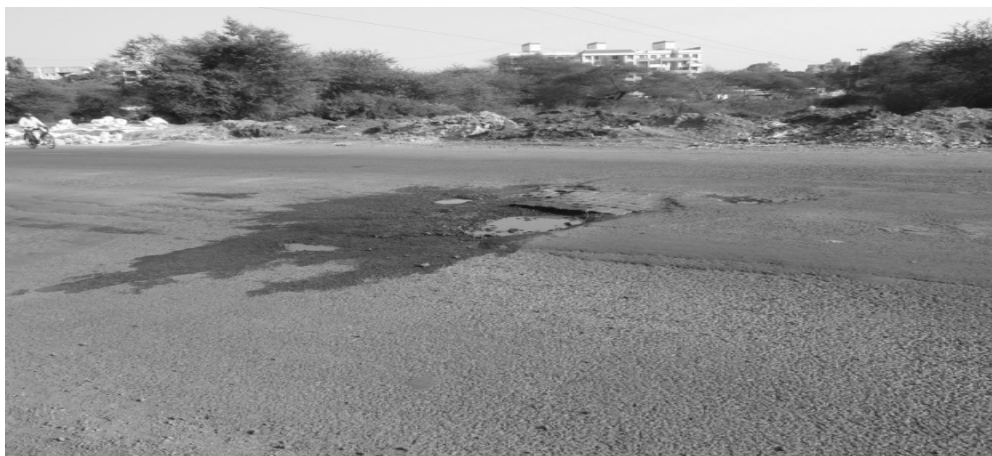
Figure 5: Expulsion of water from road

This location contains the presence of black cotton soil and water logged area around the road. The swelling Index of soil is more than 50 % which indicates that the soil is highly expansive. As it seen that variation in the moisture content causes considerable variation in Volume of sub grade, this contributes to the pavement failure (Fig.4). One of the most important causes of failure in this area is formation of waves and corrugations due to poor drainage (Fig.5 and Fig.6). Also excess moisture causes increase in weight and thus increases the stress causing the simultaneous reduction in strength of soil mass.

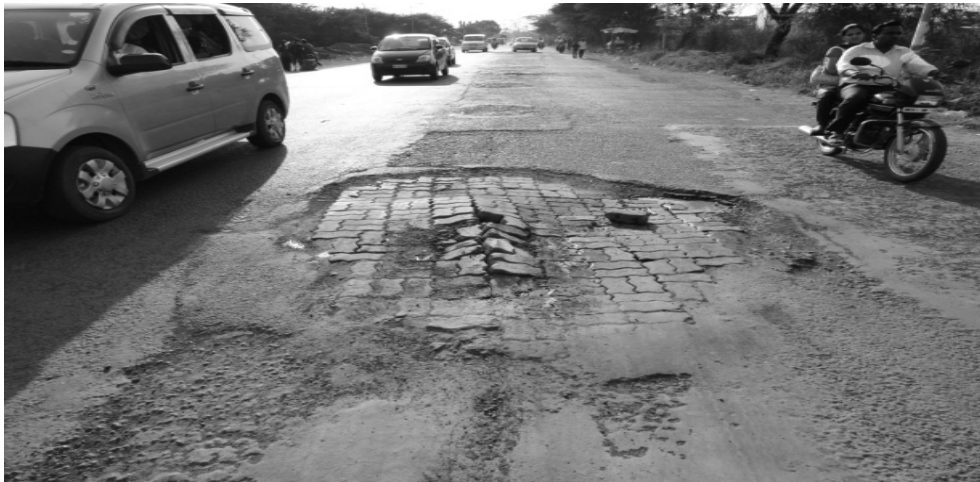
Figure 6: Formation of waves and corrugations

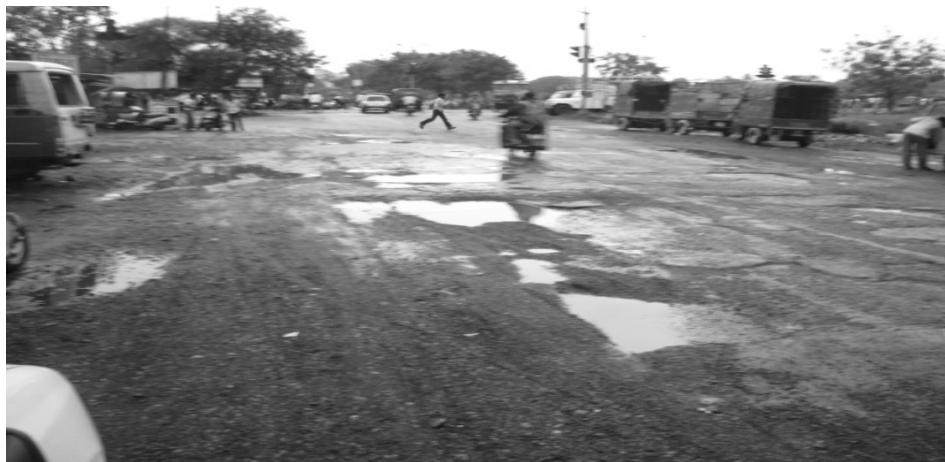
At this location the removal of bitumen has taken place which is followed by the loosening of aggregates. There are two reasons for this. The location is having water logged area on one side and other reason is improper provision of drainage of road. Some of the water is flowing away due to gravity but large amount of water is getting collected on the road surface and then getting penetrates into the road. This causes the increase in moisture content of the sub grade and hence the potholes are getting developed. Also the pore pressure causes the removal of aggregates from its place and accumulates on road sides (Fig.7).

Figure 7: Formation of potholes due to Poor Drainage

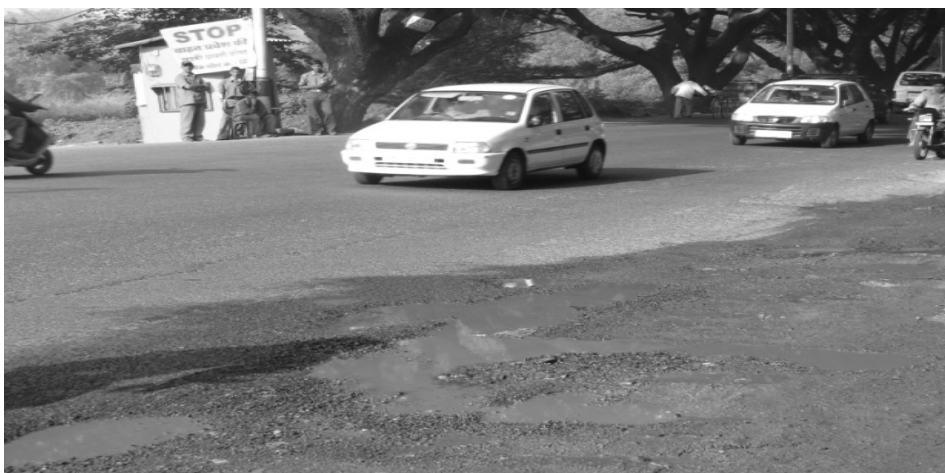
The present area is badly affected by the presence of water surrounding the road. The highest level of water table should be fairly below the level of sub grade in order that the sub grade and pavement layer are not subjected to excessive moisture. From practical consideration it is suggested that the water table should be kept at least 1.0 to 1.2 m below the sub grade. But at this location the water table is very high and hence the capillary rise through sub grade is taking place. This causes the water to come out on road surface (Fig.8). When vehicles are passing on this road, because of its load water is getting emerged from the road which also brings the clay particles on the surface .This causes the formation of potholes and the pavement is also becomes weak.

Figure 8: Expulsion of water due to Capillary action

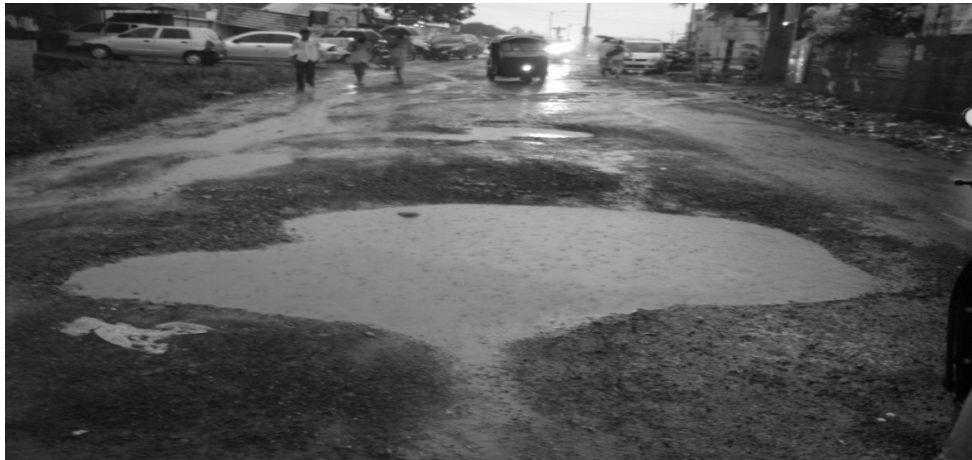
The road is having a nala parallel to it which is running full of water almost throughout year. The nala is also getting flooded due to the drainage water of surrounding houses. The result of this is increase in moisture content of the area. Secondly the sub grade soil is highly expansive clayey soil results in formation of potholes (Fig.9).

Figure 9: Formation of potholes due settlement of sub grade

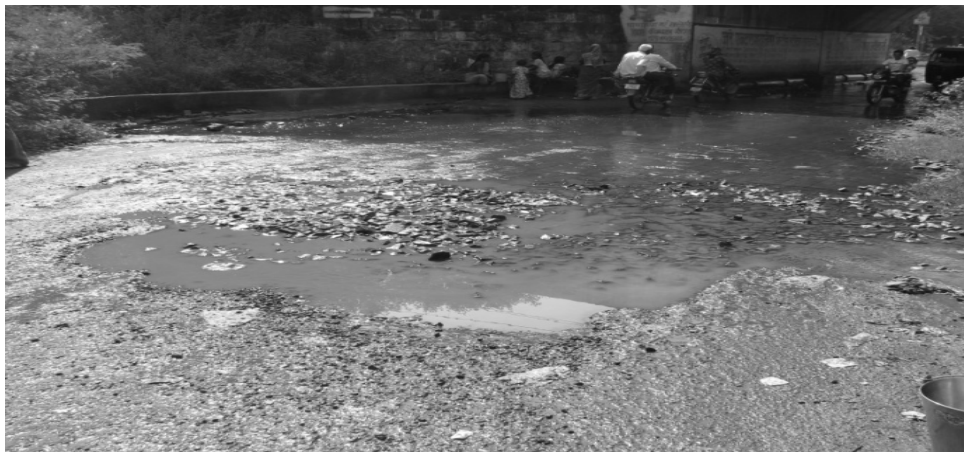
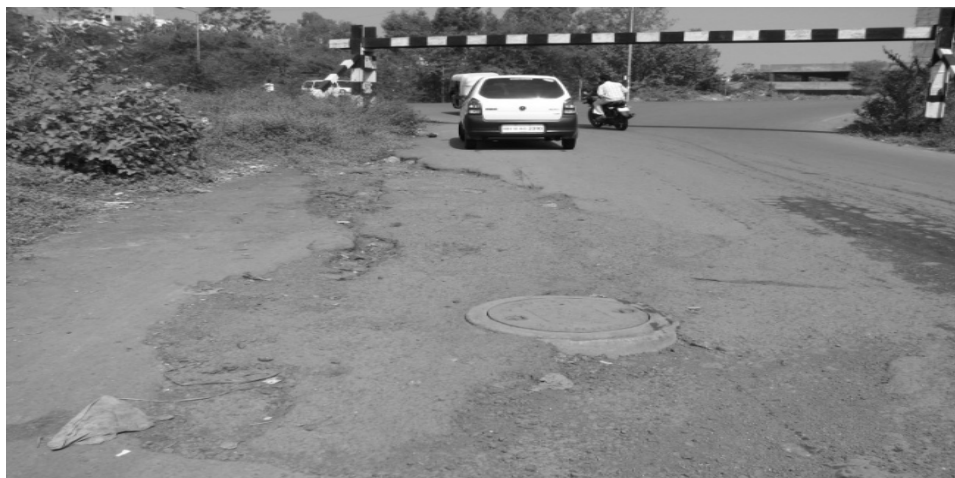
The major failure at this location of road is due improper drainage of water. The road is flooded under water due to rainwater in rainy season and the drainage water from the surrounding houses in other seasons. The roads at this location are completely cut of due to the flow of water. (Fig.10 and Fig.11)

Figure 10: Road affected by flow of water

Figure 11: Cuts in roads due to the flow of water
