Fiber Reinforced Polymer Repair Techniques for Reinforced concrete Beams Pre-Damaged in Shear

Muhieddin Saleh TUGHAR

Department of Civil Engineering, Faculty of Engineering, Al Mergeb University, Libya

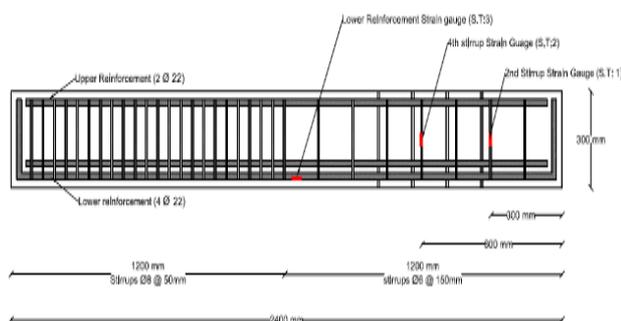
Fig. 1. Reinforcement Details for all Tested RC Beams

In this study, six RC beam specimens were tested. The specimens included three repaired beams; two strengthened beams and one control beam without strengthening. All specimens had a cross section of 160 mm x 300 mm, and a total length of 2.40 meters. The specimens were designed to fail in shear at one side (The weak side). For flexure reinforcement four 22 mm deformed bars arranged in two layers were used as bottom reinforcement with 3.16 % reinforcement ratio, while two 22 mm deformed bars were used as top reinforcement. The bottom and top reinforcement were used the deformed bars with a steel grade of 360/520. The shear reinforcement for the strong side consisted of 10 mm closed-type stirrups spaced at 50 mm, while the shear reinforcement for the weak side consisted of 6 mm bars with a spacing of 150 mm. Figure 1 shows the reinforcement details of the beams.

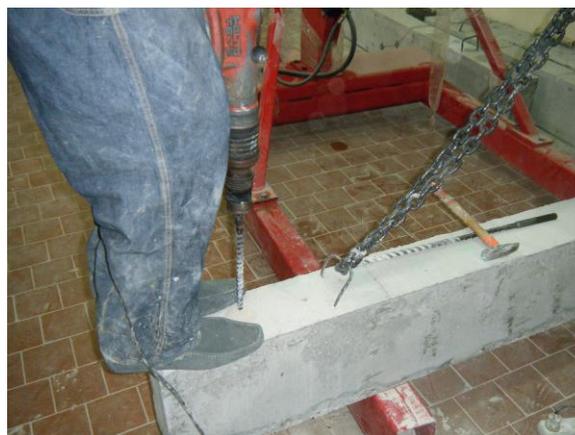
Fig. 2. Drilling of Holes for Specimen IER

In this research two different techniques for repairing or strengthening RC beams against shear were used. The first technique used Internally Embedded Reinforcement (I.E.R.). In this technique 12 mm CFRP bars were embedded in circular holes drilled through the depth of the beams. All the bars had a spacing of 150 mm. Figures 2, 3 show the preparation work for the repaired specimens using I.E.R. technique.

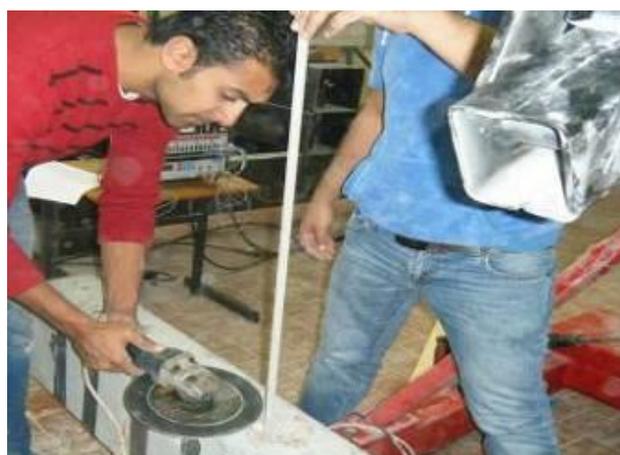
Fig. 3. Installing of Reinforcement in Specimen IER

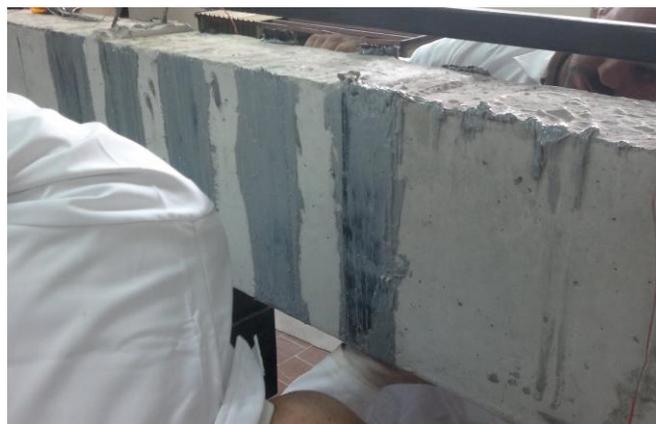
Fig. 4. Strengthening of Specimen EB

In the second technique CFRP sheets were externally used to repair or strengthen the beams in shear. The CFRP sheets were externally bonded (E.B.) to the sides and bottom of the beam forming a U shaped wrap around three sides of the beam. A single layer of 60 mm wide sheets with a spacing of 150 mm was used to strengthen these specimens. Figure 4 shows the strengthening of EB specimen. The configuration of the specimens was chosen so all specimens would have an equal amount of material.

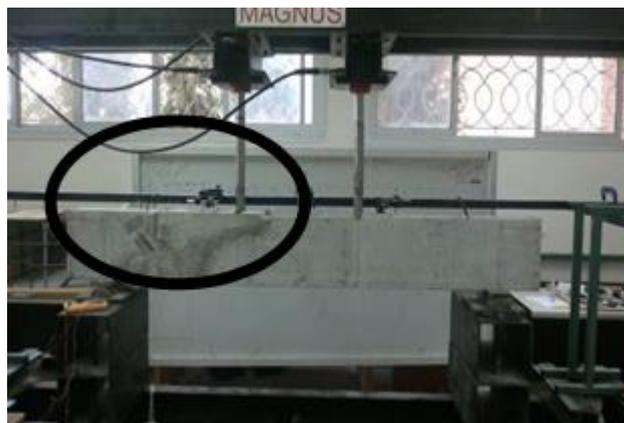
Fig. 5. Repaired Specimen

The steel bars used for the flexure reinforcement and the stirrups on the strong side had a nominal yield strength of 360 MPa, while the bars used for reinforcing the weak side had a nominal yield strength of 240 MPa. The sheets were supplied by Sika brands under the commercial name (Sikawrap Hex-230 C). The thickness of the CFRP sheets was 0.13 mm. The tensile strength and modulus of elasticity of CFRP sheets were 3.5 and 230 GPa, respectively as provided by the product data sheet. Two-component epoxy adhesive (Sikadur 330), supplied by the same company, was mixed according to the proportions recommended by the manufacturer to bond the CFRP sheets to the target surfaces of the tested beams. 12 mm V-Rod CFRP bars manufactured by Pultral Inc. were used for IER specimen, Sikadur 31 CF epoxy adhesive was used for fixing the internally rods inside the holes. The cracks in the control beam was patched after testing to failure using cementitious materials as shown in Figure 5. Afterwards the beam was repaired using the I.E.R technique, and then retested.

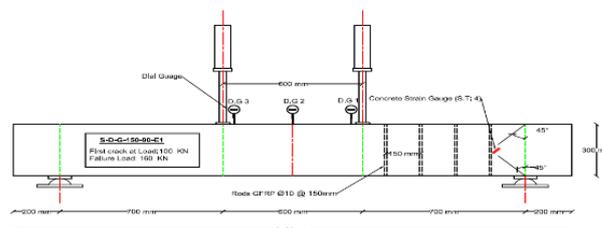
Fig. 6. Test Set up and Instrumentation

All specimens were tested under four point bending. The span of the beams was 2.0 m and the distance between the loads was 0.6 m. The shear span for both sides was 0.7 m which is larger than 2.5 the depth of the beam to avoid effects of arching action. Three dial gauges were used to measure the deflection at mid-span, and both loading points. As train gauge was mounted on the second stirrups after the support at the weak side. Long strain gauges were also mounted on the concrete surface at a 45° angle. In addition strain gauges were also mounted on the second sheet and second bar after the support for specimens EB and IER respectively. Loading was applied manually through a hydraulic pump to two hydraulic jacks at increments of 10 kN, at which time readings from the dial gauges and strains were manually recorded. Figure 6 shows the loading set-up for tested beams & tested specimen.

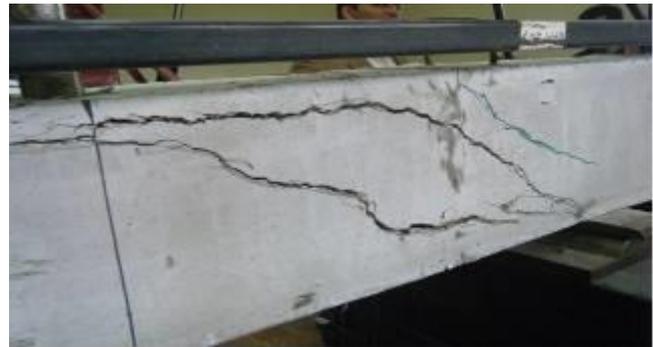
Fig. 7. Crack Patterns of Control Specimen

For the control specimen the first visible crack appeared at a load of about 70 kN. The crack extended from the point of loading to the support in the weak side. As loading progressed, the crack widened, and another major crack appeared in addition to several minor ones as seen in Figure 7. The specimen failed at a load of 100 kN (for one jack only). Although the failure was brittle it was less sudden than in the case of all other specimens.

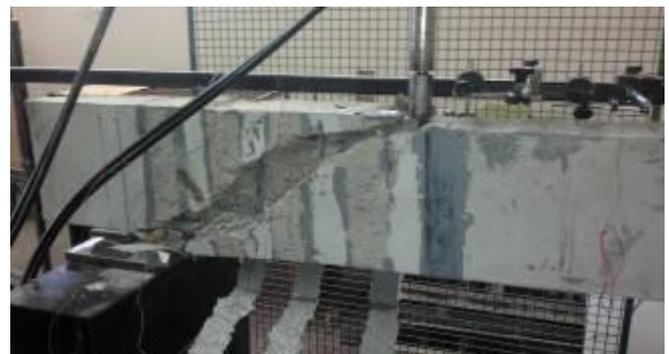
Fig. 8. Crack Patterns of Specimen S-EBR

The first visible crack appeared at a load of 78 kN between the sheets. As loading progressed, cracks widened then the specimen finally failed in a brittle manner at a load of 130 kN after debonding started at the second sheet after the support. Then with further loading the failure occurred progressively one sheet at a time.

Post failure examination of the specimen showed a similar crack pattern to the control specimen as seen in Figure 8. It was noticed that the bonding failure took place in the concrete thin layer adjacent to the sheet, not in the adhesive epoxy.

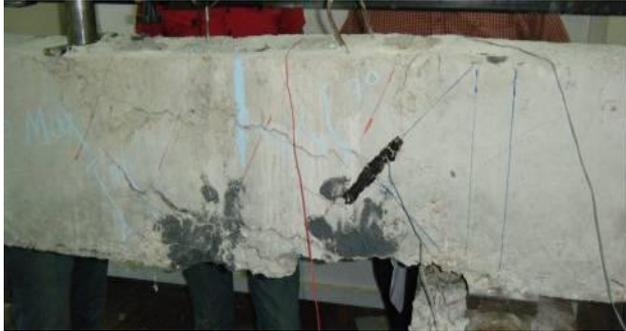
Fig. 9. Crack Patterns of Specimen S-IER

For the internally embedded reinforcement specimen, the first visible crack appeared at a load of 70 kN at the loading point at a steeper angle than the case of the control specimen and even when compared with the specimen strengthened with externally bonded sheets. This can be related to the crack arresting action of the embedded bars which altered the cracking pattern compared to the control specimen. Several other cracks appeared and widened as the loading progressed, although at steeper angle as seen in Figure 9. Failure occurred suddenly at a load of 138 kN due to the debonding at the thin layer of concrete adhered to the CFRP

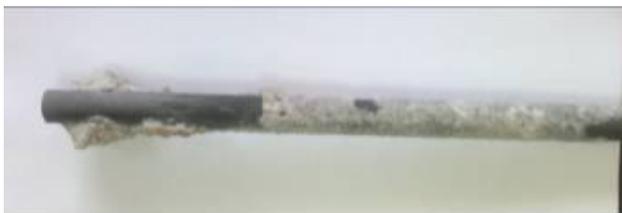
Fig. 10. Debonded CFRP Bar

bars. Some de-bonding occurred between the inner core of the CFRP bars and the outer coating of the bar as shown in figure 10. This can represent a weak point for the FRP bars as this outer coating is added to the bar to enhance its bonding properties with the surrounding concrete specimen.

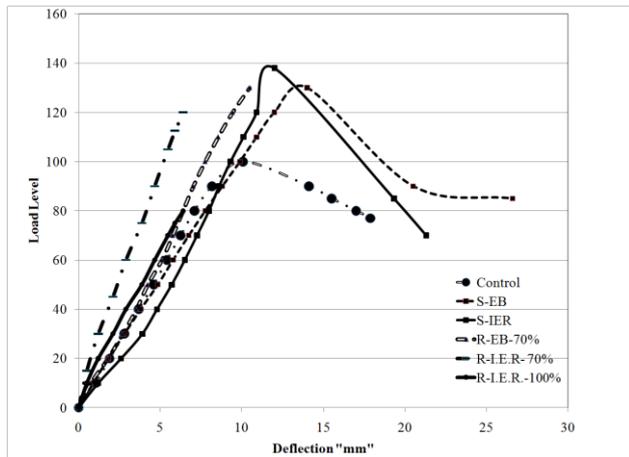
Fig. 11. Deflection Behavior of the Different Beams

Figure 11 shows the mid-span deflection behavior of all specimens. From this figure it can be concluded that the load-deflection behavior of all repaired beams don't have a post peak behavior and it all fail in a brittle manner while all the strengthened beams and the control beam failed in a more ductile fashion and showed a post peak or post failure behavior, this may be due to the fact that the strengthened beams act as single composite unit from the beginning of the loading till failure. Consequently, the load is distributed between the concrete, stirrups, and the strengthening FRP bars or sheets leading to a behavior of more ductile fashion. On the other hand, when repairing a cracked beam, most of the load is transferred directly to the strengthening FRP sheet, or bars leading to sudden failure due to de-bonding between FRP and concrete.

Also it can be shown that a slight increase in stiffness of all repaired beams is noticed when compared with the control beam or the strengthened beams. This might be due to the major role played by the strengthened FRP bars or sheets in carrying the load in the pre-cracking stage which had a bigger role in the slight increase of stiffness.

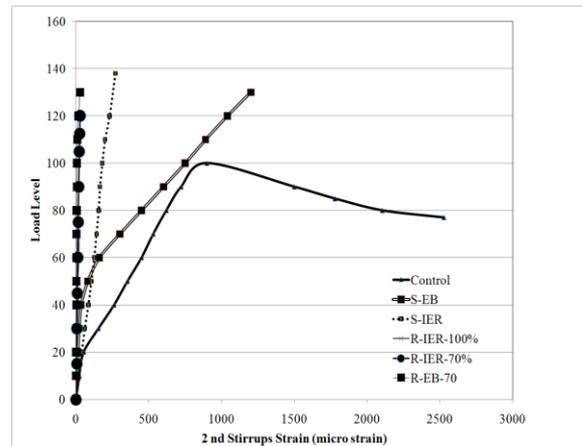
Fig. 12. Second Stirrups Strain Behavior

Figure 12 shows the load vs. strain in the second stirrup after the support for three control beam, compared with the strain behavior of the second stirrups for all strengthened beams and the repaired beams. It is clearly shown that all the repaired beams exerted lower strain than the strengthened beams or the control beam. Based on this fact, it can be concluded that the stirrups in the repaired beam carried lower load than the stirrups in both control or strengthened beams. This may be due to the same conclusion drawn from the deflection behavior that the FRP carried most of the load in the repaired beams leading to a much lower load in the stirrups. Also it can be related to that the repaired beams are retrofitted after cracking and while unloaded to zero level. Therefore when reloading takes place, most of the load is picked up by the new repaired materials (FRP rods or sheets) leaving the stirrups with lower levels of loads. This can explain the more brittle nature of the failure pattern for the repaired beams as when failure takes place due to the de-bonding of the FRP from the concrete, there is no other part to pick up the load.

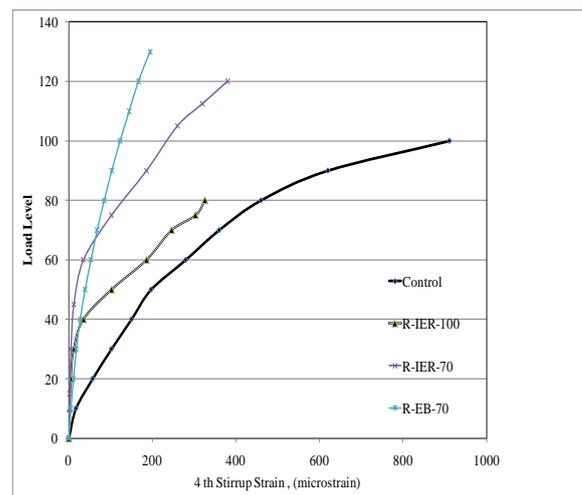
Fig. 13. Fourth Stirrups Strain Behavior

Figure 13 shows the load vs. strain in the fourth stirrup after the support. By comparing the strain behavior of the second stirrup with the fourth stirrup, it can be found that the strain in the fourth stirrups in all beams is much higher than the second stirrups in repaired beam, this may be related to the position of the strain gauge that meet the crack propagation.
