# Effect of biochemical environment on fiber concrete containing silica fume

**Abstract.** The durability of a concrete depends on several factors, one can quote: final mechanical characteristics, operating stresses, environmental stresses... Specific conditions of surrounding environment generate disorders. This is the case of structures and equipment of wastewater treatment which pose some problems not being in the other traditional uses of the concrete, the phenomenon is bacterial in origin. The impact of these degradations is very harmful for our hygiene of life. The present study focuses on the durability of fiber-reinforced concrete kept in two environments: Sewer (aggressive environment) and cyclic wetting / drying (control environment). Three tests were carried out: strength, depth of pH reduction using phenolphthalein, and micro-structural analysis by SEM. The mixes studied had various water cement ratios (0.5; 0.65; 0.8), with a 0.5% steel fibre content and 10% silica fume content. To characterize the durability performance of the mortars studied, samples were exposed to one-year cyclic wetting and drying: control samples under laboratory conditions and exposure samples

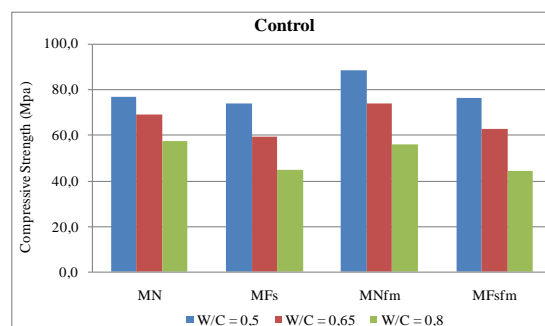
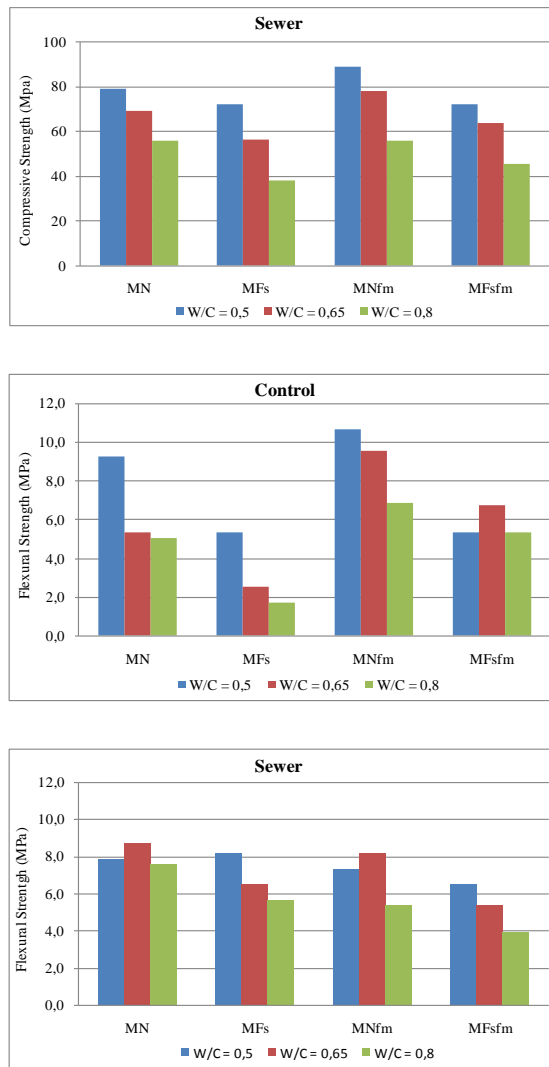
Fig. 1. Variation in compressive and flexural strength.

The stress at failure was determined in flexure and compression for the various water cement ratios. Fig 1 show the results obtained for mortars conserved in the two environments (pumping station sump and cyclic wetting / drying).

With regard to the compressive strengths: The mortar with fibres (MNfm, MFsfm) showed slightly higher strengths, when compared with the same mortars without fibres (MN, MFs), for both exposure environments and for all water cement ratios.

In the case of the control samples, exposed to wetting and drying under laboratory conditions, the samples with fibres (MFsfm) showed a higher flexural strength than the control samples without fibres (MFs). On the other hand the flexural strength of the MNfm and MFsfm mortars was lower than the MN and MFs mortar when exposed to sewage. These samples have been exposed to aggressive agents in the sewer; the steel fibres have corroded and suffer a loss in section and consequently a reduction in strength and bond; this also resulted in an increase in porosity and surface cracking with a consequential reduction in flexural strength. On the basis of these observations it is noted that the use of steel fibres in a wastewater environment may have a detrimental effect on performance except if the fibres are well coated.

The compressive strength of the mortars subjected to both environments are sensibly of the same order, however marked differences are seen in the flexural strength. This disparity between compressive and flexural behavior implies a surface modification to the mortar; an

Comparing the mortars with silica fume (MFs), it is interesting to note that the flexural strength of the samples exposed to sewage is significantly higher than those exposed to laboratory conditions. This effect suggests that a surface hardening has occurred in the case of sewage exposure; once again the aggressive biochemical environment results in structural modification of the surface layers of the mortar. It is suggested that the increase in flexural strength may be due to an accumulation of organic and secondary crystallites forming in the skin of the mortar, which would have the effect of filling the pore structure and inhibiting the propagation of tensile cracking.

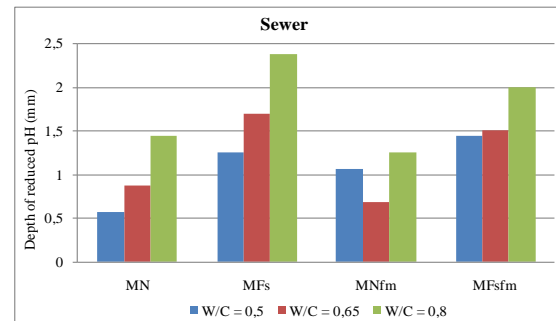
Fig. 2. Variations in depth of pH change for exposure samples.

The depth of pH modification of the mortar was determined by the phenolphthalein test (color indicator); a sprayed solution turns pink if the pH is greater than 9 which allow the visualization of the modification to the mortar. Five measurements were taken from each face of the sample, ignoring the measurements at the corners; this allowed a mean value of 20 readings for each sample. Figure 2 sets out the average depth of pH reduction.

It is interesting to note the variation of depth of pH reduction for the three water cement ratios: For a water cement ratio of 0.5 the steel fibres mortar had a greater depth of pH loss whereas with the higher w/c ratios the converse was true. This can be explained by two factors being responsible for the alteration of pH. Firstly, as previously noted the corrosion of the steel fibres engenders an opening of the structure; secondly as the w/c ratio increases the cement paste becomes more porous.

Given a low w/c ratio the C-S-H resulting from the pozzolanic action of Portlandite and silica fume will fill pores in the matrix. In cases where the matrix has an initial high volume of voids, higher w/c ratios, the secondary C-S-H is insufficient to block the pore structure. In the cases of high w/c ratios (0.65 and 0.8) the high porosity of the cement paste has a dominant effect with respect to depth of pH reduction, i.e. steel fibre corrosion occurs but the subsequent effect is secondary to the cement paste porosity.

The depths of pH alteration in the samples exposed in the sump are significant. It is normal that the humidity in a closed space such as a sump would be high, a condition not favouring carbonation. Given the reduced portlandite content in the mortars and the high humidity it is suggested that carbonation is not the reason for the reduction in pH. It is probable that bio-chemical effects are responsible for the alterations to the external mortar surface under sewer conditions.

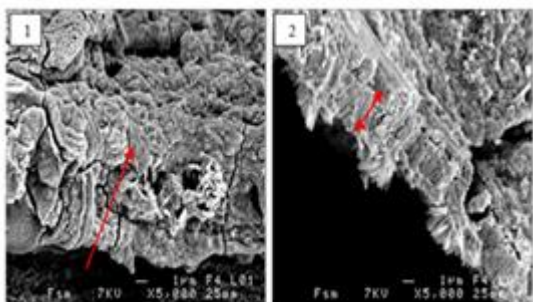
Fig. 3. Aspect of Surface degradation.

Observations by scanning electron microscope (SEM) are shown in Figure 3 and 4; these observations were restricted to the MFsfm samples, w/c ratio 0.8, conserved in the sewer. The aim of this exercise was to study a series which had undergone the most marked modification to microstructure.

On photograph 1, we can see the dried organic material which gives this aspect of wrinkling. The aspect of C-S-H degraded on the surface of sample is shown in photo 2. We can notice that the degradation of C-S-H was apparent on a small thickness of about 4 microns.

The duration of one year allow us to see the effect of fibers and silica fume on improving the durability. The SEM observations revealed a slight thickness degraded and healthy phase of the matrix. This aspect of the study merits further investigation.

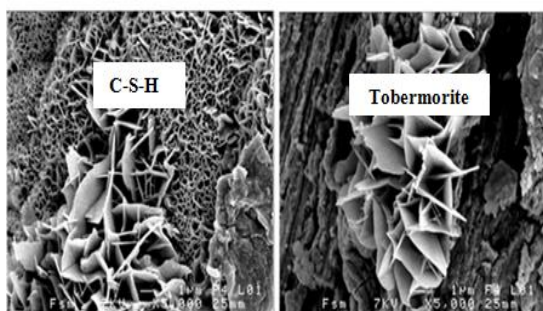
Fig. 4. Healthy phase of the concrete (C-S-H).

Fig 4 shows the phase of sound concrete. The photos shows the undegraded plates of C-H-S which one also calls "Tobermorite".
