# Non-Destructive Evaluation of Corrosion on Insulated Pipe using Double Wall Radiographic Technique

The research explored the Double Wall Radiographic inspection technique using Ir-192 for evaluating deposits and corrosion attacks across the inner and outer walls of an insulated steel pipe. The experiment was performed on a designed test piece to simulate corrosion attacks and deposits on industrial pipes. From the relationship curve drawn between the radiographic film density and the thickness of the pipe, the attenuation coefficient of the insulating material was negligible compared to the concrete deposit. The Double Wall Technique (DWT) had a maximum underestimation of 1.3% of the corroded surface area of the pipe and was within an accuracy of  $\pm 0.29$ . This tolerance limit is 5% less than the wall thickness of the pipe. From the results obtained, effective corrosion monitoring of insulated pipes can reliably be executed by the DWT without the costly removal of insulation material. **Keywords:** Double Wall Radiography, Corrosion, Insulated Pipe, Ir-192, Attenuation Coefficient.

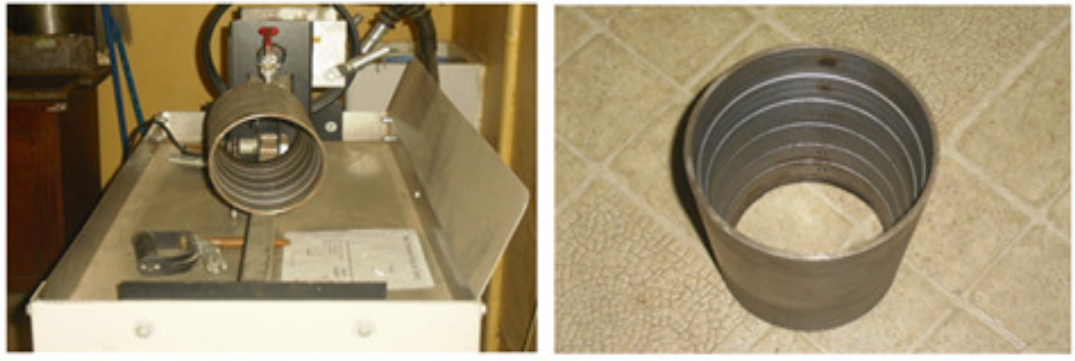
**Figure 3. Interiorly machined pipe (test pipes)**

- Step pipes with holes (pits) inside and outside - one pipe specimen with machined steps inside and other pipe specimen with machined steps outside. "t" is the pipe wall thickness before introducing steps or any discontinuity.
- Each step chosen to range from 0 to 0.7 t in steps of 10% wall thickness; precision in wall thickness shall be  $\pm$  0.1 mm.
- Hole diameter equal to remaining wall thickness, minimum of 3.00 mm.
- Hole depths ranging from 0.50 mm to 3.00 mm spaced at different circumferential positions; holes were to be flat bottom.
- Where steps were located on the inside surface of the pipe, material was to be removed by grinding or machining to a depth of 15% of maximum wall thickness of the pipe, forming a flat surface. Length covering all the steps. Precision was to be  $\pm$  1% (Final Report. 2008).

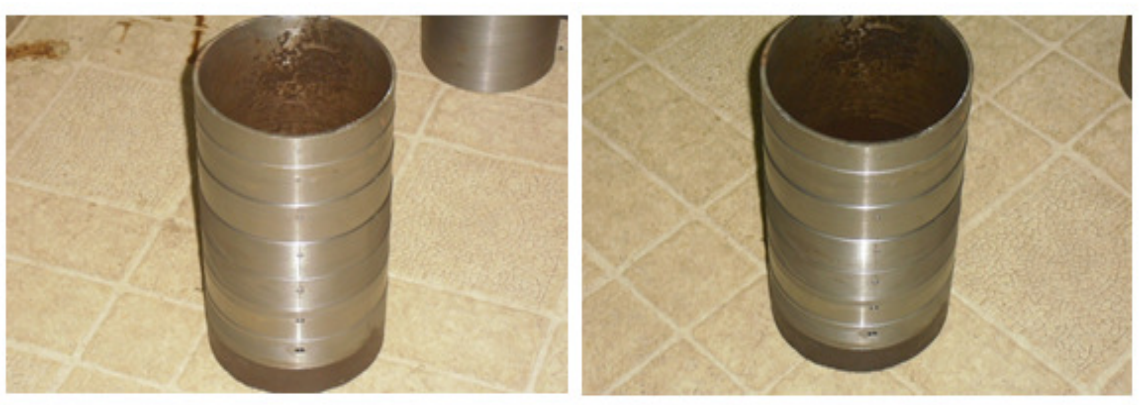
**Figure 5. Exteriorly machined pipe (test pipes).**

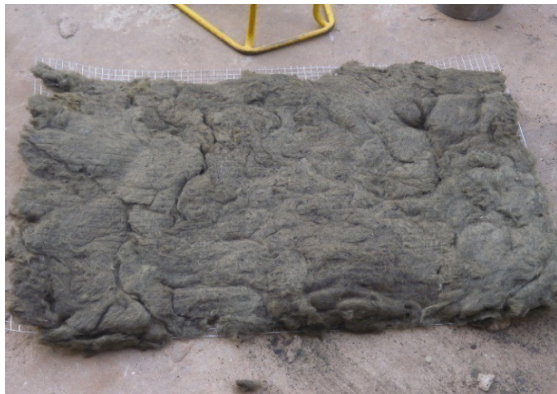
Figure 6. Fibre wool insulating material

The material used to simulate the deposit attack in the experiment is concrete with uniform thickness of 40 mm within the internal diameter of the pipe and a fibre wool insulator of 30.00 mm thickness was used to insulate the pipe.

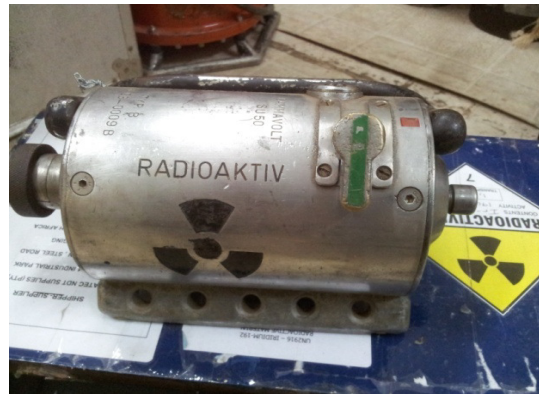
Figure 7. Gamma Ray Source (Ir-192)

- RADIOAKTIV
- Type B(U) D/DB-0009B
- Weight 16kg/ U(depleted) 12.1kg
- Activity 3700 GBq (100 Ci), Ir-192
- Film Kodak industrex AA-400, with a lead screen.

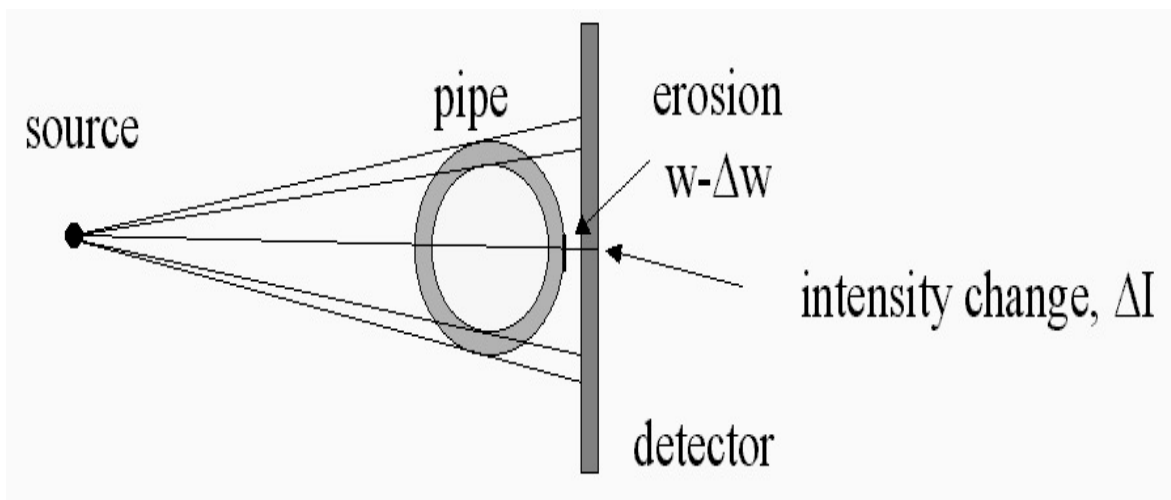
Figure 8. Density Evaluation in the Double Wall Technique.

The double wall radiographic technique set-up for the pipe had source positioned perpendicular with respect to the pipe axis projecting the double wall of the pipe on the radiographic film. Here the steps on the pipe (erosion corrosion) and the size of the pits diameter are captured on the film (Final Report. 2008). A source-film-distance of 1450.00 mm was used with exposure times of 32, 38, 43, 68 and 78 seconds. The density transmission applied in the double wall technique configuration was the classical density measurement radiography where the gamma rays penetrate through two walls of the pipe tube placed between source and film. On the side of the pipe, the steps were kept for comparison of density with the defect density.

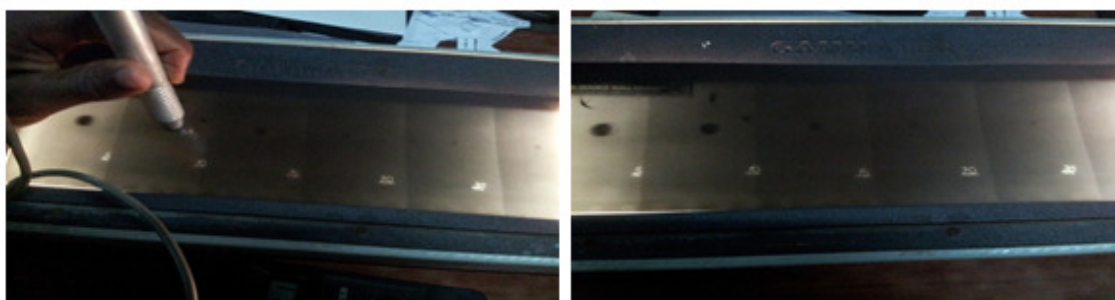
Figure 9. Reading of Radiographic film (Radiograph) in the dark room.

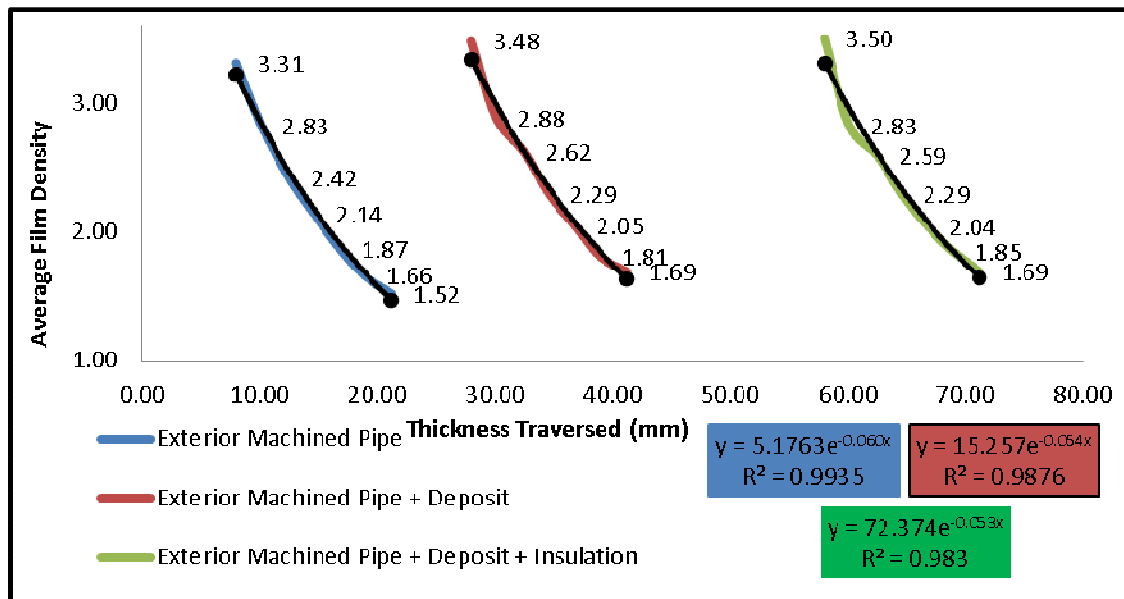
Figure 10. Exteriorly Machined Pipe (Step Block) with various Exposure Conditions.

The results of the experiment for the exterior composite pipe geometry and that of the interiorly machined pipe including insulation are shown in table 3 and 4 respectively. Table 5 shows the comparison between the actual pit diameter and measured mean diameter. Figure 10 and 11 compare the average film density with the various exposure conditions of the exteriorly and interiorly machined pipes respectively. Variation of film density against

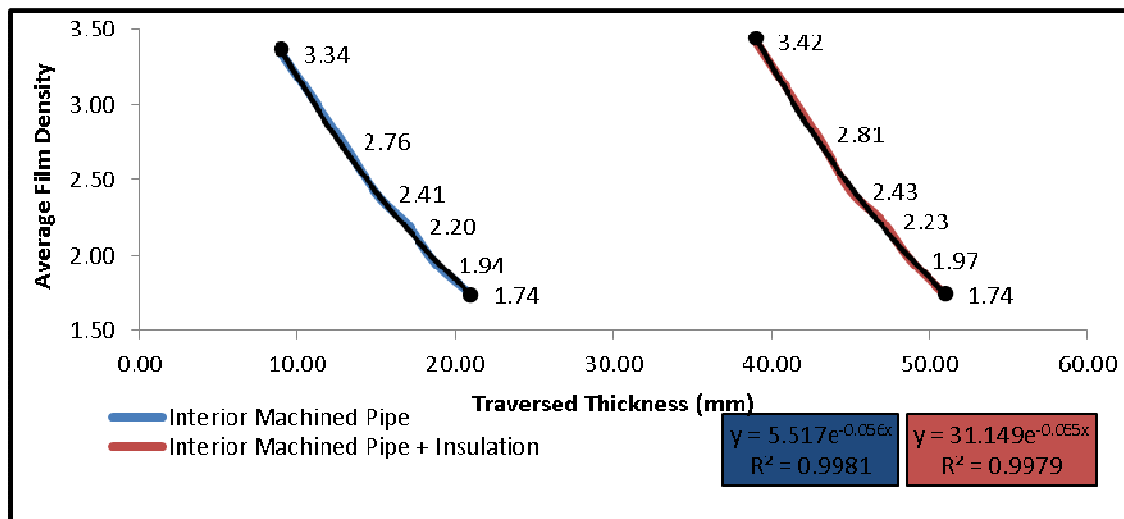
Figure 11. Interiorly Machined Pipe (Step Block) with various Exposure Conditions.

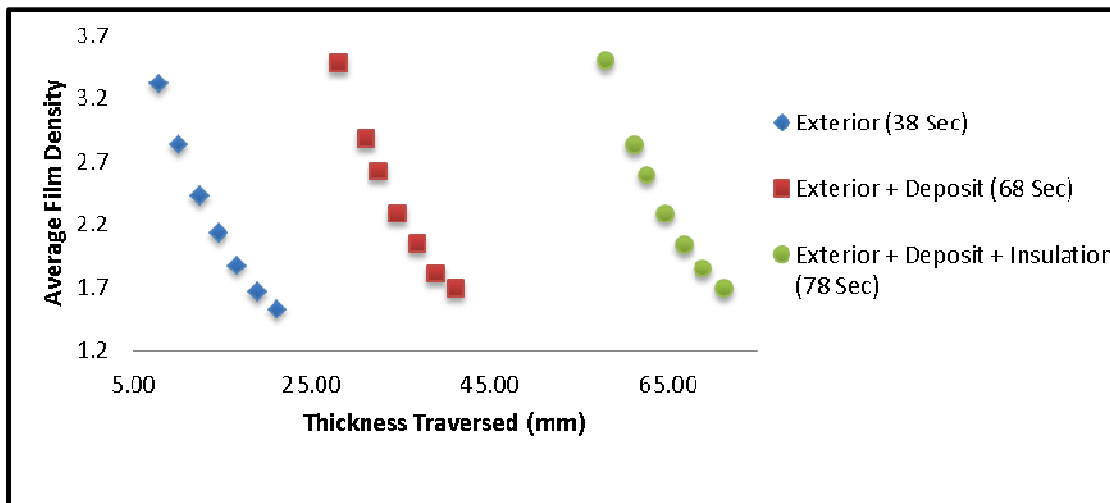
Figure 12. Density variation against Thickness at different Exposure Conditions by DWT

thickness at different exposure conditions is shown in figure 12.

The three different exposure conditions depicted how the radiographic film density varied with thickness of material. This confirmed the linear relationship that attenuation or absorption coefficient had with thickness. The density (mass per unit volume) of concrete was much higher than the insulating material (fibre wool) hence attenuate much better than the insulator. This was what informed the increase in much higher exposure time for the concrete deposit in order to have a good radiographic record on the film for interpretation.
