The Conservation Status of the Pyramid of Khufu

DR. ARCH. FIRAS GANDAH

PhD in Architecture Assistant Professor - Balqa Applied Science University, Salt- Jordan .

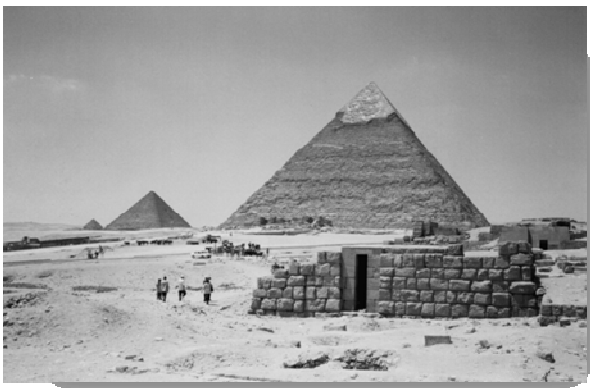
In fact, we do not know the amount of material which has already dissolved because of the different factors of atmospheric degradation, nor how many blocks of stone have been stripped or lost due to the anthropogenic degradation. One of the largest losses was the intentional stripping of the outer coat of the Pyramid of Khufu. This coating (made of Tura limestone considered the best lime of all Egypt) was the lime used to build the city of Cairo. This spoilage lasted for centuries and reduced the Great Pyramid to rare traces of its white coating of limestone. As can be seen on the apex of the Pyramid of Khafre. Figure 2.

Figure (2) The remains of the limestone coatings of the Pyramid of *Khafre*.

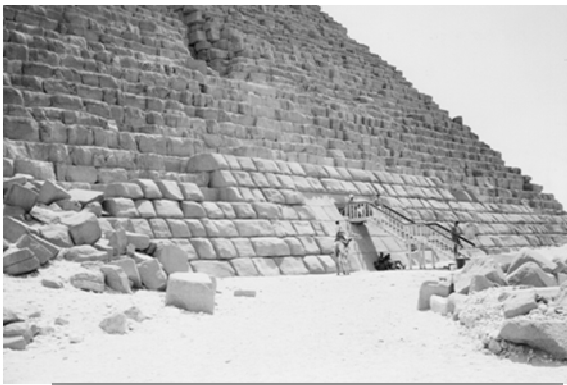
Climatic changes are of a superficial and selective nature. The superficial alteration are caused by the arid climate acting on the stone material located in the lower parts of the monuments at Giza, which undergoes temperature variations and water infiltration that penetrates only superficially. The selectivity of the alteration, however, is due to the lithological and structural characteristics of the stone material used in Giza which cannot defend itself from the alteration process. Figure 3.

Alteration processes, therefore, cause firstly micro-fractures then fractures, faults, and other lines of weakness in the stone material already weakened by its exposure to the local variations of temperature and air humidity. The phenomena of this type of alteration, concern flaking, peeling or exfoliation, rupture and granular disintegration.

Figure (3) Stone material placed in the lower parts of the Pyramid.

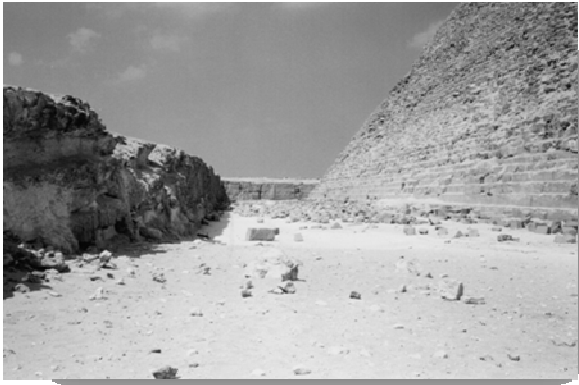
Also, the same phenomenon was seen in the Pyramid of Khufu, although it is limited to a small portion of the west side, where the shield given in part by the Pyramid of Khafre and by the small hill, located between the two Pyramids, is missing, therefore leaving the tomb of Khufu unprotected on that side. It is here, that the area's predominant winds rule, so that the blocks placed in the lower rows of the Pyramids on the west facade are still intact, because they are protected, while the unshielded part of the same western facade is eroded by the atmospheric agents. This is another indication of the state of abandonment of these prestigious archaeological remains and how little conservation action has been taken so far. Figure 4.

Figure (4) Western side of the Pyramid of *Khufu*.
