GIS and REMOTE Sensing Based Water Level Change Detection of Lake Hayq, North Central Ethiopia

Abstract

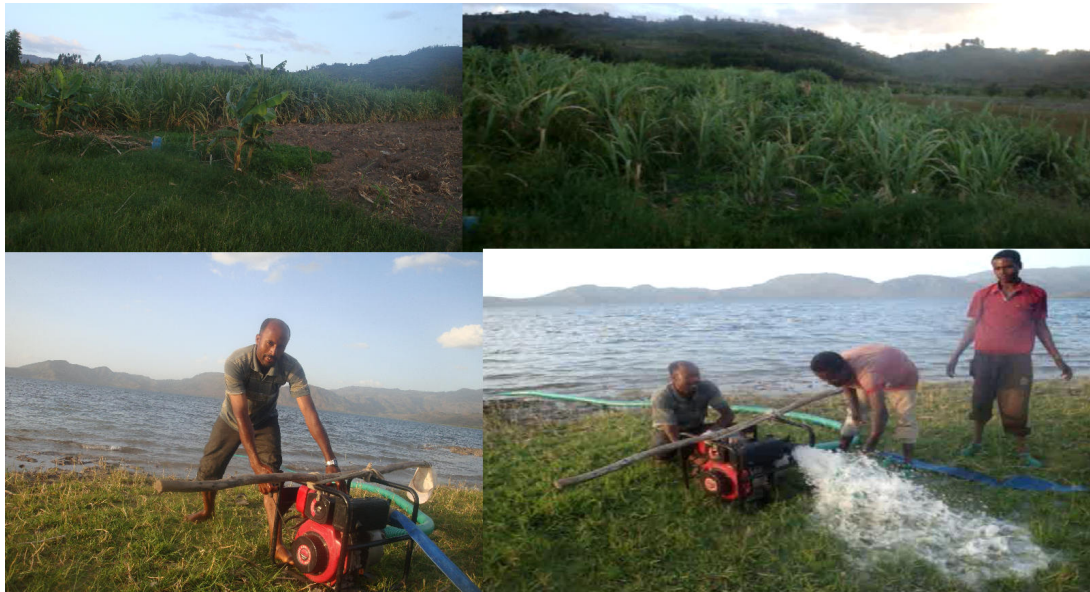
Figure 12: Activities of small scale irrigation by local farmers, 2013.

Abstraction of lake water by human activities are affected the equilibrium of the water balance and the fluctuation of the water level. According to Molla et al. (2007), there is pumping of the lake water without the basic knowledge of the hydrology of the watershed. The major abstraction of Lake Hayq water resources is for the purpose irrigation and other domestic water use. The annual abstraction for domestic water supply of framers and their livestock, Lodges, St' Estiphanos Abune Eyesus Moa monastery, which fetched by plastic bags and pumped by pedal pump from the lake, was calculated 79,200 m³. According to TWARD0 and WWARD0 (2012), there are 46 generators (with the capacity of 1000 litter minute⁻¹) and 2 huge (5,500 litter minute⁻¹ water pumping capacity) generators around the Lake Hayq. Based on field survey, the abstraction of lake water for small scale irrigation (Figure 3) by the local farmers around the lake in the lower irrigation scheme and St' Estiphanos monastery at the rate of (8hr^{day} × 20day^{month} × 5 months^{year} × m³) was estimated 2,208,000 m³ and the abstraction of lake water for medium scale irrigation at Tiggo and Estena pump at the rate (6hr^{day} × 15day^{month} × 4 months^{year} × 5.5m³) was estimated 237,600 m³. The total consumption or abstraction amount of water to be calculated 2,524,800 m³.

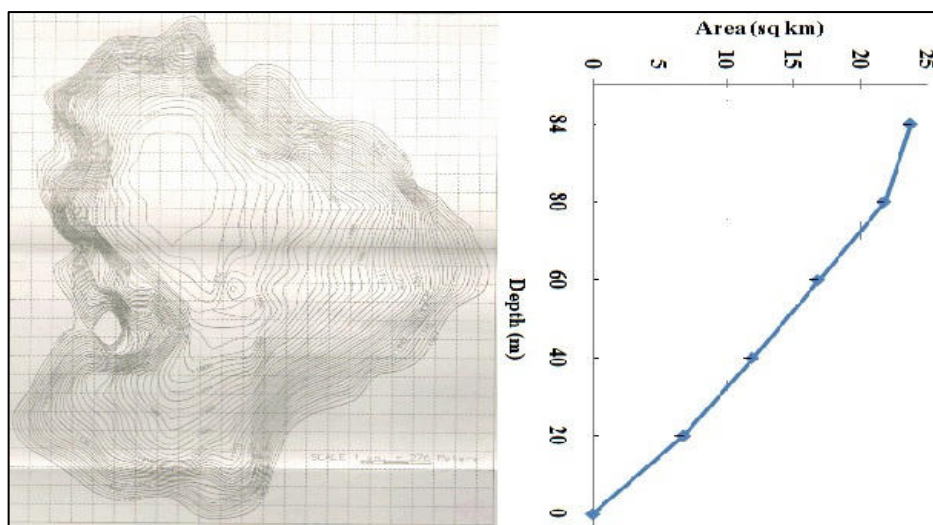
Figure 14: Bathymetric map of Lake Hayq (from Morandini, 1941).

The bathymetric maps of the lake over time provide information on the analysis of depth and storage changes of the lake. According to Morandini (1941), cited in Baxter and Golobitsh (1970), the first limnological studies and bathymetry map of Lake Hayq were carried out by Italian limnologists during the 1930s. Some of their morphometric data found in the bathymetric map are presented in (Figure 5).

Based on the first bathymetric map of the lake Hayq, some morphometric data are presented in (Table 2). The maximum depth of the lake was 88 meters. The perimeter of the lake had 21.7 km length and it covered 23.4 km².
Table 2: Morphometry data of Lake Hayq in 1938 (from Morandini, 1941)

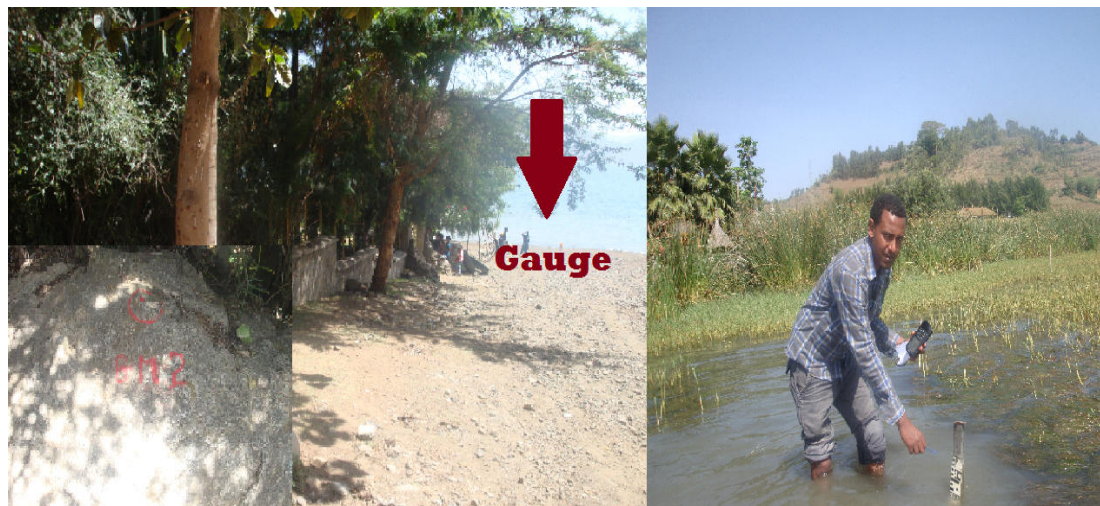
Figure 16: The distance between BM and the current Gauge, 2013.

After MoWR stationed the first water level gauge in 1975, different gauges were planted at different area on the basis of high fluctuation lake water. The difference between benchmark and current staff gauge location has been measured. It has been found that the current gauge location is 6 meter lower than the benchmark (Figure 7).

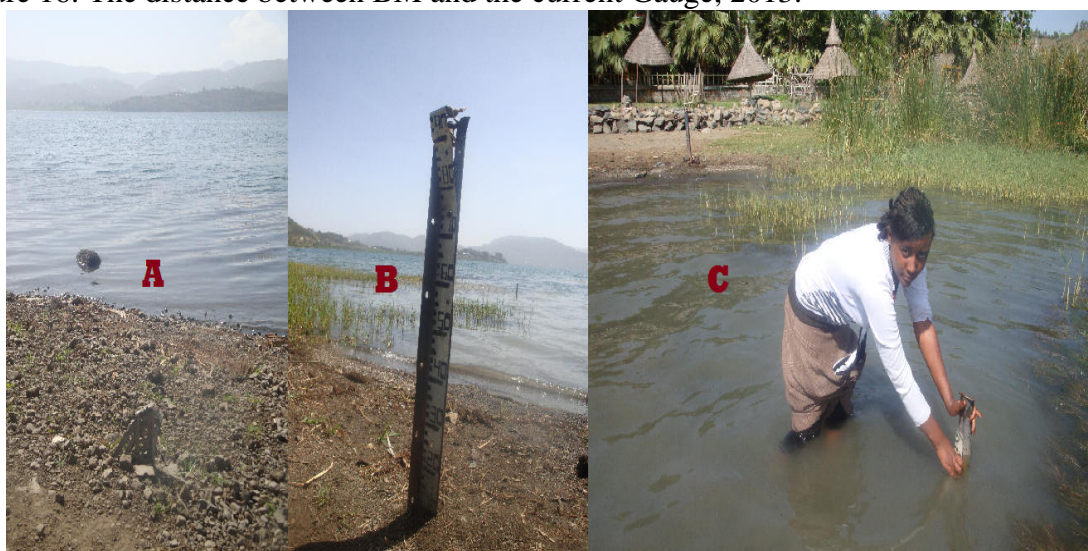
Figure 17: Different gauges on Lake Hayq at different time, 2013.

Figure 8-A, depicted the earliest gauge of the lake but at this moment the data collector is not taking reading from this gauge because the level of the lake reduced in a timely manner from the previous position and became dry land at this time. On figure 18-B and C shows the current gauges of the lake. From these gauges the gauge reader collects water level readings at different time, the first one used only in summer when the water level rises and the second one used in both summer and winter season. Both gauges give different readings.

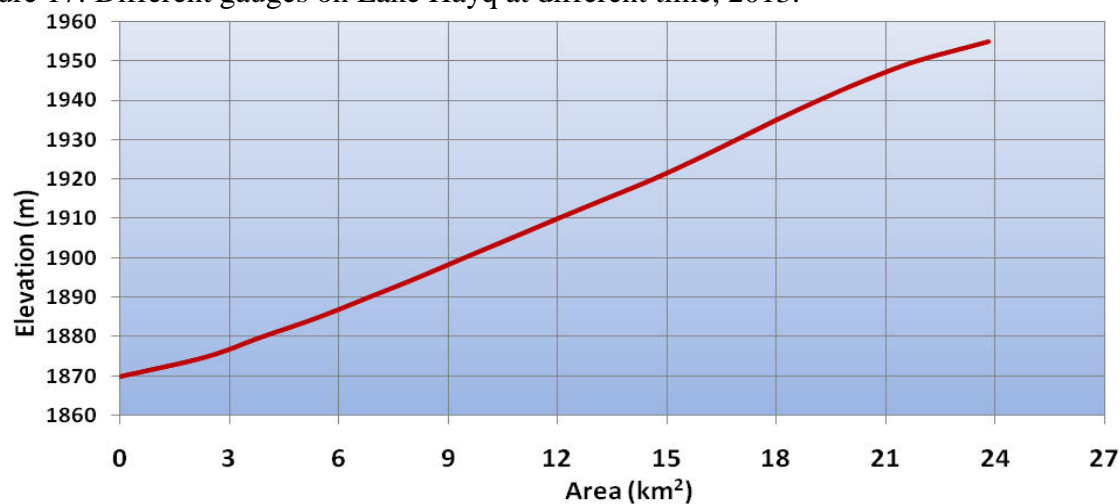
Figure 18: Lake Hayq Elevation area curve (Source; MoWR, 2000).

The bathymetric map and the calculated corresponding of elevation with lake level area volume capacity curve are accessed from MoWR. This is useful to understand the lake level fluctuation of Lake Hayq. However, it is more feasible to determine relative level fluctuations in computing changes in water storage of a lake for the definite period of time. Surface area is the area of a lake relative to a specific water level. Storage of a lake is volume of water accumulated in the basin at a specific water level. Lake surface area and their storage capacity at various water levels were determined from surveys of (MoWR, 2000). Based on these surveys, the storage

capacity of the Lake Hayq was 1034Mm^3 , the depicting surface area (area curve) and the volume of stored water (storage curve) against the water level of Lake Hayq are plotted in (Figure 9 & 10).

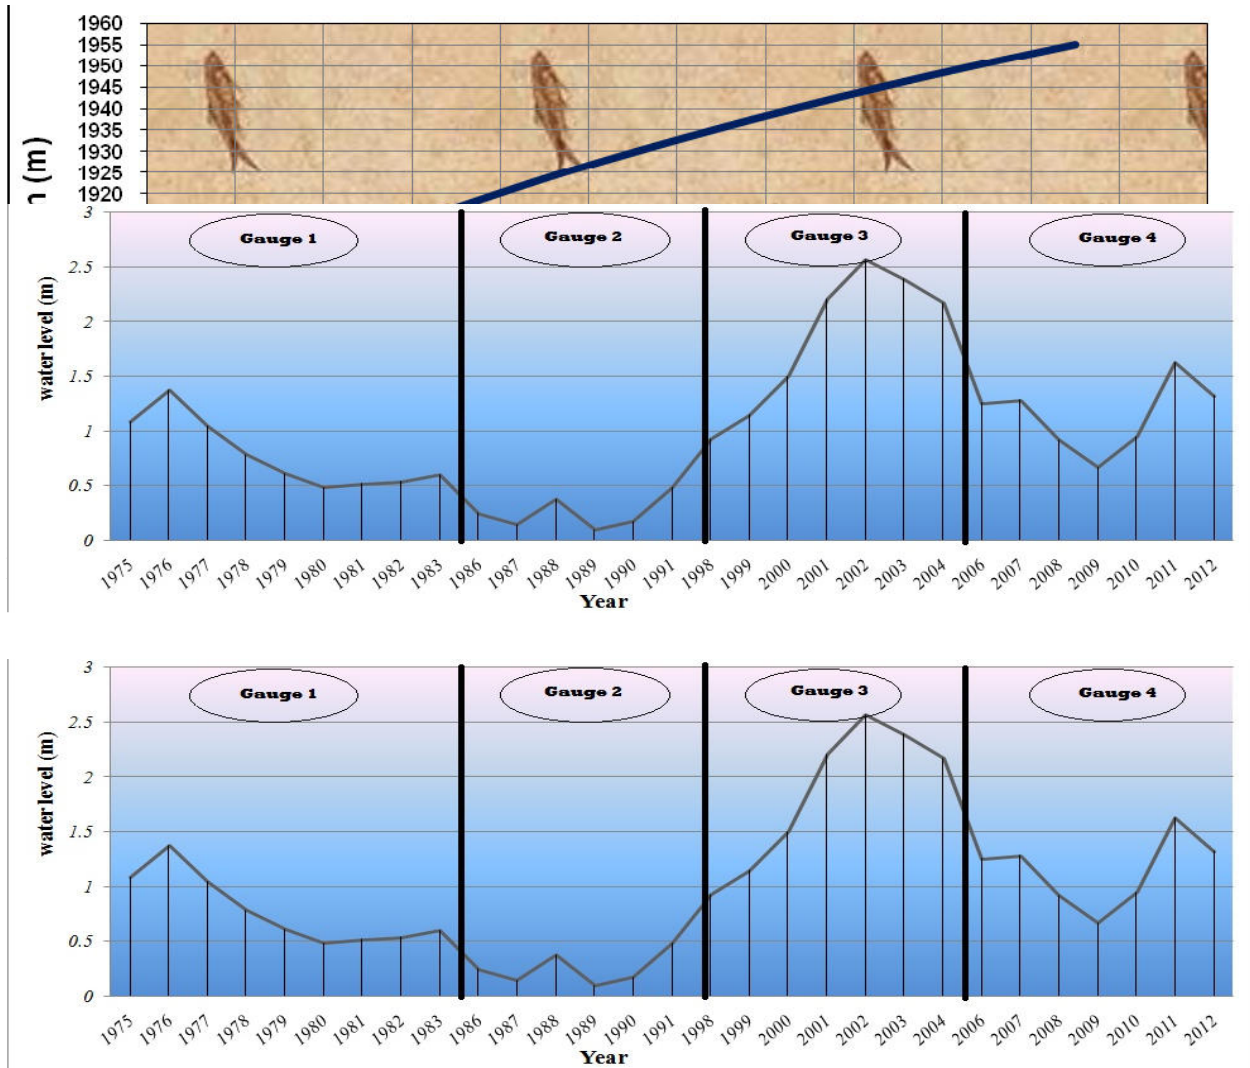
Figure 20: Water level change trend of Lake Hayq (Source; MoWR, 2012).

The actual situation revealed the reduction of water level as shown in Figure 8(A, B, C). The MoWR had given conclusion based on the water level data from different gauges readings. According to gauge reader information and field survey, it has been tried to determine the periods of each gauges had been used for measurement of water level. The first gauge was used from 1975 to 1983, the second gauge used from 1986-1991, the third gauge was used from 1997-2003 and the fourth gauges used from 2007-2012. For partitioning the general trend water level readings of lake Hayq in correspondence of different staff gauge periods (Figure 11); this study gave consideration data gathered from filed survey and the years that were not taken gauge readings (1984-1985), (1991-1997) and (2004-2005). In addition to this, in 2007, Molla et al. stated that the lake level gauging position has been shifted on the basis of fluctuation of the level.

The water level reading from 1975 to 2012 shows constant decrement of water level, it has been reduced from 88 meter to 81 meter and all water level recorded value indicated that below the benchmark of the lake level.

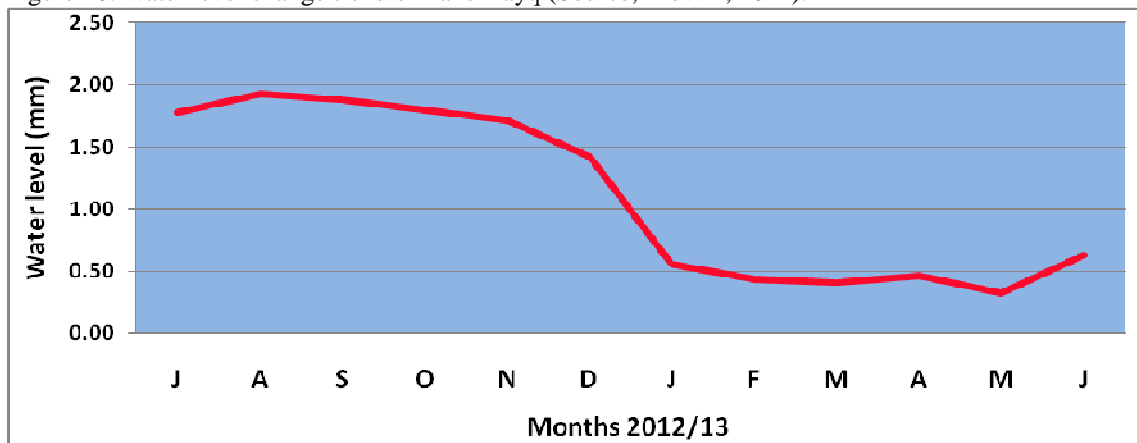
Figure 21 : water level change of Lake Hayq (source; Author, 2012/13).

According to the annual water level (2012/13) recorded data by the author, the annually water level showed a seasonal water level decrement of Lake Hayq. The lowest water levels recorded from January (0.56m) to May (0.33m), and highest is recorded in the rainy season of August (1.93m) (Figure 22). This result showed that there is 1.6 meter annual water level variation. Precipitation, surface runoff, at rainy season; evaporation and extraction of lake water for irrigation purpose at dry season are the major input and output factors for water level change of Lake Hayq.

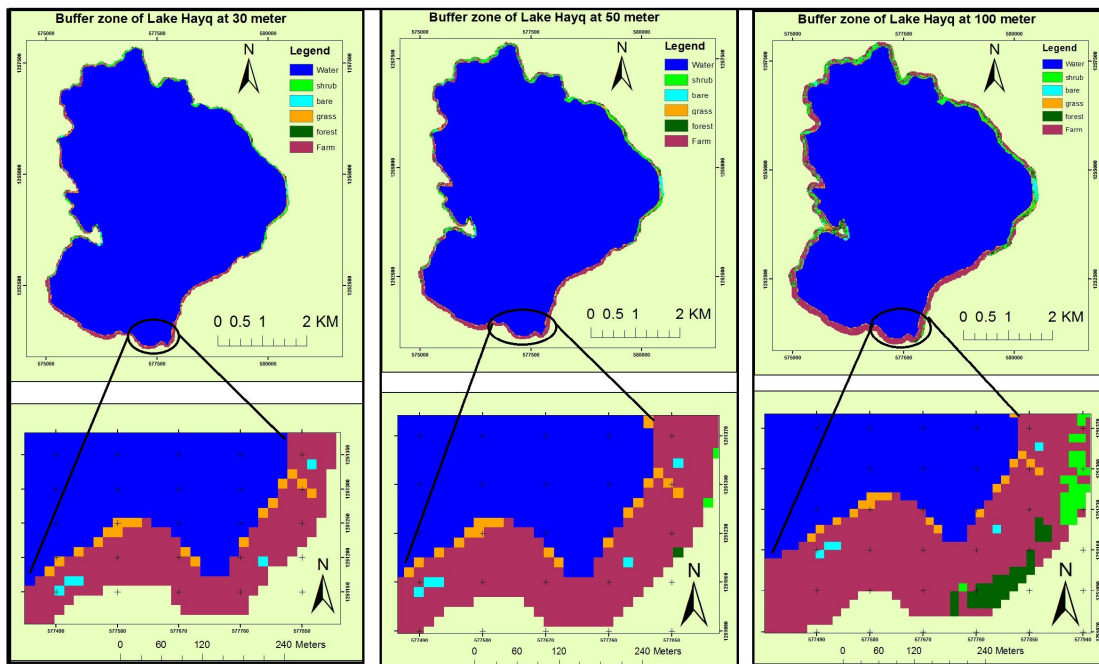
Figure 13: Farmland Practices on the buffer area of Lake Hayq at 30, 50 & 100 meter.

To analyze the agricultural practices around the lake shore, the author extracted farmland activities at 30, 50, and 100 meter buffer area of the lake from the result of LULC changes. According to the results obtained from LULC change of farmland on the buffering zone of Lake Hayq, the distribution of the farmland in 1972 was very small. Areal values of farmland for the period of 1972, 1986 and 2010 satellite image classification at 50 meter buffering zone were calculated as (4 %), (38 %) and (66 %) respectively (Table 4), this indicating that such areas were converted to farmland with very fast and continuous trend. These given data expressly stated that the increase of farmland around the periphery of lake areas accelerated by high population pressure.
