# An Appraisal of Gully Erosion along River Ngaddabul Floodplain, Maiduguri, Borno State, Nigeria

## Abstract

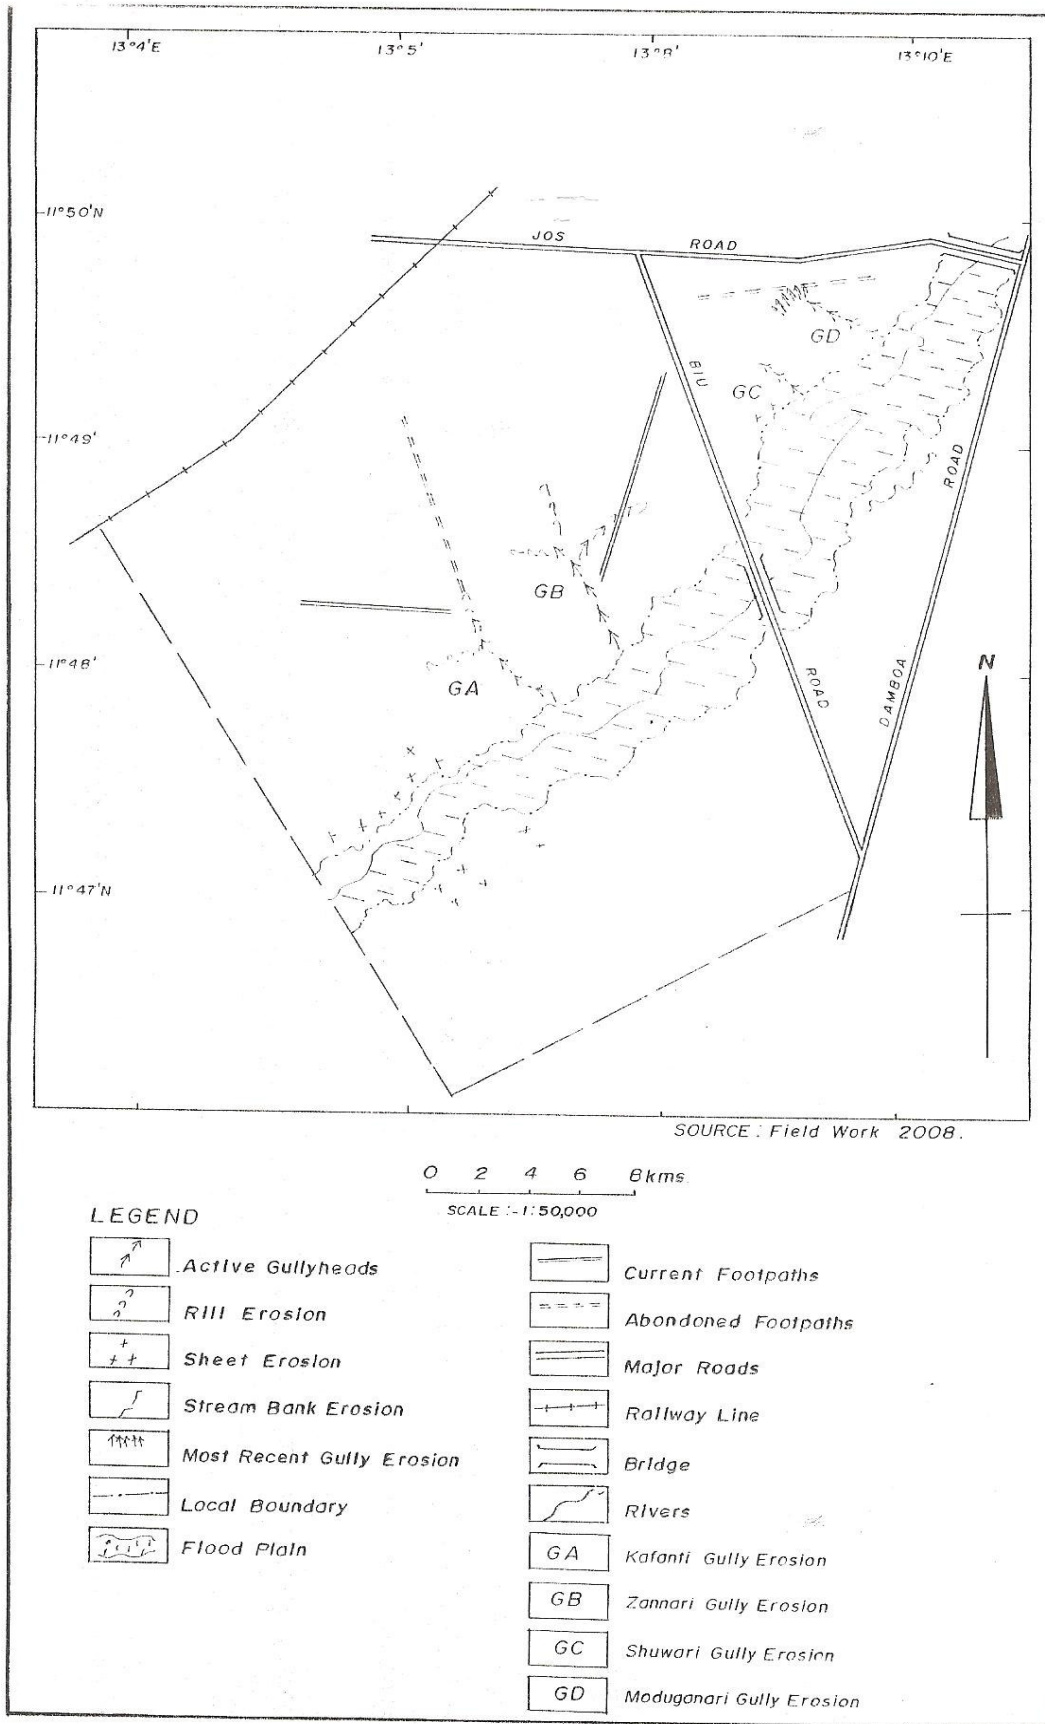
Fig. 4.1 : GULLY STRUCTURE ALONG NGADDABUL RIVER FLOOD PLAIN.

The gullies were measured at two different periods. First they were measured and mapped before the onset of the rain in March and later another measurement was also taken after the peak rain in August. Four prominent gullies were identified. These are Kafanti, Zannari, Shuwari and Moduganari gullies respectively. From the results obtained by physical assessment of the prominent gully catchments, two types of the gully forms were identified. These are 1<sup>st</sup> order gullies as in Shuwari and Moduganari gullies and 2<sup>nd</sup> order gullies at Kafanti and Zannari gullies. The gullies at Kafanti and Zannari exhibited 2<sup>nd</sup> order gullies. The gullies here are incising in a gently sloping valley (Plate 4.1), with generally well – defined, somewhat irregular margins due to the existence of numerous small lateral head cuts. While, Shuwari and Moduganari gullies displayed remarkably 1<sup>st</sup> order gullies (Fig 4.1)

The gully above shows the main gully channel which served as the subsequent basin at Kafanti and Zannari areas, while the two other minor gullies connected to the main gully channel at the western side are the consequent basins which made the morphometric of the 2<sup>nd</sup> order gully.

The morphometric of the gullies in most locations showing evidence of recent incision into the mottled weathering horizon. The gullies are very wide where they cut across the surface sandy soil, becoming narrower where incised into the clayed mottled zone. The narrow 1<sup>st</sup> order channels which are near vertical to overhanging are usually asymmetrical with the slip-off slopes facing near perpendicular slopes. The first order gullies around Kafanti and Zannari gully sites are all seen to develop on footpaths, while the 2<sup>nd</sup> order segments have developed along former unpaved drainage channels where sheet flow, rills and the 1<sup>st</sup> order gullies converge.

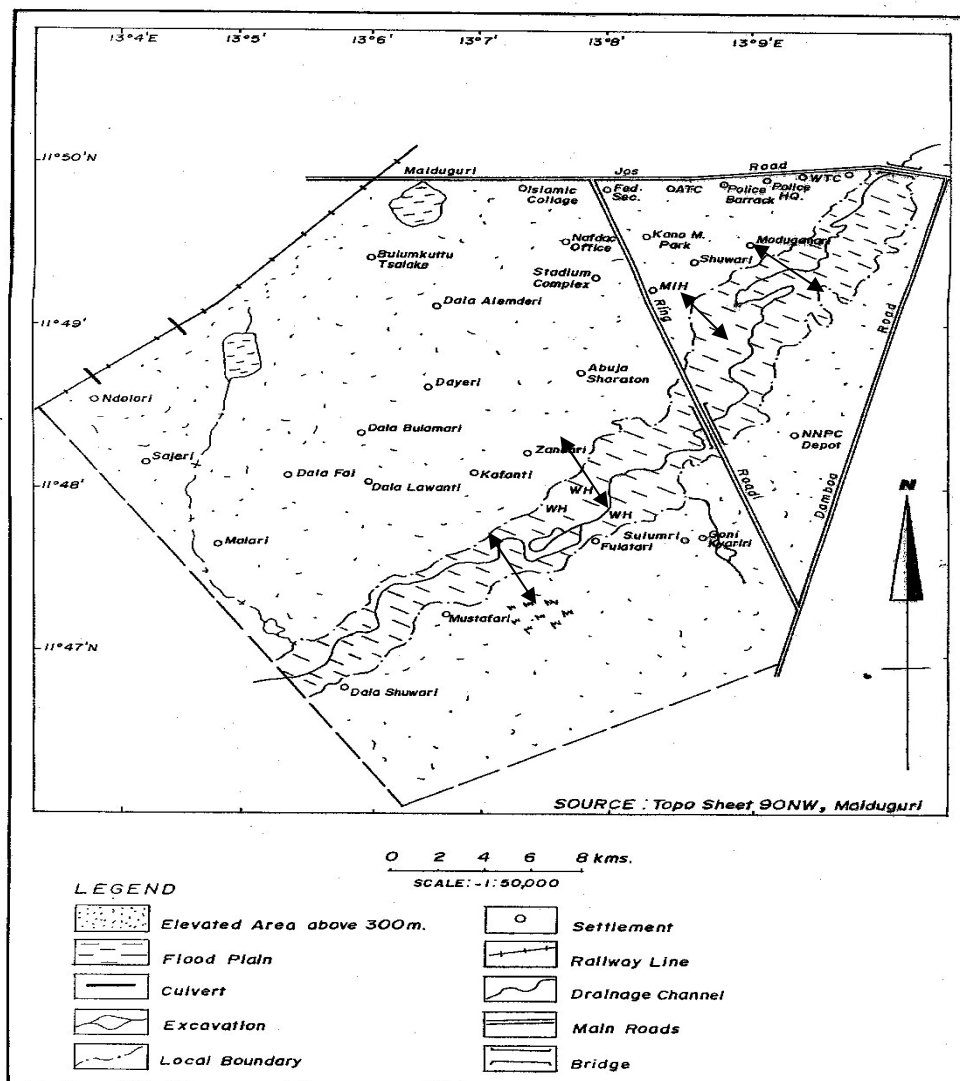
Fig. 4.2 : SETTLEMENT DISTRIBUTION ALONG NGADDABUL RIVER FLOOD PLAIN .

The findings also reveal that both physical and human factors played important roles in influencing gully erosions. Also the main gullying processes examined ranged from mechanisms of undermining, collapsing, and carving of the gully channels. However, rills also developed on the adjacent plains of the river banks which discharged runoff to the main gullies taking advantage of slopes and gravity and end its water to Ngaddabul River. The gullies are more in the western side of the Ngaddabul river bank showing the influence of the settlements (Fig 4.2).

In this study it would be premature to formulate a general model on the development of gullies along River Ngaddabul floodplain, Maiduguri Metropolis. Nevertheless, the study has shown that there are interesting possibilities for further research on these gullies, particularly in terms of evaluating hypothesis on episodic erosion and rates of gully growth. This preliminary survey has also provided some useful information concerning the distribution, morphology and enlargement of gullies in this part of River Ngaddabul, Maiduguri. However, mapping of the gullies shows that these features are restricted almost entirely to the western side of the road. This appears to be related to settlement influence.
