# Sedimentation and Vegetation Colonization in Shah Tours Gully after Rehabilitation, Kilimanjaro, Tanzania

The Shah Tours gully, rehabilitated under the auspices of the project on Reducing Land Degradation in the Highlands of Kilimanjaro Region, is showing signs of recovery, only one year after rehabilitation. Check dams of stone and wire gabions, and sandbags, measuring 1.0 m high filled up with sediments at a rate of approximately  $10.9 \text{ t ha}^{-1} \text{ yr}^{-1}$ . Considering that the average depth of gully is 3.0 m, it is projected that it will take 2 more years for sediments to fill up the gully, if more layers of check dams are added to the existing ones. With respect to colonization by vegetation, there is 100% cover mainly by herbaceous layer (grasses and herbs), but also some shrubs and trees in the gully bed, which was rocky and devoid of plants before rehabilitation. These results will be crucial in planning for other gully-rehabilitation works in the Kilimanjaro region.

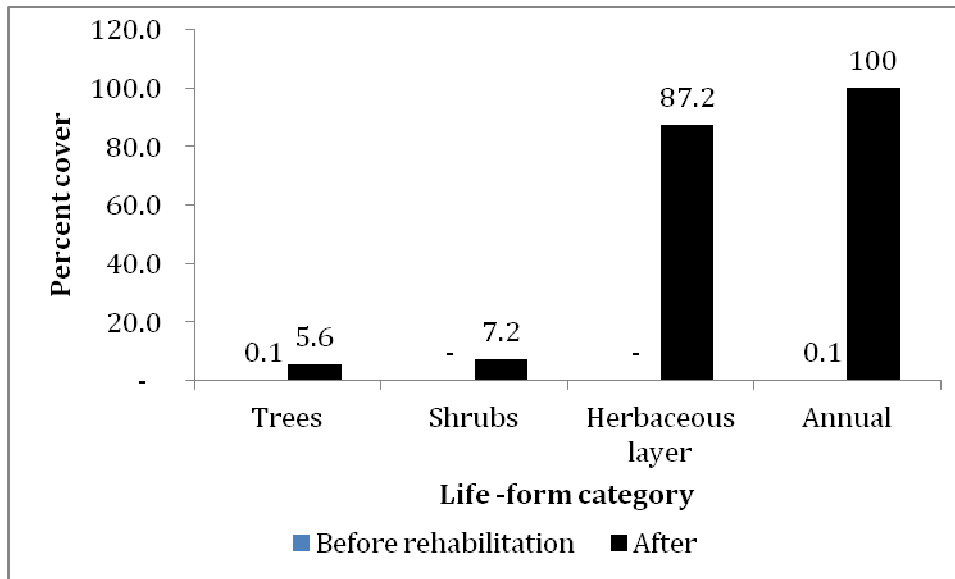
With regard to vegetation colonization, the percent cover was 100% after rehabilitation of the gully (Fig. 3), the bed of which was devoid of any plant prior to implementing the intervention measures. The percent cover of the herbaceous layer is the higher than that of shrubs and trees because herbs and grasses have short lifespan (one growing season), rapid maturity, and produce numerous small easily dispersed seeds (Anon., undated). In terms of seasonal percent cover (Fig. 4), it is highest during the minor dry season, and lowest in the main dry because during the latter the bed was rocky, devoid of moisture and substrate on which plants could grow. During the main rainy season, there is not much cover either because of too much water flowing in the gully for plants to colonize, even though the accumulating sediments provide the right substrate. As soon as seeds germinate, they are easily washed away by storm water. However, the plants are able to establish themselves during the dry season when there is either less water or none in the gully; they grow on residual moisture.

Figure 3: Percent cover of naturally colonizing plants, Shah Tours gully, Moshi Municipality, Tanzania
