# Evaluate the Quality of Physical Soil and Water Conservation Structures in Wyebela Watershed, Northwest Ethiopia

Simeneh Demissie Walie  
Gambella University

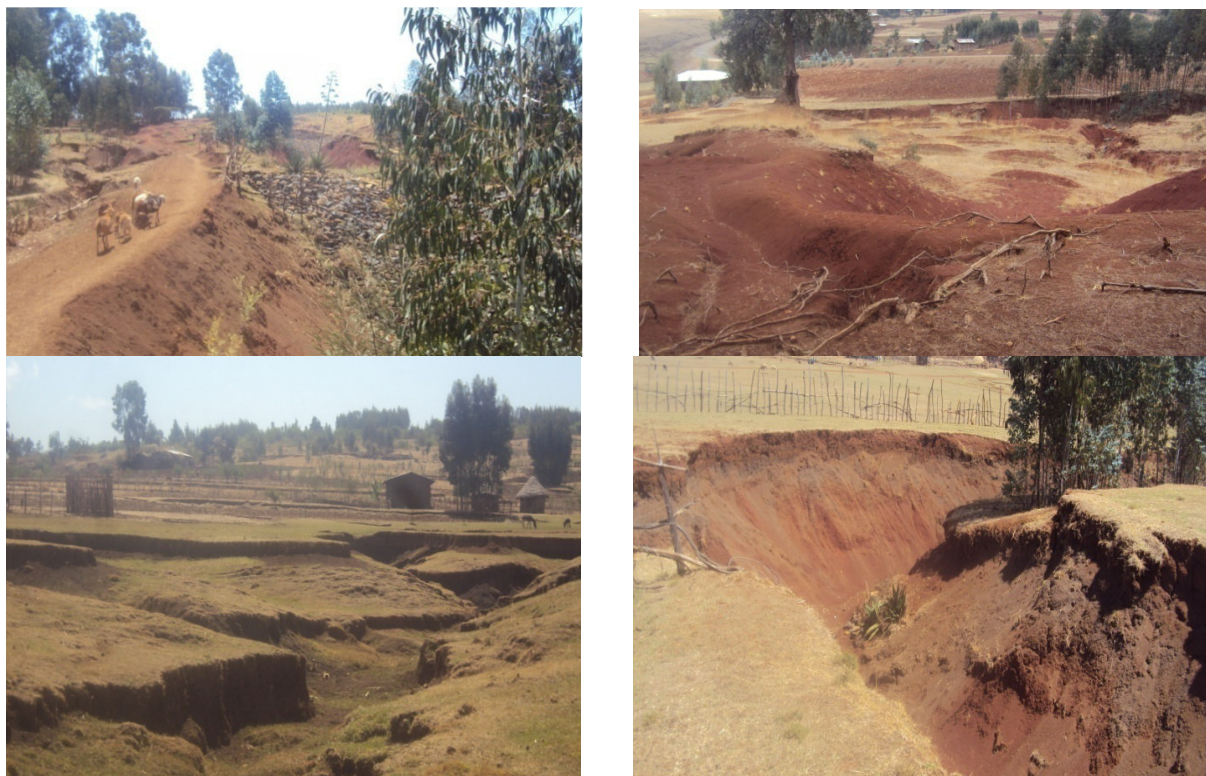
**Figure 3. Gully erosions formed in different sites of the watershed.**

From households' survey results, 36.8% of the farmers land was affected by gully erosion. Gully erosion is one of the forms accelerating soil erosion (Gang *et al.*, 2009). Soil loss rates by gully erosion represent more than half of the total sediment yield caused by water erosion (Valentin *et al.*, 2005). From the field observation, the main causes of gully in the study area were over grazing, poor design of physical SWC structures, deforestation, and continuous use of arable land and cattle tracks lines Fig.3, According to Getachew F. (2012) the cause of gully formation are soil characteristics, human activities, and natural factors. Gully formation can be also stopped by disturbed concentrated run off coming from the roads, increasing vegetation cover and reducing over grazing.

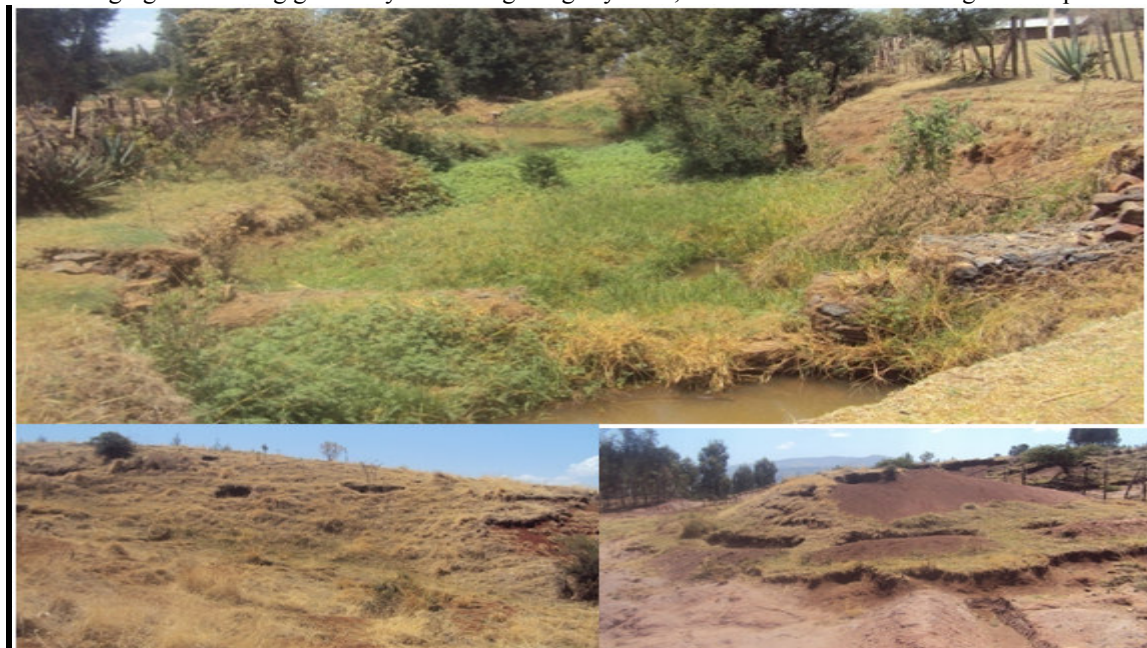
**Figure 4. Different types of water harvesting structures under area closure reduce gully development in the lower catchment.**

In the study area, several gully rehabilitation measures were implemented in the past 10 years Fig.4, though restoring gullies is more complicated and expensive. Once gullies are formed, large amounts of soil from surface and subsurface layers have been already lost (Blanco and Rattan, 2008). Gully prevention measures in the study site includes soil managements, agronomic practices, correctly designed and constructed physical SWC measures in the watershed base which reduce run off development. When gullies were already formed, there were two options of control are; to reclaim the gullies to conditions similar to the uneroded portions of the field and managing the existing gullies by stabilizing the gully head, bed and sides and reducing their expansion

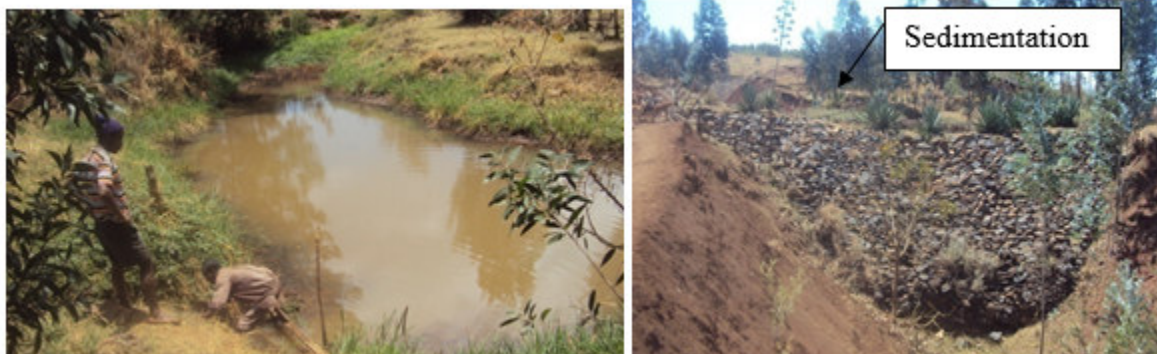
**Figure 5. Farmers fetch water from SSD. Figure 6. SSD constructed on a large gully**

Almost all gully control measures in the study area were effective to arrest loss of soil and protect development of new gullies Fig.5 & 6. This is because check dams and sediment storage dams (SSDs) where

constructed based on the package except some check dams.

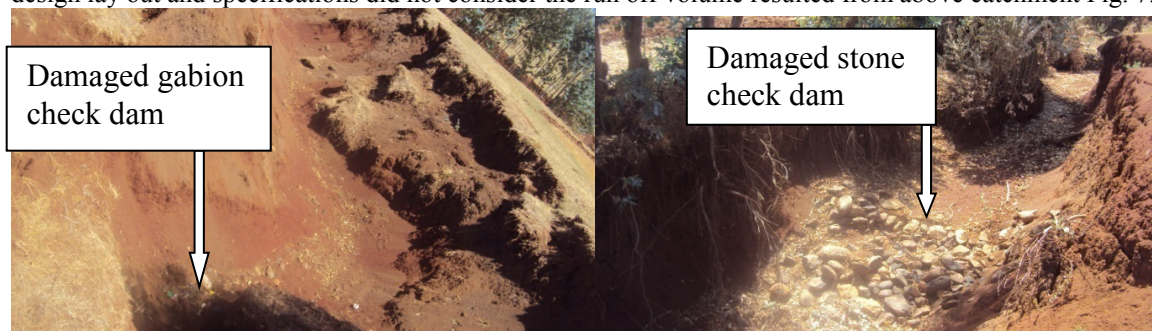
**Figure 7. Ineffective stone and gabion check dams on large gullies.**

From 13 sampled check dams 11(84.6%) of the average vertical interval between check dams is not more than 1m and side keys and spill ways also designed based on the package specifications. As a result streams were developed in restored gullies where watershed communities used for irrigation purpose in dry season Fig.5. In some parts of the watershed gully rehabilitation activities were not effective Fig. 7. The failures of these check dams were poor design lay out and specifications selection. The height of check dams was 1 m but the vertical interval was 2 m. This shows that the spacing between two successive check dams was greater than the recommended one (1 m). From the field survey data record the average gully width, depth and catchment areas are 5m, 4m and 9ha, respectively. In these gully dimensions stone check dams are not recommended. Rather these types of check dams were used for small gullies which have  $\leq 2.5$  m depth (BoA, 2005). Even though gabion checks dams were used, it did not achieve the desired goal. The reason is that the design lay out and specifications did not consider the run off volume resulted from above catchment Fig. 7.
