## Slum Conditions in Urban Nigeria: A Case of Jimeta-Yola, Adamawa State, Nigeria

### Abstract

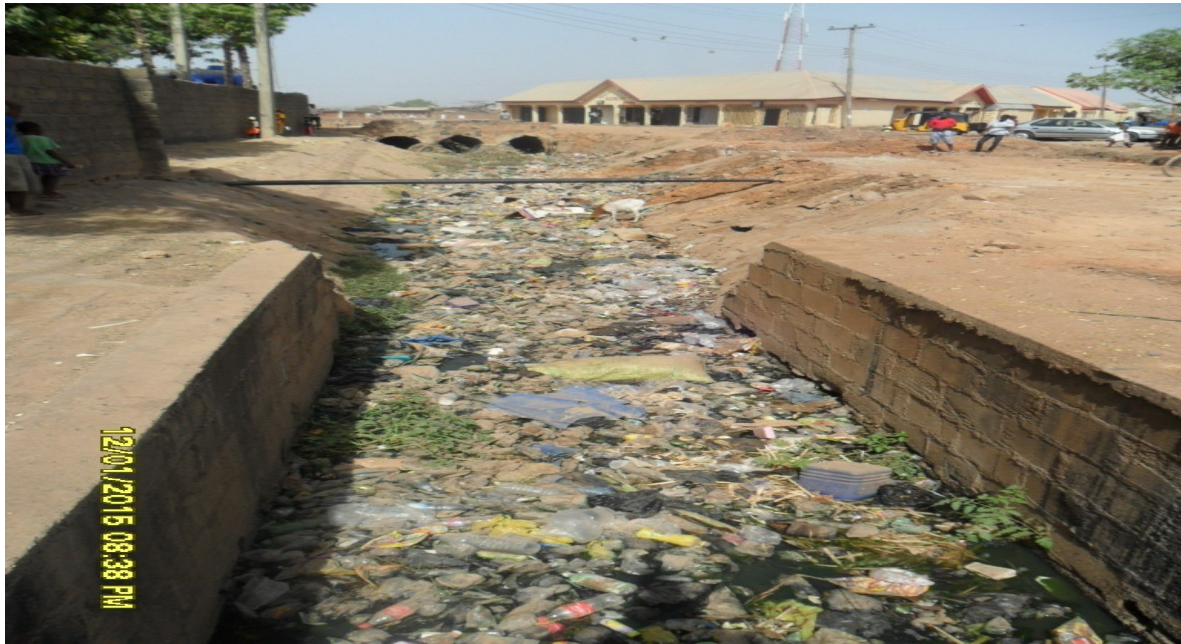
Of all the Streets mentioned above only, Zaranda Street has better surface drainages. On one side is storm water drainage measuring 2x3metre and 0.5x1metre drainage on the other side of the street. Demsawo is a low-lying area adjoining the River Benue flood plain which makes it vulnerable to flood. Demsawo area suffers flooding almost every rainy season, the worst of which was the 2012 flooding that ravaged most parts of Nigeria. This is more so because the few other narrow drainages are blocked from silting and indiscriminate dumping of refuse by residents of the area. Dumping of refuse in storm-water drainage is a regular practice in the area because of the belief that it will be conveyed to the River Benue close by. This practice is evident on plate 1.

*Plate 1: Blockage of Storm-water Drainage due to indiscriminate dumping of refuse in Demsawo. This is the only storm-water drainage in the area.*

4. Government through the Ministry of Environment and Department of Sanitation should provide wheeled-waste-bins among groups of 5-7 houses for collection of refuse and should be evacuated on weekly basis. The youths of the area should be involved in this planning strategy through participatory approach and enlightenment.

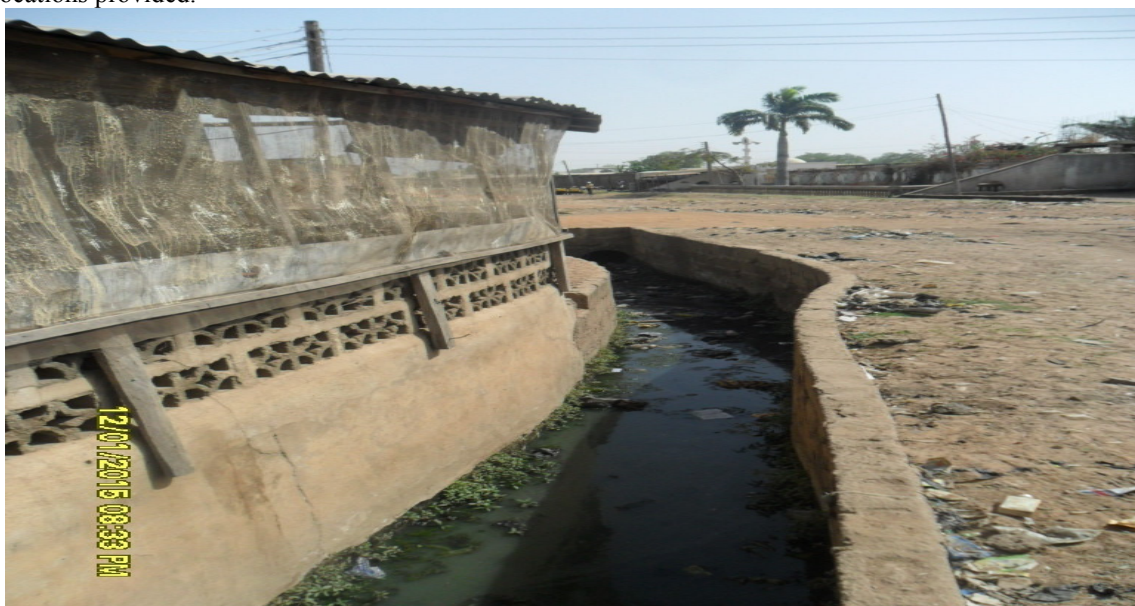
Living conditions in the slums is pathetic considering the health implications especially where there is stagnant water which aids the breeding of mosquitoes. In some parts of Demsawo where study was conducted, we came across a drainage right at the door-step of some residents whereby they have to contend with the smell from this drainage and the mosquitoes that are being bred there (see Plate 2). When asked why they live in this kind of condition, a resident responded:

*Plate 2: Showing a Gutter/Drainage in front of a dwelling (House) in Demsawo area in Jimeta. Note the filthiness of the environment which aids breeding of mosquitoes and stinky smell.*

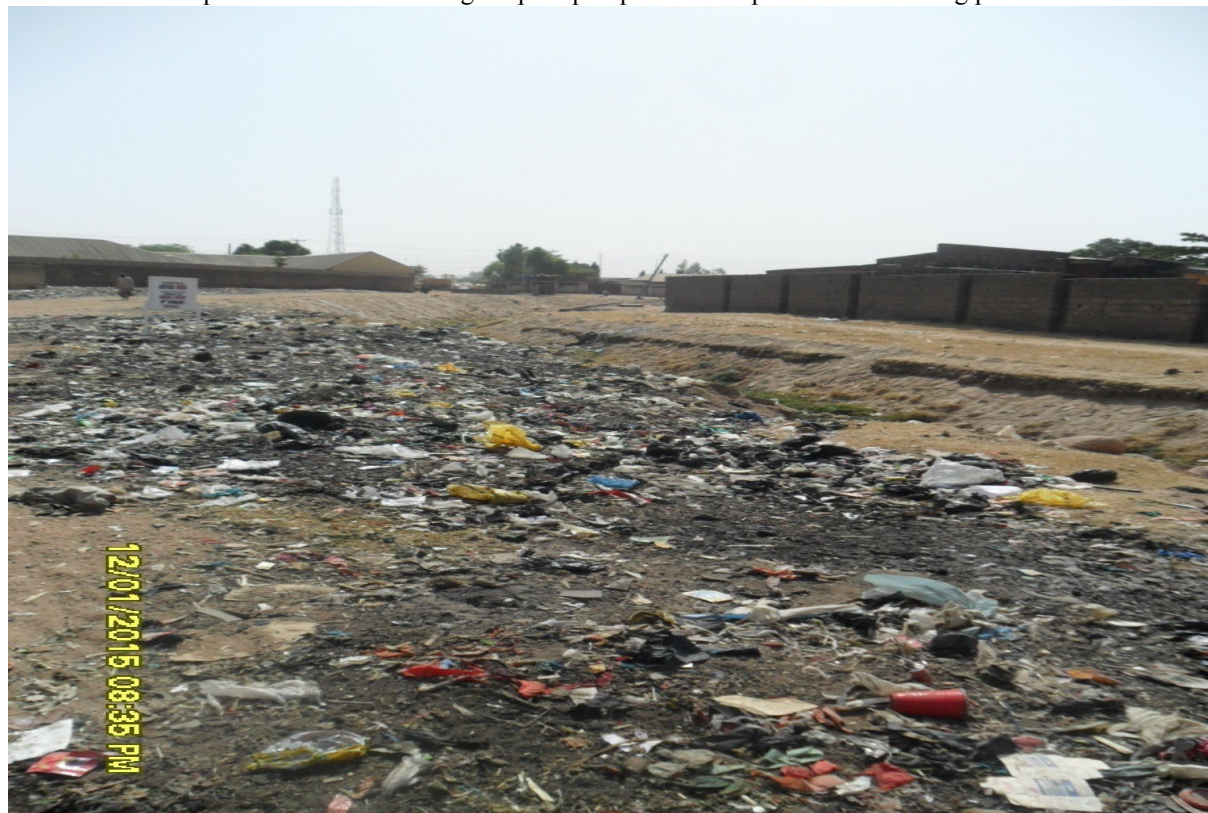
The filthy nature of the environment and living conditions in this area can better be imagined than experienced. Refuse are dumped on the streets and the wind blows it into the gutters thereby blocking it over time (see plate 3). Even though the Local authorities have put up a sign to stop people from dumping refuse indiscriminately at some locations, residents still do not comply with such orders. The residents complain of local authority’s insensitivity to their plight in terms of proper waste management and disposal. The Local authorities on the other hand said that people have simply refused to dispose of their refuse at designated locations provided.

Open waste disposal on the street in the area is further demonstrated on plate 3 where it is noted that residents still dump refuse even where a sign is put up to prevent this practice from taking place.

Plate 3: Open waste disposal/Refuse dump is a common sight in the slums in Jimeta
