The Impact of Sand Mining on Riparian Areas of Eyaa, Onne, Nigeria

Giadom, F.D. Akpokodje, E.G.
Department of Geology, University of Port Harcourt.

Abstract

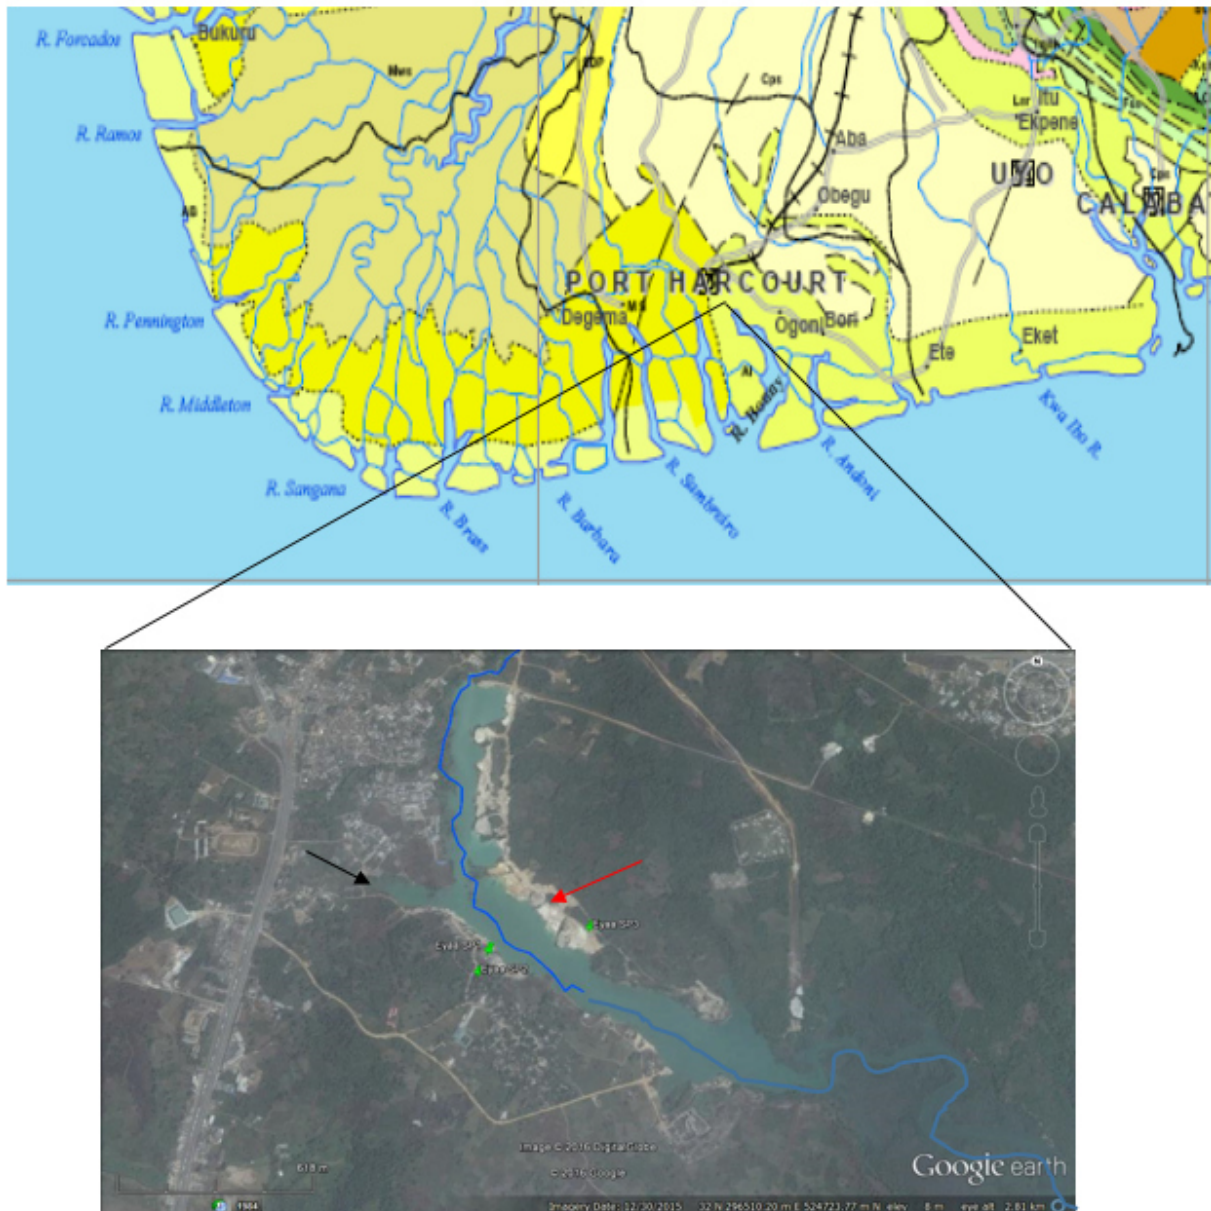
Figure 1: NGS Map of Southern Nigeria, inset (imagery) shows in-stream sand mining on the Eyaa River, Onne, Rivers State. Red arrow shows mined sand stockpile on the banks of the River, black arrow show prograding gully heads and green pins show soil sampling points.

The lithology of the study area was established through manual augering of boreholes situated at the banks of the river (see Fig 1) and advanced to a maximum depth of 3.5m. Soil samples were obtained from the augered boreholes at 0.5m intervals and at horizons where there were obvious lithological changes. Samples were visually assessed, described on site and sent to the laboratory for Particle Size Distribution analysis and Crumb tests using BS 1377 (1990) and ASTM D6572, (2000) standard methods respectively. Archival Google Earth satellite imageries of the study area from 2006 to 2015 were obtained and critically evaluated to establish the expansion of the Eyaa river channel and the changes that have taken place within the riparian corridor during the period. A change detection analyses of the imageries were carried out, establishing a progressive variation in riparian morphology and channel size within the ten year period. In carrying out this multi-temporal analysis, the imageries had to be of the same scale and sensor to ensure comparability of the various aspects.

Subsurface lithology of the riparian corridor of the Eyaa River, reveals a greyish brown sequence of silty sands at the surface; and coarsening downwards into greyish yellowish, friable, angular to sub-angular sands with little or no fines at depths of 3m and below (see figure 3 for lithologic logs). The soils are cohesionless; which explains its erodibility and low resistance to erosive forces of the river, resulting in undercutting and collapse of the bank walls; ultimately widening the channel. This inherent susceptibility of the soils within the riparian corridor to erosion and failure, facilitates the development of active gully heads that are extending to community farm-lots and neighbourhoods (see figure 1).

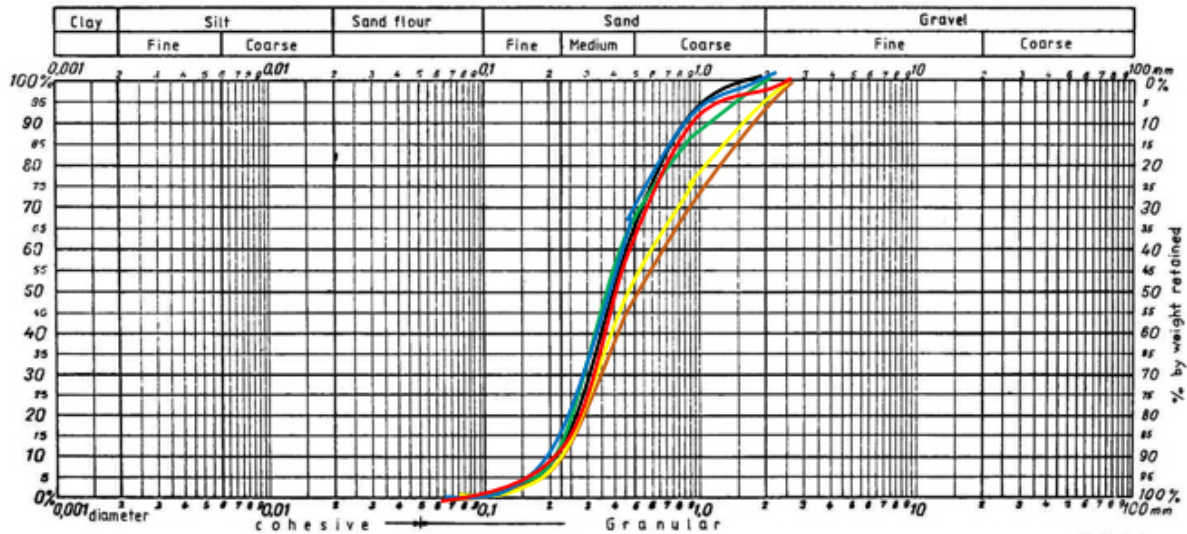
The PSD displays a uniform gradation Curves shown below

Figure 2: Particle Size Distribution Curves of Borehole ESP1 (6 layers 0.0 - 3.5m)

4.1 Particle Size Distribution: PSD from the study site reveals a poorly graded, well sorted sands, with 6.8% fine sand, 61% medium sand and 31.9% coarse sand; with very little fines (1.2-0.1% passing through 0.075mm sieve). The sands are therefore classified as SP (Poorly Graded) under the Unified Soil Classification System (U.S.C.S). The gradation patterns and particle size distribution curves are shown in figure 2.

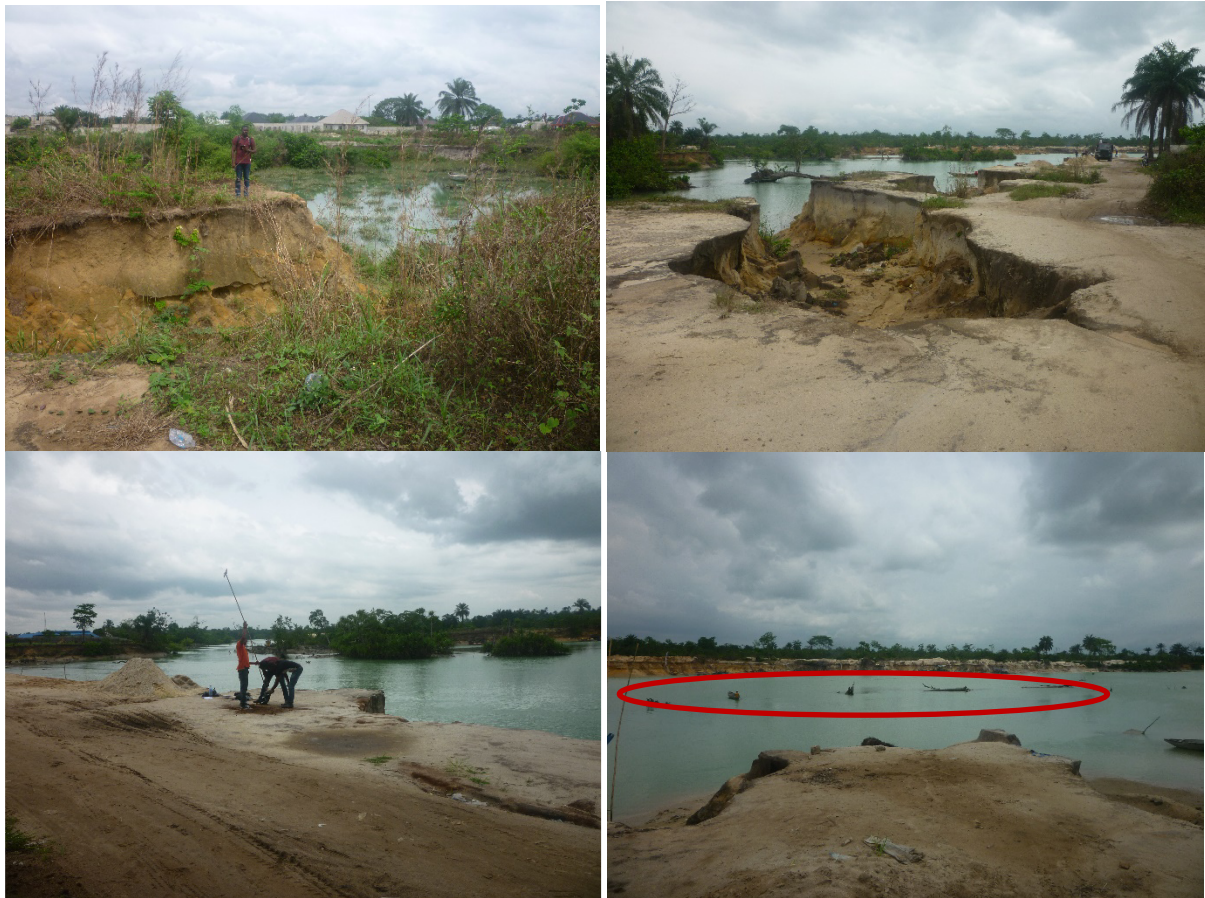
Figure 5: Clockwise from top, a gully head prograding towards Eyaa community. The red ellipse shows stumps of riparian zone trees that are now in the centre of the river due to erosion (disappearance of a community of riparian flora).
