GIS-Based Study of Prioritized Gully Erosion and Flood Locations in Ebonyi State

DOI: 10.7176/JEES/10-2-11

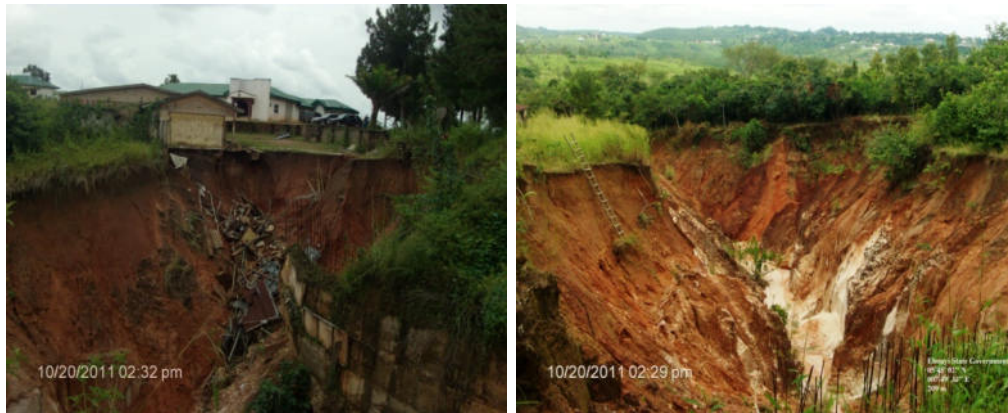
Figure 5: Court house destroyed by gully erosion at Afikpo South LGA

The impacts of flood and gully erosion as observed in Figures 3-7, includes the following:

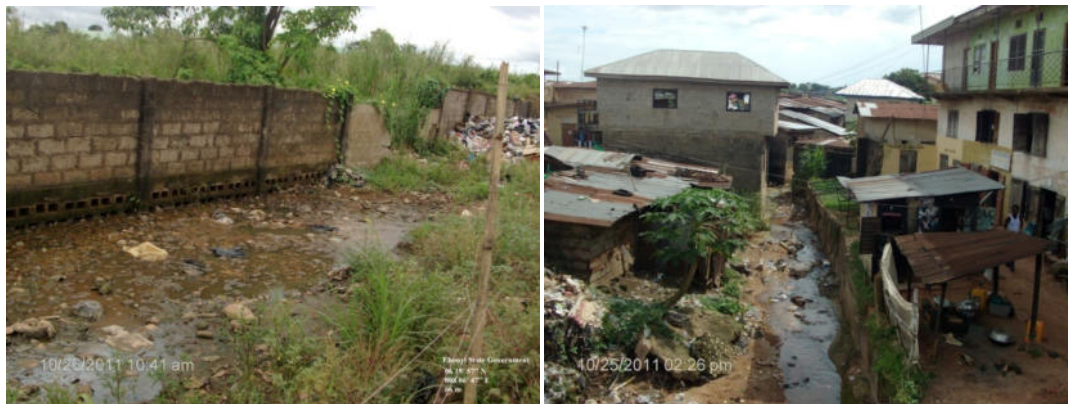
Figure 6: Federal Medical Centre Abakiliki and residence areas in Afikpo affected by flood

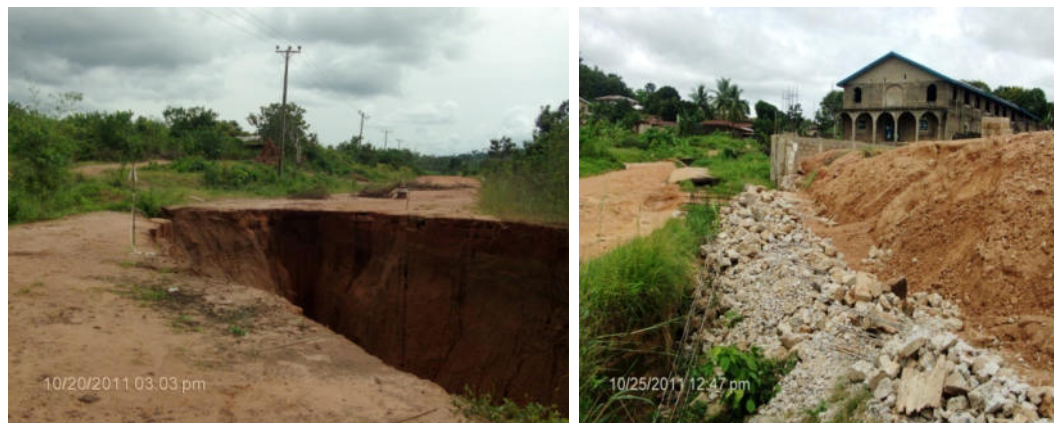
Figure 7: Electric poles and wires under threat by gully erosion at Nguzu Edda and catholic Church fence destroyed by flood water
