# Application of Electrical Resistivity Tomography (ERT) and Aerial Photographs Techniques in Geo Hazard Assessment of Karst Features in Constructing Sites in Perak, Peninsular Malaysia

Riyadh R. Yassin\*, Ros Fatimah Muhammad, Samsudin Hj Taib

Department of Geology, Faculty of Science, University of Malaya, 50603 Kuala Lumpur, Malaysia. \*Email: [riyadh.geophsea@gmail.com](mailto:riyadh.geophsea@gmail.com)

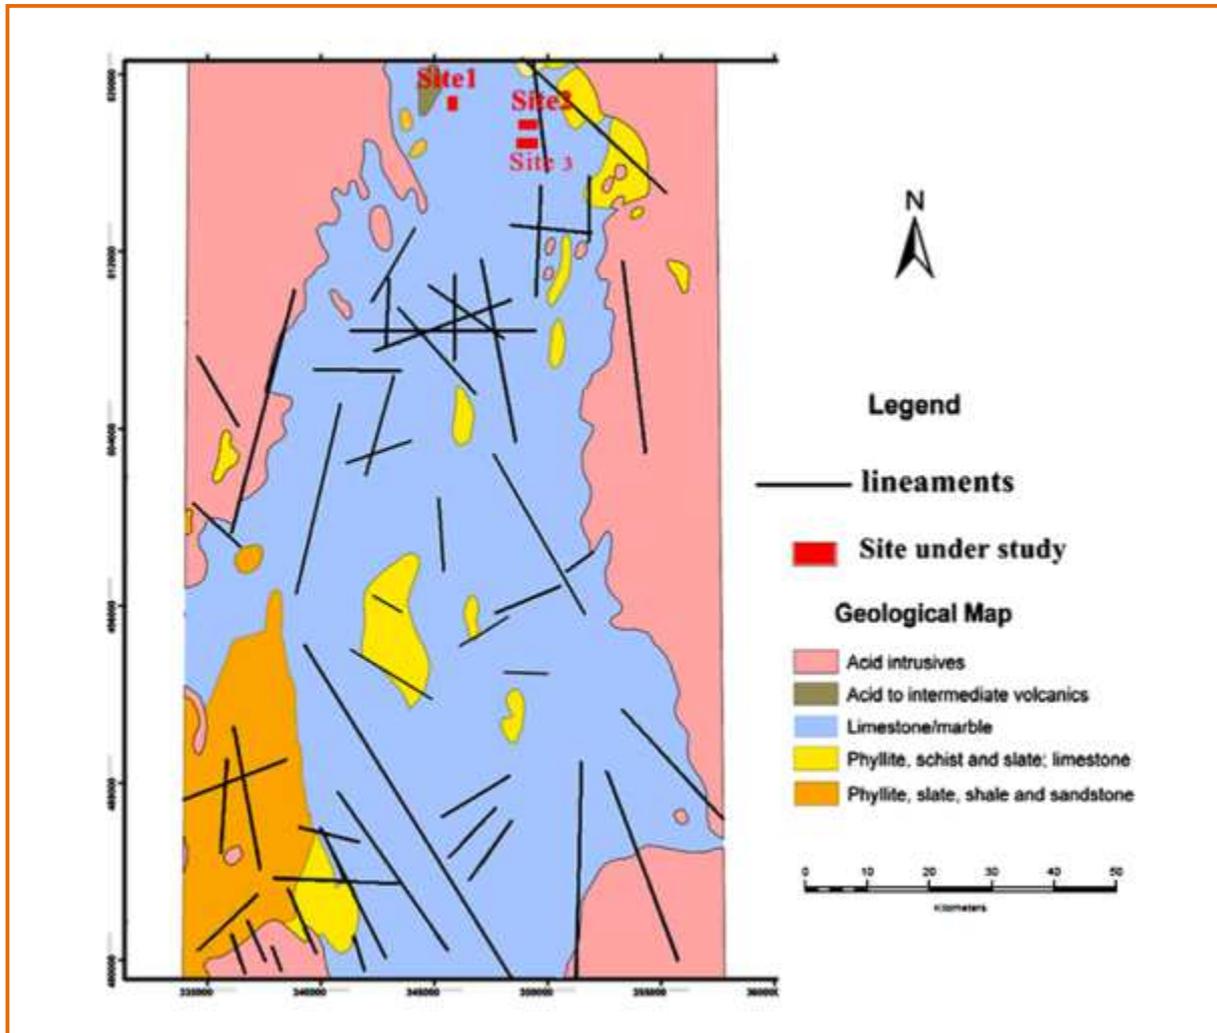
**Figure 2: Geological map of Kinta valley viewing the location of construction sites under study North of Ipoh city, Perak state**

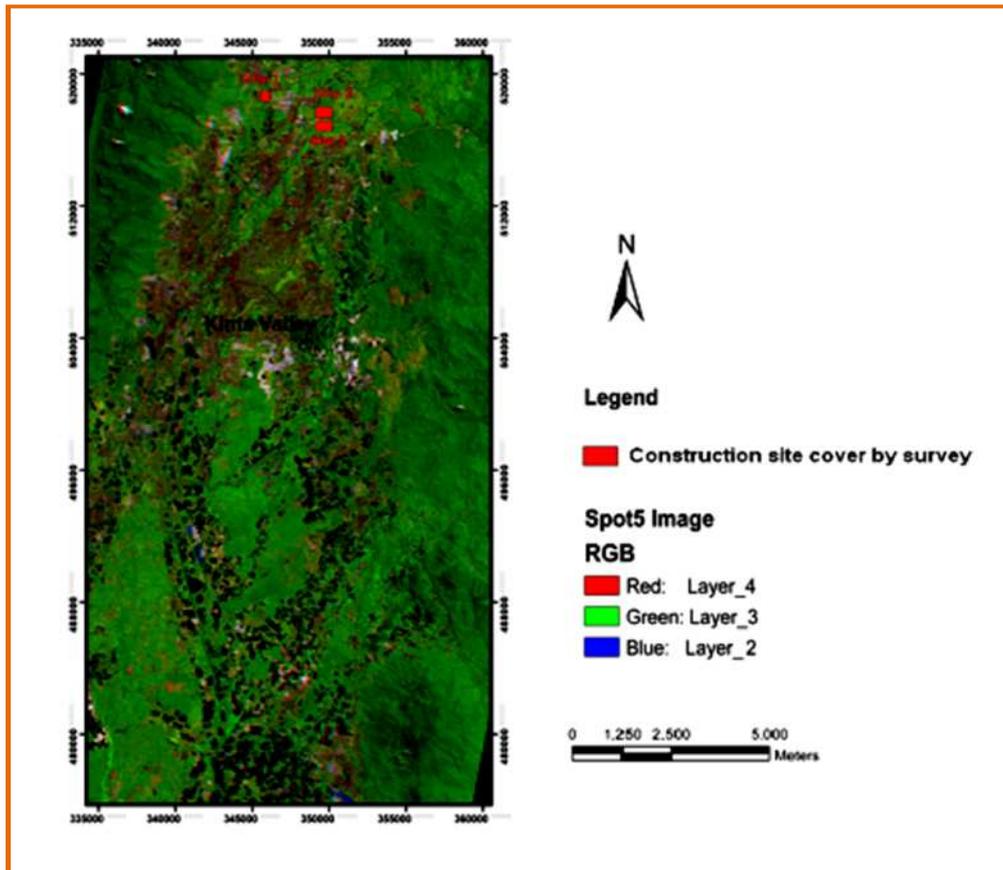
**Figure 3: Five layers spot images of Perak state (2008) presenting the location of construction site #1, site #2 and site #3 north of Ipoh city (Kinta valley)**

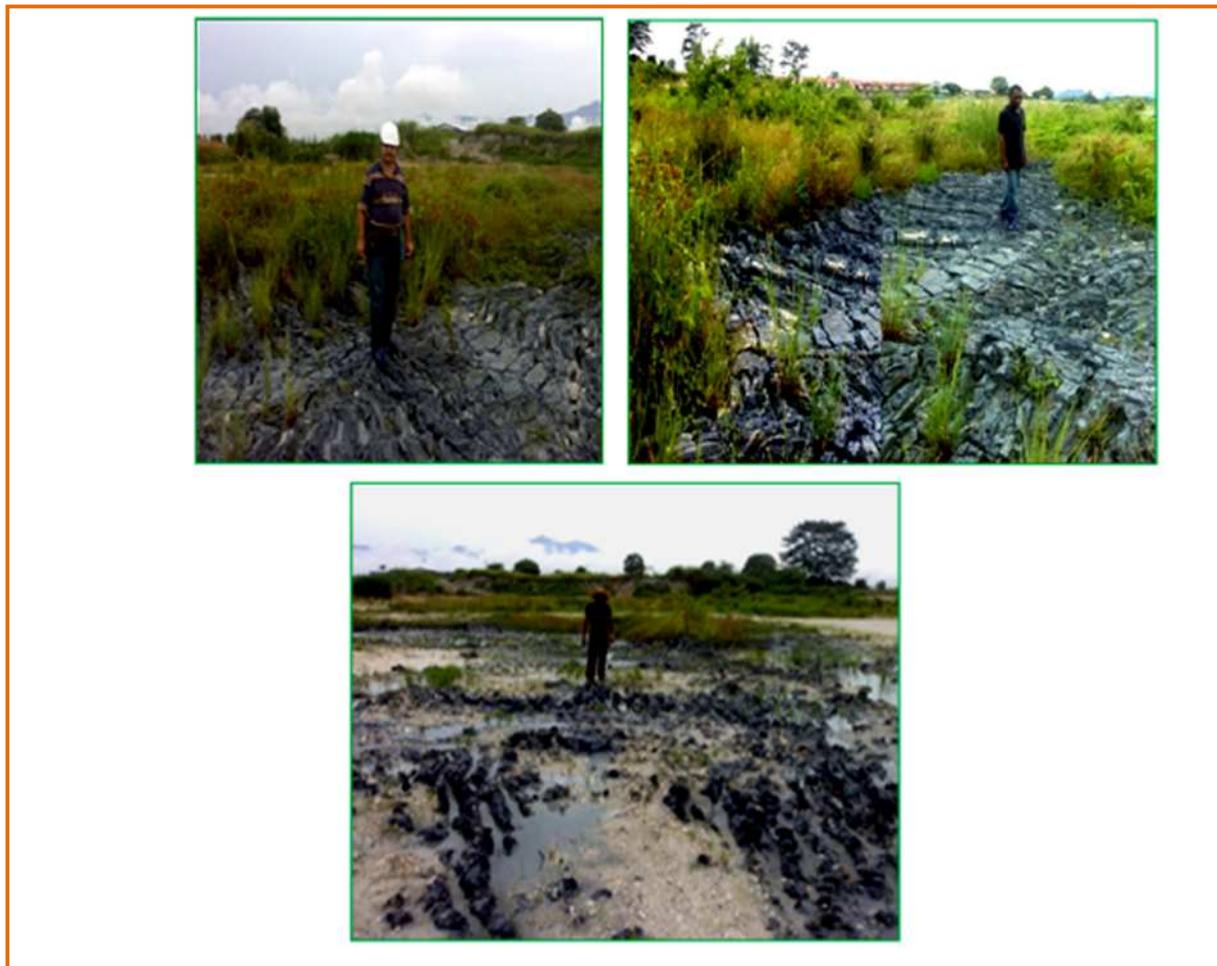
**Figure 4: land Photographs viewing several positions that recognized in aerial photographs in construction site #1, which identified as the depositional of gry swamps clay**

Direct ground inspections in the two construction sites resulted in the discovery of sinkholes that were not visible in aerial photographs and satellite images due to many factors. For example, the area may be enclosed by vegetation, sinkholes definite size, or their depth is too small to be detected. The recorded model is used for the explanation of each sinkhole, including a diagram of the sinkhole and its access geometry, the covering features with the district and the coordinates, orientation, dimensions, age, continuation degree, vegetation and symbols of volatility as cracks, scarps or pipes. These features supply information on the activity and the periods of the sinkholes, and act as indicators of plausible location of future sinkholes in proximity to human structures and other observations. The existence of features such as muddy areas, or the expansion of vegetation and holes crammed with materials may help detect shallow subsidence depressions. Generally, the application of geophysical surveys is desired to determine whether these irregular characteristics are interrelated to sinkholes. Ground inspection at site#1 reveals no sinkhole. On the other hand, aerial photographs of the area imply that it is made up of old swamps, which might contain sinkholes on its subsurface. More than four big black spots were recognized in aerial photographs, three of them circular to semi circular in shapes, while the others possess an extended shape. However, due to human activity and excavating work being done there as an ex-mining area, most of these features were packed with sand and other material, and among them, three areas with deposits of grey swamp clay in circular shapes were acknowledged. The clay seems to sink down due to numerous factors, which will be explained shortly. Figure 6 shows land photographs and the positions of three big black spots in the aerial photographs, which might include sinkholes under the depositional of gray swampy clay construction site #1

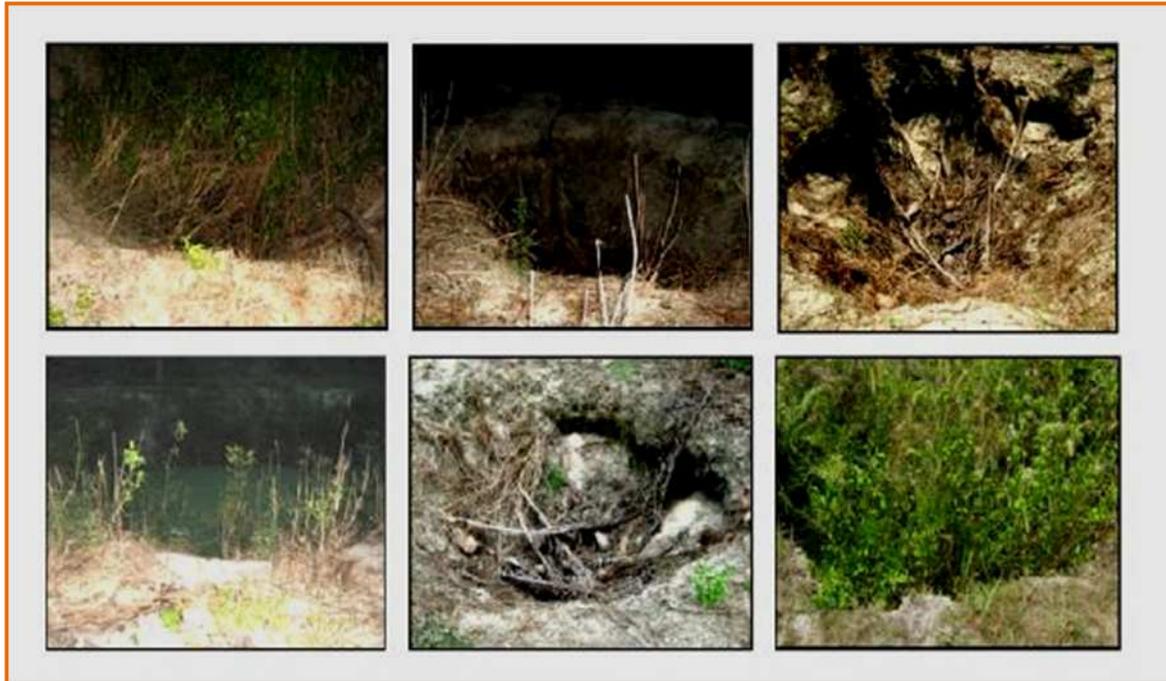
**Figure 5 : Land Photographs viewing a number of sinkholes that identified as water in-fill, empty and covered with vegetation was determined as small and narrow in construction site #2 and site#3**

During the ground inspection at site #2, two sinkholes was discovered, but not recognized in aerial photographs and satellite images, as adjacent small plants enclose it. One of these sinkholes has a diameter of ~7m-10m., water in-filled, of visually undetermined depth, are recognized and proven as a sinkhole with a narrow showing throat, positioned in the south west flank of this site. The other sinkhole has a diameter of ~35m- 40m, positioned in the north east side of this site, was in-filled with wet clay and other material of sediments due to karst activity, raised a question that this sinkhole might be linked in the subsurface to one or more of the large tabular conduits or channels, and the presence of cavities or voids of undetermined depth. Clay, or air in-filled karstic sinkhole or cavities were present, which could compromise the veracity of this site. The south section of this site is littered with soil cover collapses.

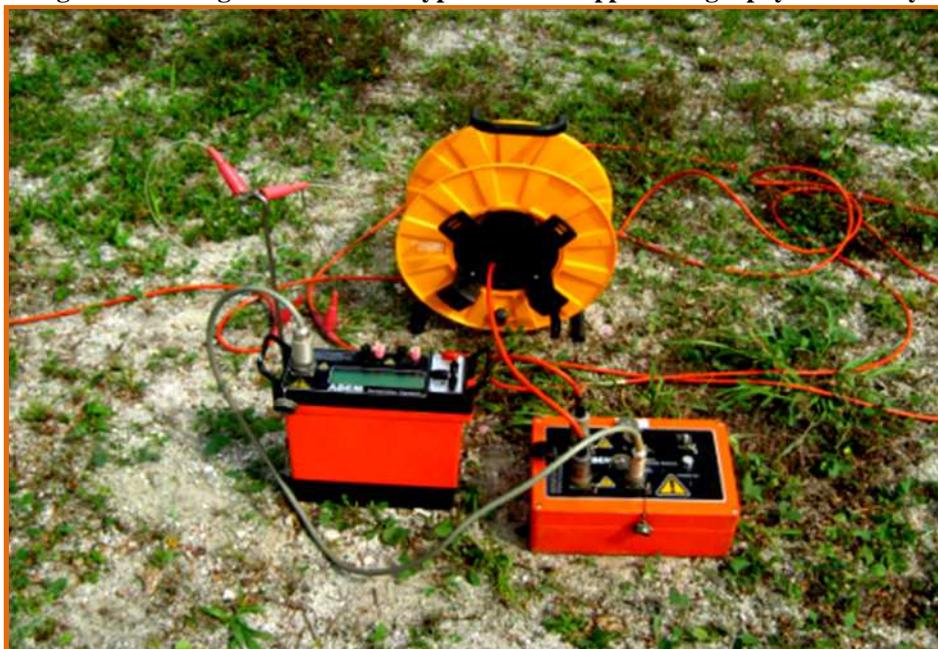
**Figure 9: viewing the instrument type SAS1000 applied on geophysical survey**

In a distinctive survey, most of the fieldwork involves laying out the cables and electrodes. After doing that, the measurements are taken automatically and stocked into the computer. This resistivity procedure usually gives a better grouping of spatial resolution and depth of study in karst terrain than any other geophysical technique.

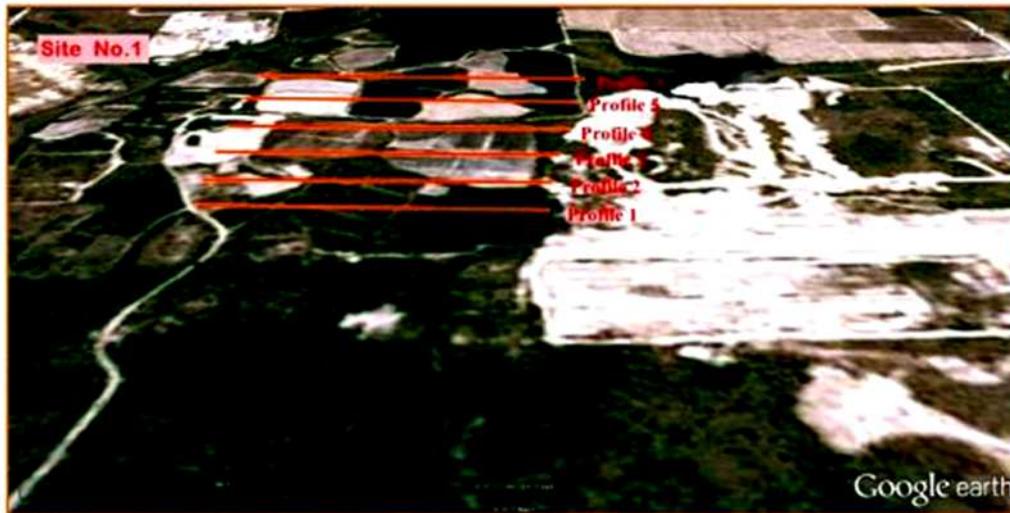
**Figure 10: Google earth satellite images viewing the location of resistivity profiles in construction site #1**

Six electrical resistivity traverses or profiles, Profile-1 to Profile-6, were controlled over and along the survey area in site #1. The direction of these profiles in (N90°W), and the level of those lines are shown in the location map, illustrated in Figure 10. The electrical resistivity data accumulated along the two dimensional (2-D) electrical resistivity profiles were determined to be in excess of, or beneath the sinkhole, using a 41-channel array in the Wenner configuration. The length of each profile was 200 m, with an electrode spacing of 5m, on average, spaced at 25m between each profile. The total length of all profiles in this site was 1200 m, covering an area of 30000 m<sup>2</sup>; 190 data points were composed for each (41-electrode) in one profile, and on average, about 1140 data were composed for a total six profiles in this site.

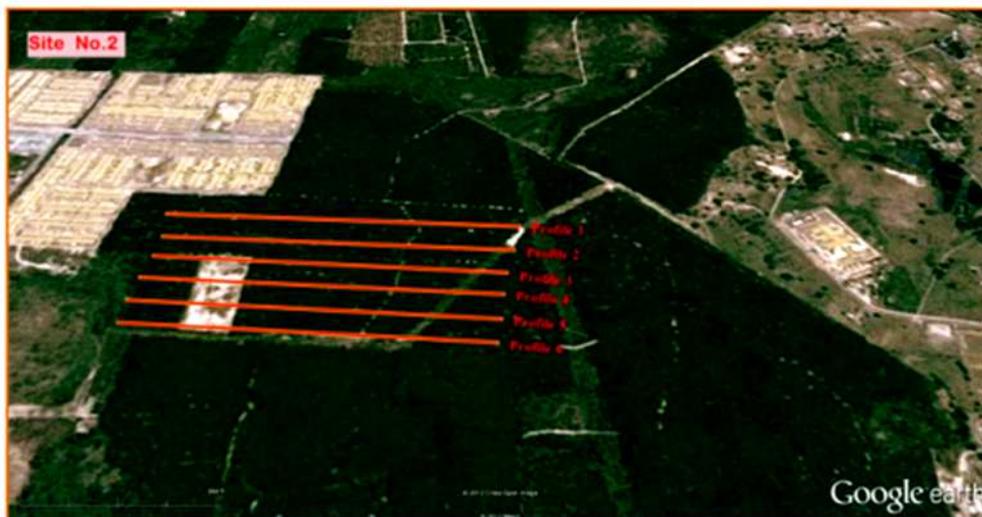
**Figure 11: Google earth satellite images viewing the location of resistivity profiles in construction site #2**

Six electrical resistivity traverses or profiles, Profile-1 to Profile-6, were conducted over and along the survey area in site#2. The directions of these profiles are in (N80° W), and the points of those lines are shown in the location map in Figure 11. The electrical resistivity data were acquired and accumulated for the purpose of mapping this site along the two dimensional (2-D) electrical resistivity profiles, in excess of, or beneath the sinkhole, using a 61-channel array in the Wenner design. The measurement length of each profile was 400 m, with an electrode spacing of 5m, on average, spaced at 25m intervals between each profile. The total length of all profiles in this site was 2400m, covering an area of 60000m<sup>2</sup>, and 320 data points were composed for each (61-electrode) in one profile. On average, about 1920 data were collected from a total six profiles at this site.

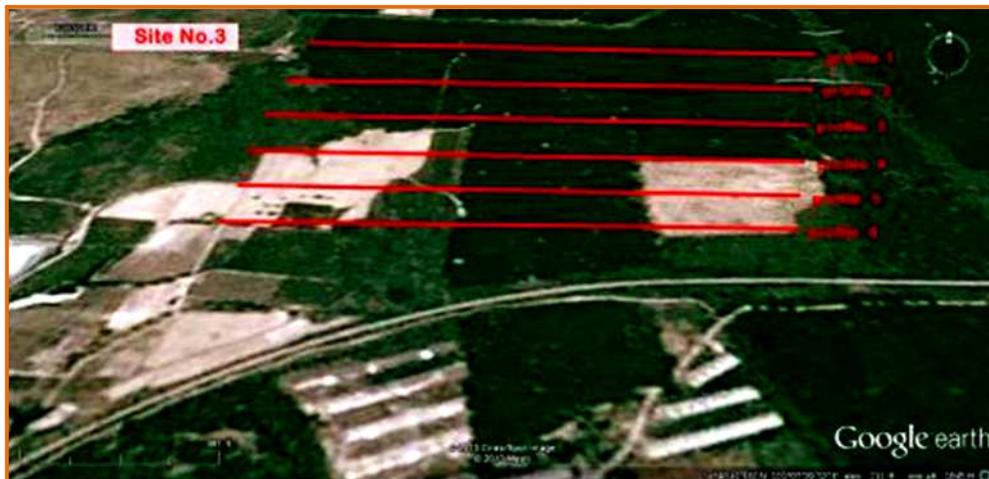
**Figure 12: Google earth satellite images viewing the location of resistivity profiles in construction site #3**

Six electrical resistivity traverses, named Traverses-1 to Traverses-6, were controlled over and along the survey area at site #3. The directions of these profiles are in (N90°W), and the levels of those lines are shown in the satellite image, illustrated in Figure 12. Electrical resistivity data were acquired and accumulated for the purpose of mapping this site along the two dimensional (2-D) electrical resistivity profiles, using an 81-channel array in Wenner design. The measurement length of each profile was 400 m, with an electrode spacing of 5m, on average, spaced at 25 m intervals between each profile. The total length of all profiles at this site was 2400 m, covering an area of 60000 m<sup>2</sup>, with 340 data points composed for each (81-electrode) in one profile. On average, about 2040 data were collected from a total six profiles at this site.

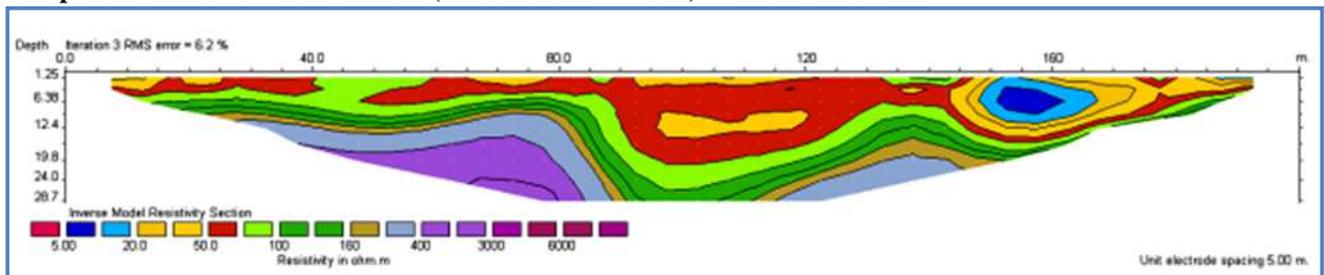
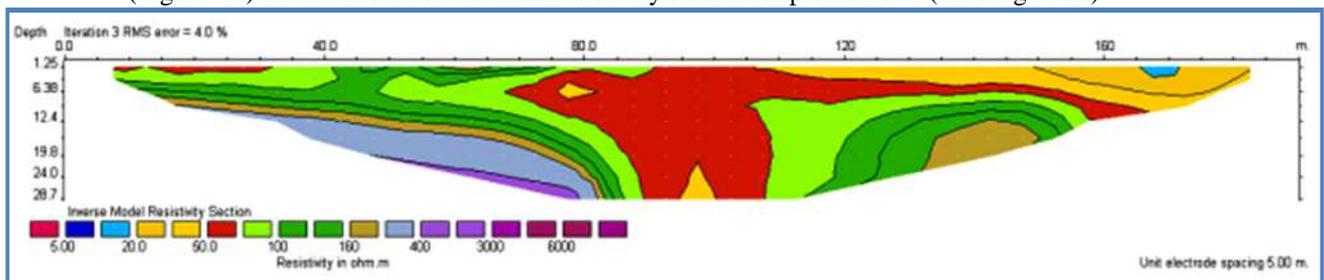
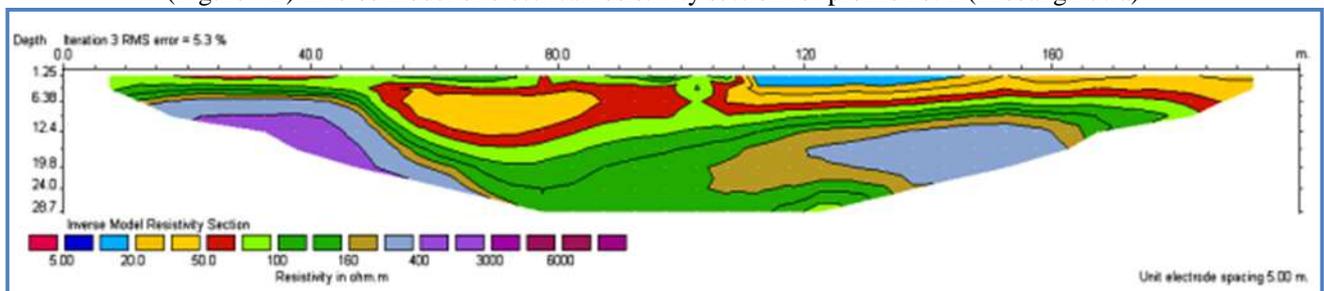
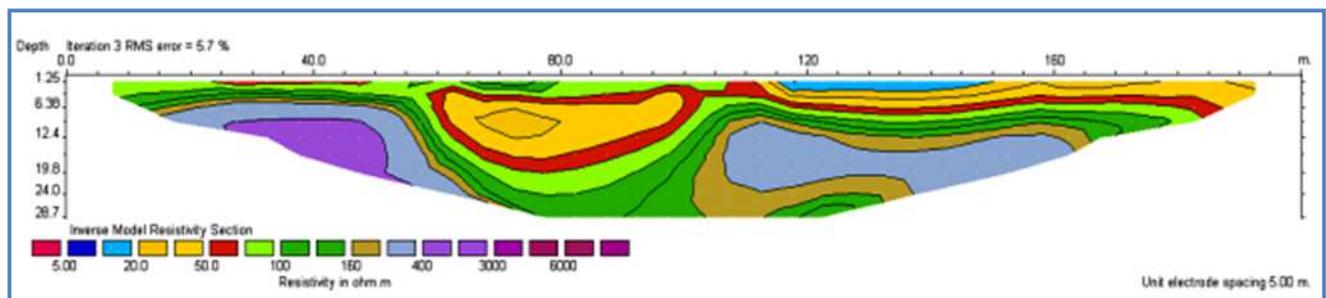
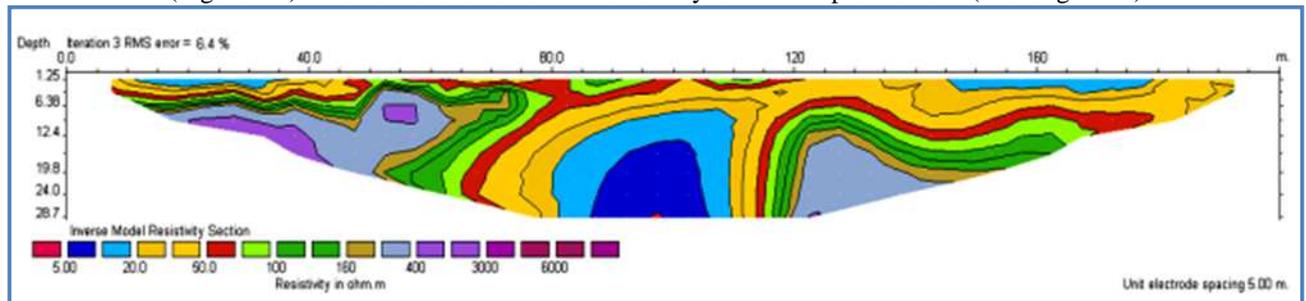
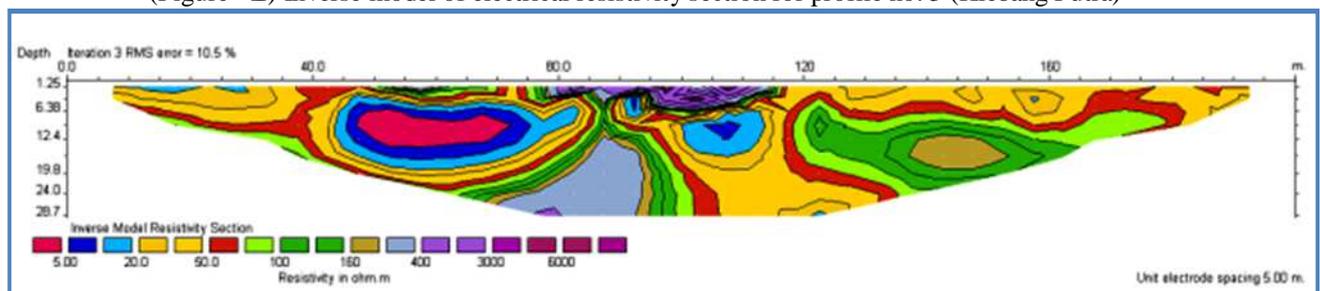
**Figure 13: Inverse model of electrical resistivity section form profiles#1 to profiles#6, viewing the interpreted location of karst features (cavities and sinkholes) in Construction site #1**

(Figure - A) Inverse model of electrical resistivity section for profile no. 1 (Klebang Putra)

(Figure - B) Inverse model of electrical resistivity section for profile no. 2 (Klebang Putra)

(Figure - C) Inverse model of electrical resistivity section for profile no. 3 (Klebang Putra)

(Figure - D) Inverse model of electrical resistivity section for profile no. 4 (Klebang Putra)

(Figure - E) Inverse model of electrical resistivity section for profile no. 5 (Klebang Putra)

(Figure - F) Inverse model of electrical resistivity section for profile no. 6 (Klebang Putra)

The electrical resistivity data accumulated in this construction site was clarified in the deficiency of borehole control by applying Table 3 above. The interpretation confirms that a massive sinkhole is present at this site and is unmitigated, located between resistivity Profile #1 and Profile #6.

This site is located in the West flank of Kinta valley, situated over a high topographic area and a flat terrain of marbleized limestone rocks, covered with soil. In resistivity Profile #1, the sinkhole appears in the core between electrode 17 and electrode 28, with an unbalanced centre between electrode 21 and 22. It stretches in resistivity Profile #2 under these same aspects. In resistivity Profile #4, the position of this sinkhole differentiates, forming itself between electrode 12 and electrode 23, with an uneven centre between electrodes 19 and 20. In resistivity Profile #6, the position of this sinkhole varies, and also comes into view between electrode 18 and electrode 26, with an uneven centre between electrodes 21 and 22. The depth of this sinkhole varies; in resistivity profile #1, it commences from the shallowest subsurface depth of <math><3.0\text{m}</math>, and continues down to a depth of >math>>28.7\text{m}</math>, the bottom being unnoticeable with same aspect mirroring resistivity profiles #2, #3, #4, #5 and #6.

Figure (13-A, B, C, D, E, F) clearly shows the jointed limestone bedrocks, which are probably made of wet fractured and/or water or clay in-fill, positioned underneath and adjoined to the sinkhole. The surface of this bed was irregular, and contains topography with uplifting and hollow space or pits. This unit indicated the remaining unique limestone formation appearing after a procedure of dissolving into subsurface karsts. The intensity of this bed varies between ~6.5m - ~12.0 m in the left flanks, and tumbling down in the middle of these profiles to get a depth of > 28.8 m, reappearing at the right flank at a depth of ~9.0 - ~19.0m. Uninterrupted bedrock of undamaged or un-weathered limestone of very high resistivity was found at this site, beneath and adjoining the jointed limestone observed in the left flank at a depth of ~8.0 m - ~15.0 m, continuing deep in order to reach a depth of >28.0 m at the core of these profiles. It reappears at the right flank, at a depth of ~24.0m - ~26.0 m. Quite a few pinnacles were observed in the subsurface of this site between a depth of ~6.0 m - ~19.0 m; Figure (13- A, B, C, D, E, F). The intensity of weathered, un-weathered or intact limestone bedrock and the depth of pinnacles in construction site#1 were viewed in Table 7.

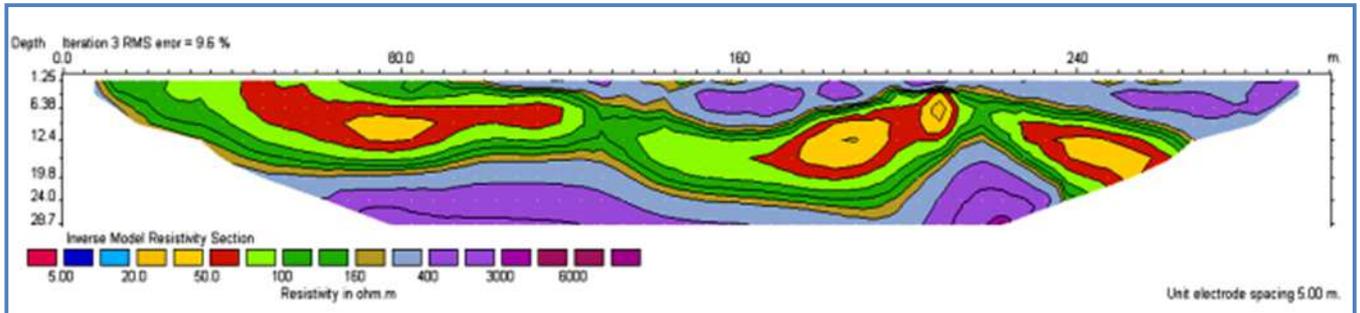
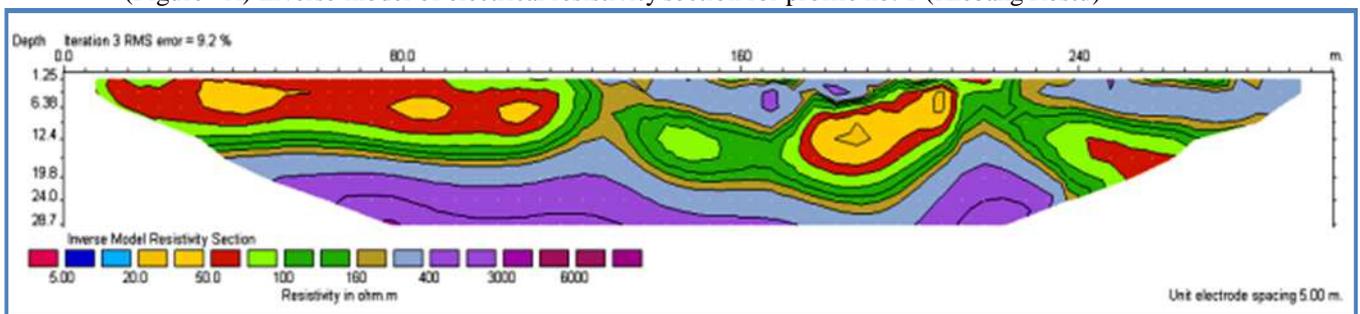
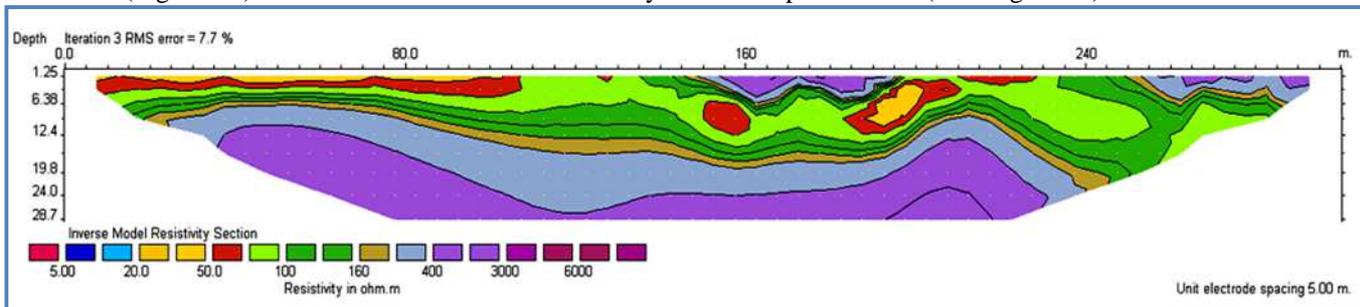
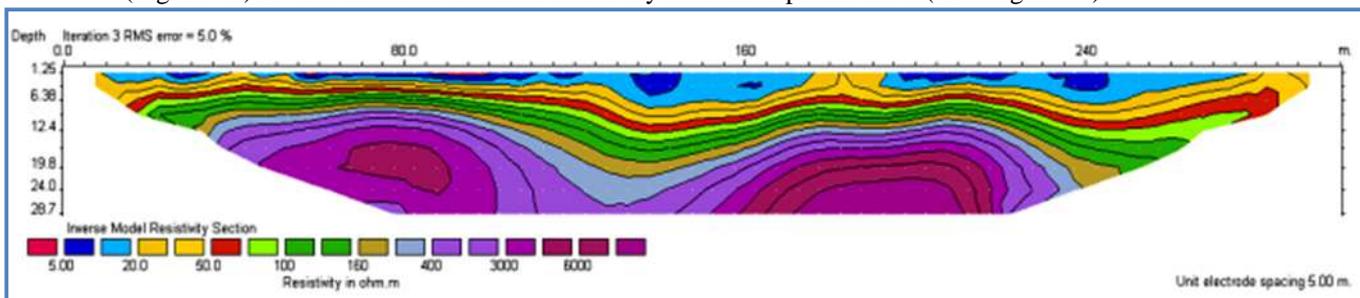
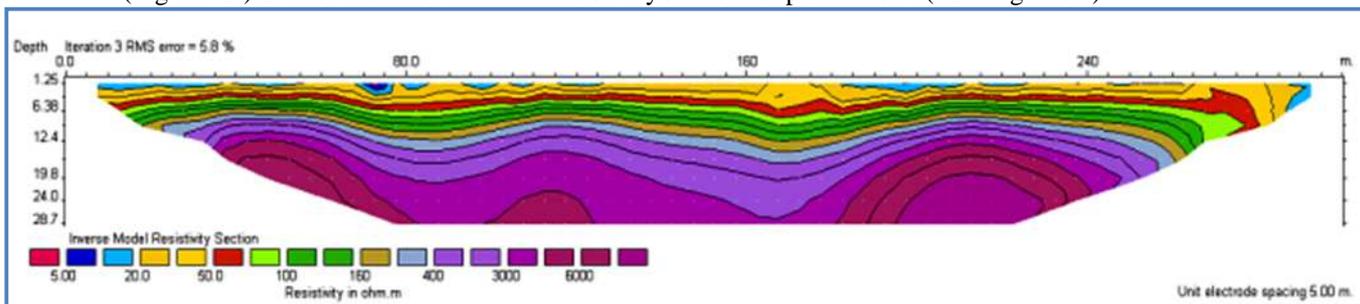
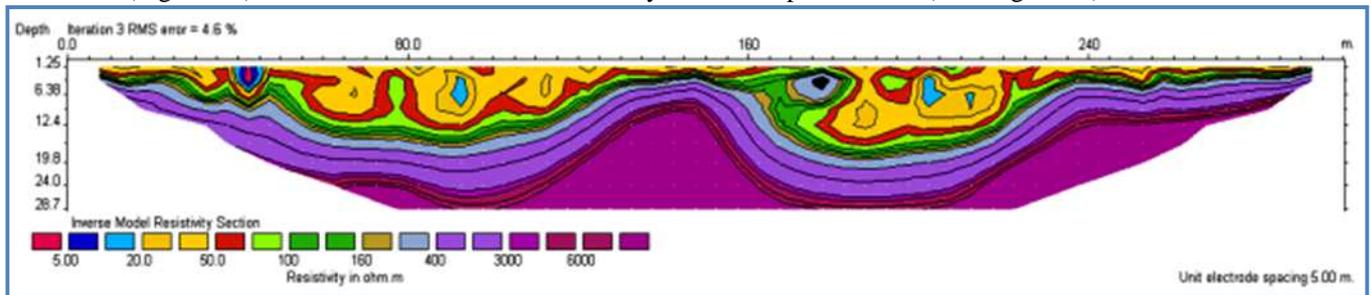
**Figure 14: Inverse model of electrical resistivity section form profiles#1 to profiles#6, viewing the interpreted location of shallow karst features (sinkholes and cavities) in Construction site #2 (Klebang Restu)**

(Figure - A) Inverse model of electrical resistivity section for profile no. 1 (Klebang Restu)

(Figure - B) Inverse model of electrical resistivity section for profile no. 2 (Klebang Restu)

(Figure - C) Inverse model of electrical resistivity section for profile no. 3 (Klebang Restu)

(Figure - D) Inverse model of electrical resistivity section for profile no. 4 (Klebang Restu)

(Figure - E) Inverse model of electrical resistivity section for profile no. 5 (Klebang Restu)

(Figure - F) Inverse model of electrical resistivity section for profile no. 6 (Klebang Restu)

The interpretation confirms that a zone of irregular sub-surface magnitudes in this site is extended between resistivity Profile #1 and Profile #3 in the shape of one longitudinal asymmetrical tubular channel. Sinkholes were detected near the surface in resistivity profile #2, commencing in the shallowest subsurface between electrode 40 and electrode 58 in the right flank, from a depth of <1.25m, sustaining deep in order to reach a depth of ~24.0 m. It appears as a slim to medium wide throat, extending to about 40 m in diameter. The centre of the sinkhole appears in this profile, and expanded in profile #1 and profile #3. This sinkhole was linked to one or asymmetrical tubular channel along these profiles. Tubular cavities of visually undetermined depth emerged as oval-shaped lenses, merging together into one tubular channel; Figure (14-A, B, C).

Undamaged or non-weathered limestone bedrocks with very high resistivity were discovered in the subsurface at a depth of ~19.8m along the left flank, in profile #1, profile #2 and profile #3. It tumbled down to achieve a depth of >27.0 m in the core, and continued to the right flank, arising up in the shape of a crest in order to reach a depth of ~12.4m Figure; (14-A, B, C). Numerous pinnacles of limestone were observed in the subsurface in profile #1, profile #2 and profile #3, which were at a depth of ~11.5 m - ~12.4 m, Figure; (14-A, B, C). In Resistivity Profile #4 and Profile #5, the cover karst deposits expanded from electrode 3 to electrode 58. Two depressions were observed in the resistivity section, one of which was between electrodes 10-36, while the other between electrodes 40-56. The utmost depth of these depressions was between ~11.5m ~13.0m for the one at the centre of this profile, and a depth of ~13.5m for the one in the right flank of this profile, Figure (14-E).

In resistivity profile #6, two depressions were observed in the resistivity section; one between electrode 3 and electrode 29, with a maximum depth of ~15.5m beneath electrode 19, while the other depression was between electrode 30 and electrode 57, with a maximum depth of ~18 m beneath electrode 39. Additionally, deposits with numerous categories of resistivity values are crammed with these depressions, ranging from 20Ω-m to 160 Ω -m, and lenses of lower resistivity values from 10Ω-m to 20 Ω -m were found in the middle of these depressions. Moreover, immature cavities were located in the sand, between electrodes 35 and electrode 37 at a depth of ~1.25m, down to a depth of ~8.0m, ~10m wide, and ~6.75m height, with enormously high resistivity that are typically air-infilled.

Limestone pinnacles were noticeably observed at the subsurface in the middle of this resistivity profile, between depths of ~3.5m to ~4.0m Figure (14-F). The depth of weathered, unweathered or integral limestone bedrocks and pinnacles in construction site#2 was presented in Table 7.

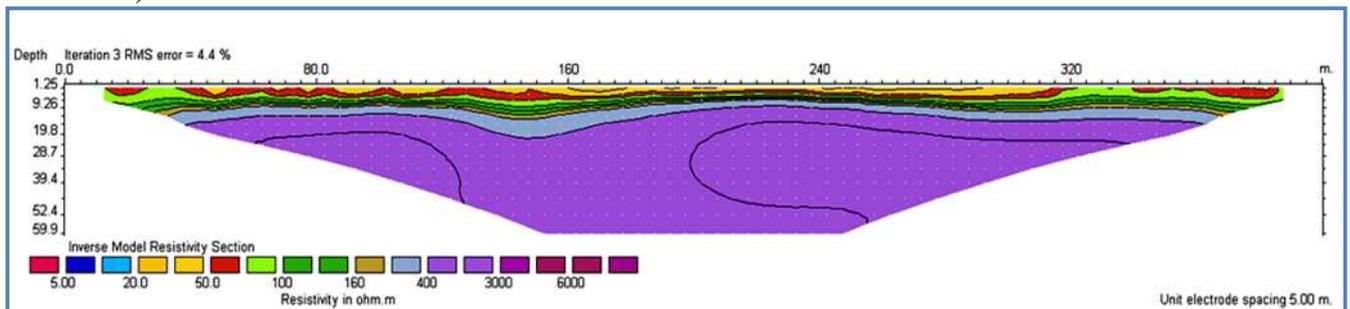
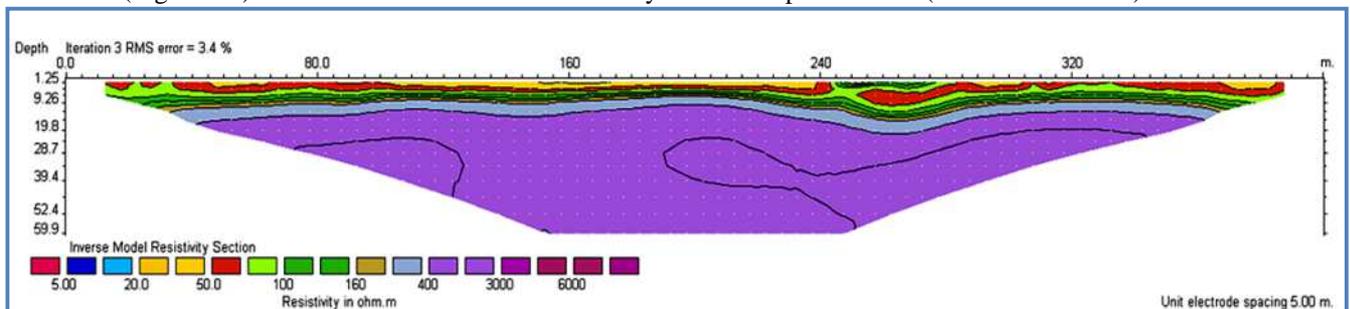
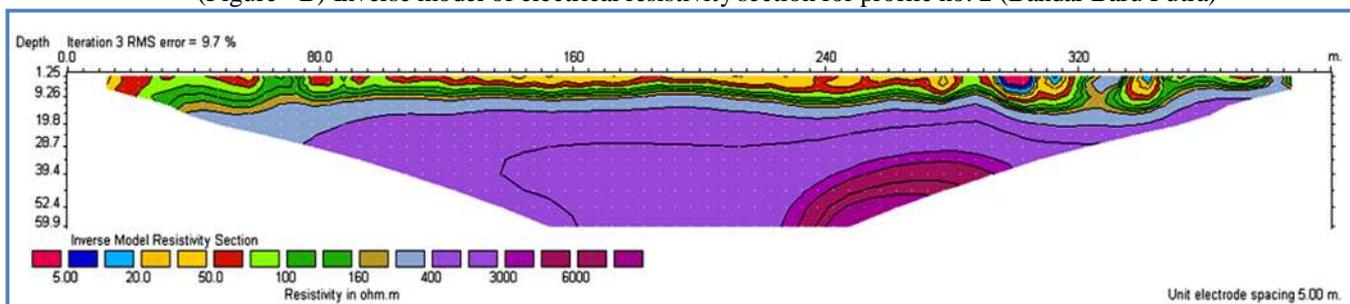
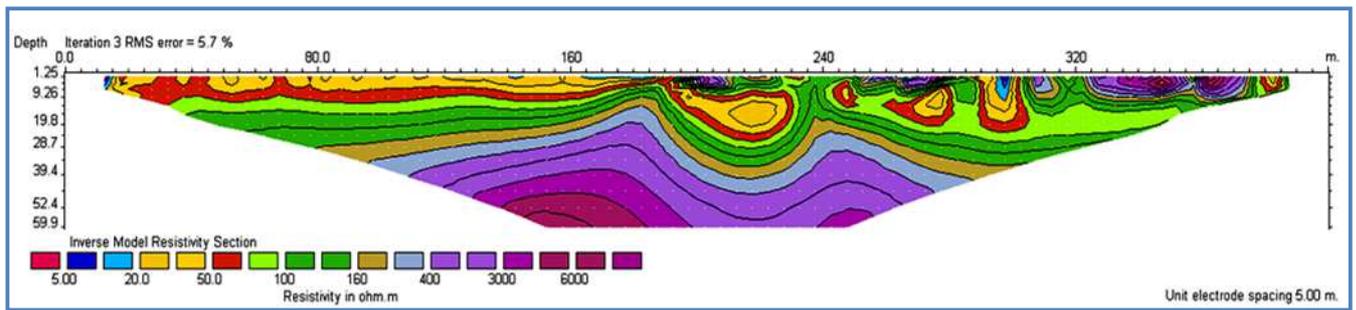
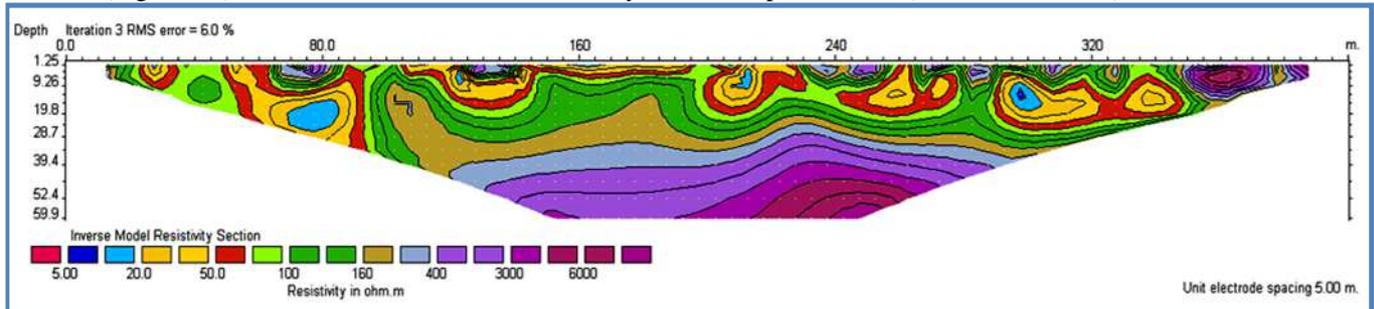
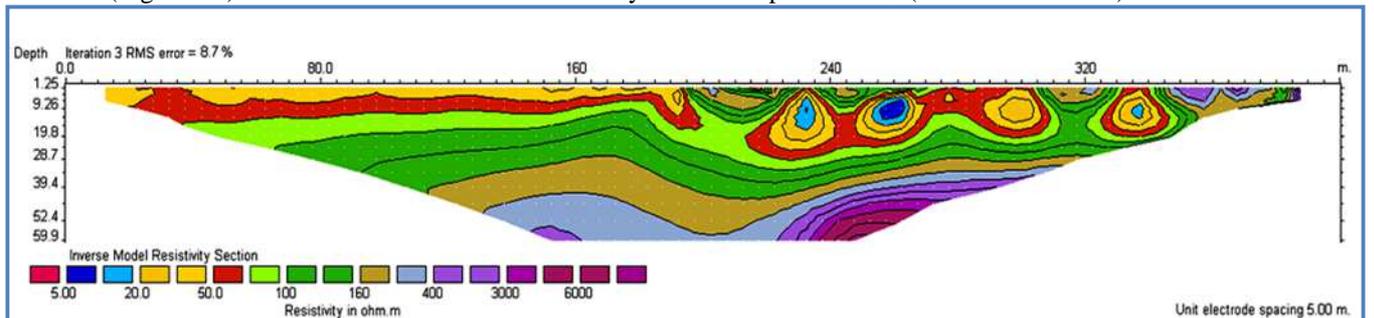
**Figure 15: Inverse model of electrical resistivity section form profiles#1 to profiles#6, viewing the interpreted location of shallow karst features (sinkholes and cavities) in Construction site #3 (Bandar Baru Putra)**

(Figure - A) Inverse model of electrical resistivity section for profile no. 1 (Bandar Baru Putra)

(Figure - B) Inverse model of electrical resistivity section for profile no. 2 (Bandar Baru Putra)

(Figure - C) Inverse model of electrical resistivity section for profile no. 3 (Bandar Baru Putra)

(Figure - D) Inverse model of electrical resistivity section for profile no. 4 (Bandar Baru Putra)

(Figure - E) Inverse model of electrical resistivity section for profile no. 5 (Bandar Baru Putra)

(Figure - F) Inverse model of electrical resistivity section for profile no. 6 (Bandar Baru Putra)

This site is normally situated over a high topography area and a flat terrain of marbleized limestone rocks. The electrical resistivity data accumulated in this construction site was clarified in the deficiency of borehole control, by utilizing data posited in Table 3. The interpretation confirms that a variety of sinkholes that are present in this site, mainly the soil cover collapse type and unmitigated, can clearly be seen between resistivity Profile #3 and Profile #6, Figure -15.

Zones with semi-regular surface and subsurface magnitudes are found along two traverses; traverse#1 and traverse #2. Adjacent to the middle of resistivity traverse #1 for the left flank, small depression began in the shallowest subsurface beneath and almost between electrodes 25 and electrode 38, with a depth of ~15.00m; Figure (15 - A). Close to the middle of resistivity traverse #2 from the right flank, small depression began in the shallowest subsurface beneath and near electrodes 49 and electrode 61, with a depth of ~15.0m; Figure (15 - B), while in traverse #3, the subsurface limestone becomes irregular, and small depression began in the shallowest subsurface beneath and between electrodes 3 and electrode 27, with a depth of ~16.00m, with the other beneath and between electrodes 49 and 65, having a depth of ~16.0m. Many small size sinkholes along this traverse appears mostly in the right flank as the soil cover collapse type, merging into the sand, some with water in its core, having a depth of ~16.00m; Figure (15 - C). Limestone bedrocks, with very high resistivity were found in the subsurface between a depth of ~4.0m to 9.26m along profile #1, profile #2 and profile #3. It tumbled down to achieve a depth of >17.0m; Figure (15 -A, B, C).

In resistivity profile #6, the resistivity section showed massive depression extended along this profile beneath electrode 3 and electrode 78, containing deposits with various categories of resistivity values ranging from 20 $\Omega$ -m to 160  $\Omega$  -m. Multi-lenses of lower resistivity values from 10  $\Omega$ -m to 20  $\Omega$  -m were found to be extended between electrode 46 and electrode 61, with a depth reaching ~22.0m. Additionally, mature sinkholes were located between electrodes 66 and electrode 69, from the surface down to a depth of ~19.8m, and a width of ~15.0m, containing several categories of resistivity values ranging from 5  $\Omega$ -m to 70  $\Omega$  -m. These sinkholes are typically in-filled with rainwater, and also consist of soft clay with pond water; Figure (15 - F).
