Combined Seismic Refraction and Geomagnetic Surveys on Hills of Industrial Wastes of Gypsum in Aqaba for Stability Hazards

Mohammad Al-Farajat¹⁾

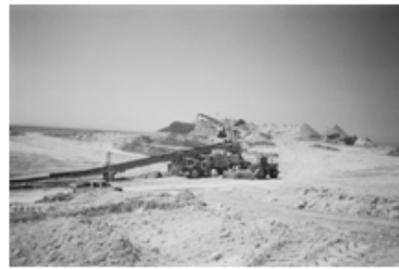
Figure (3): (a) Transportation belt of gypsum wastes. (b) Redistribution of wastes in the disposal site.

At the end of manufacturing processes in the factory, the solid wastes of gypsum are transported using long moving belts. The daily accumulation of the wastes led to hills that covered the whole area to the eastern part of the factory (Figures 3 a, b).

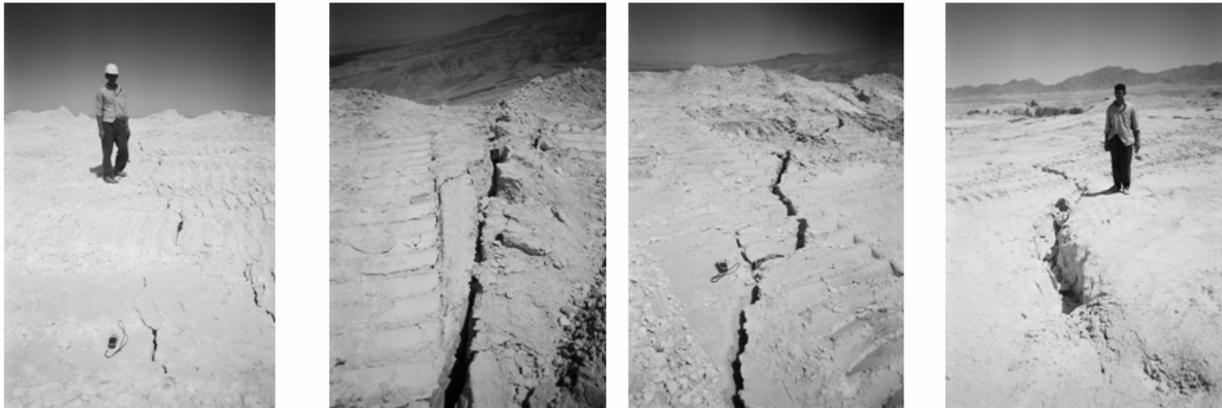
Figure (7): Some joints and cracks in the gypsum hills.

The joints were found to extend to depths of more than 10 meters, and can reach in some cases the body of the collected entrapped water inside gypsum hills, or at least penetrate the unsaturated zone overlying it (Fig. 7).
