Influence of High Temperatures on Surface Cracking of Concrete Studied by Image Scanning Technique

Belkacem Toumi¹⁾ and Musa Resheidat²⁾

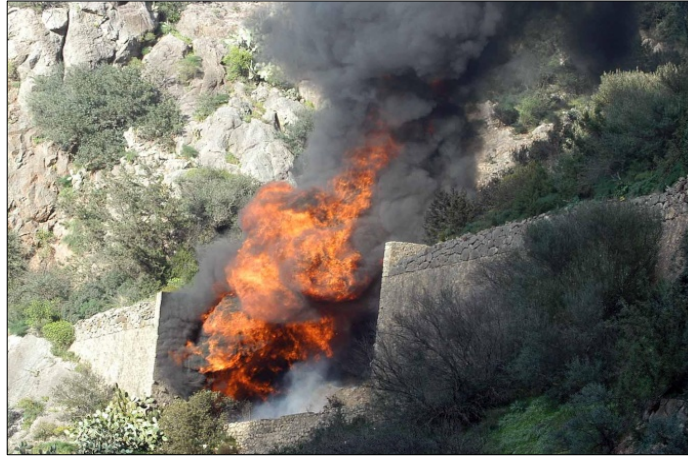
Figure (1): The fire of El Akhdaria Tunnel (Algeria)

The durability and performance of Portland cement concrete vary with its constituents (cement, sand, aggregates, additives and water) used in the concrete mixture, as well as with external exposure conditions during its service life. Elevated temperature is one extreme condition to which concrete structure could be exposed. Examples of such conditions are: concrete foundations for launching rockets carrying spaceships, concrete structures in nuclear power stations or those accidentally exposed to fire as the case of many tunnels registered in various countries as the fire of El-Akhdaria tunnel (Algeria) on February 28, 2008. Following the collision of two trains in the tunnel, 750 m³ of gas oil were burnt (Fig. 1). The temperature has reached 1200

°C and the duration of the fire was 48 hours. Interventions to extinct the fire were impossible and dramatic damages were observed in the tunnel's structure. The tunnel is closed until now.

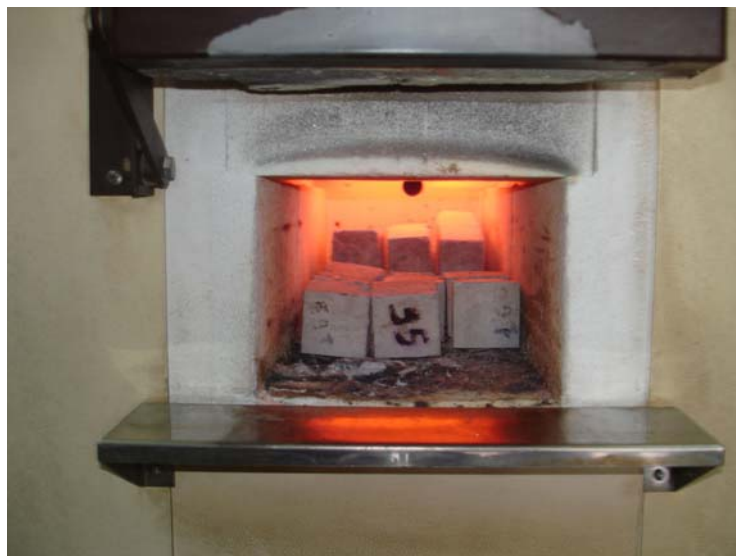
Figure (2): Specimens inside the furnace during heating

To determine the effects of high temperatures on concrete properties, cubic specimens were exposed to six target temperatures, namely; 105, 250, 500, 750, 1050 and 1250 °C by using an electric furnace (Carbolite, Fig. 2) having a heating capacity of 2100 °C at a rate of 10 °C/min to target temperature. For each target temperature, the target temperature is maintained for the duration of 1 hour. Six specimens were used for each temperature and they were allowed to cool in air to the room temperature for 24 hours. After cooling, tests were performed to determine their residual physical and mechanical properties. The data obtained were compared with the results obtained for the control specimens which were stored at 20 ± 2 °C in the laboratory.

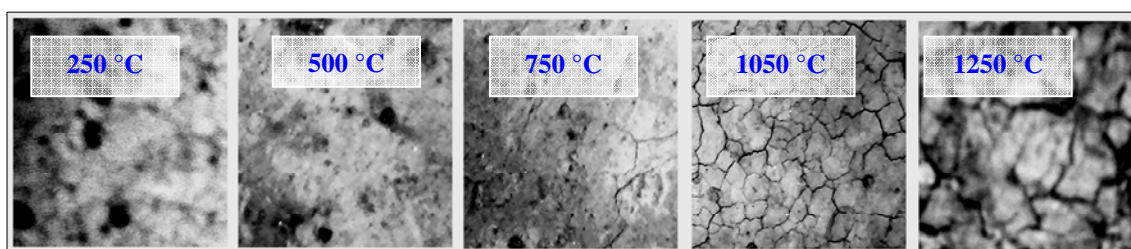
Figure (3): Surface state of concrete heated at different temperatures

A high resolution flatbed scanner was used for image acquisition. Images of the specimens were collected at 9600 x 9600 dpi (equivalent to a pixel resolution of 2.5 x 2.5 micron). Specimens were placed on a sheet of paper in which six square windows of 40 x 40 mm were pierced. This sheet of paper protects the glass surface of the scanner and provides landmarks around specimens for possible measures. Up to six specimens may be scanned together. Figure 3 gives a typical image of concrete heated at different temperatures.

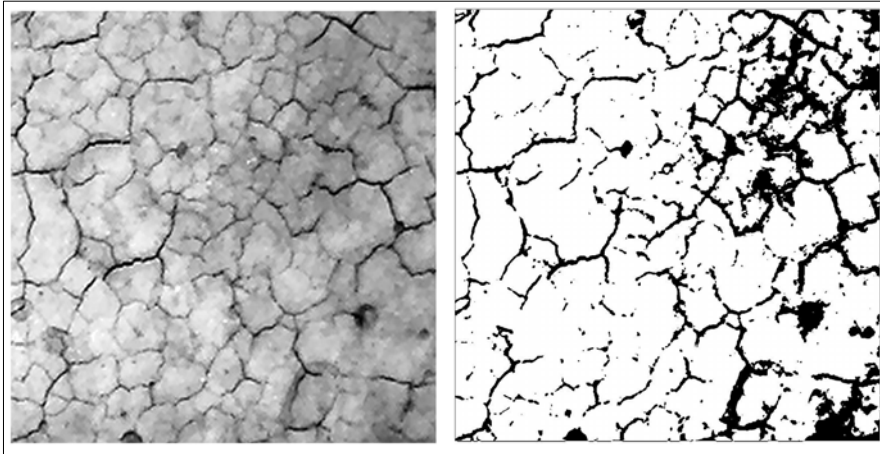
Figure (4): Crack extraction from scanned image

Digitized images (JPEG format) were stored in a computer and then analyzed via an image treatment software. The computer used was a laptop equipped with a processor Core 2 Duo 1.6GHz and running under windows, Vista Home edition. The software used for image processing was the JASC Paint Shop Pro version 7.04. The captured images were first encoded in grey scale then the function of histogram adjustment was used to enhance the black level. Finally, the images were segmented in two colours; black that represents cracks and white (Fig. 4) that represents the solid phase, and then the crack density was computed.

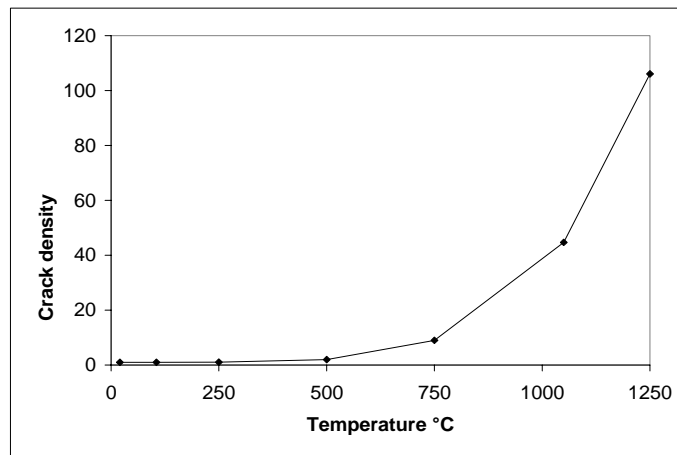
Figure (5): Surface cracks' density *versus* heating temperature

cracks is useful in determining the minimum exposure temperature. Figure 5 shows the degree of cracking in connection to the temperature increase. Crack density is given in units of mm of crack length per cm^2 . Each point is an average of the crack length measured in 20 different squares of 40 mm x 40 mm. According to

Figure 5, the crack density increases strongly with temperature beyond 500 °C. The value of crack density at 1050 °C is 45 times greater than the reference, and at 1250 °C the value of crack density is 106 times greater than the crack density of unheated concrete.

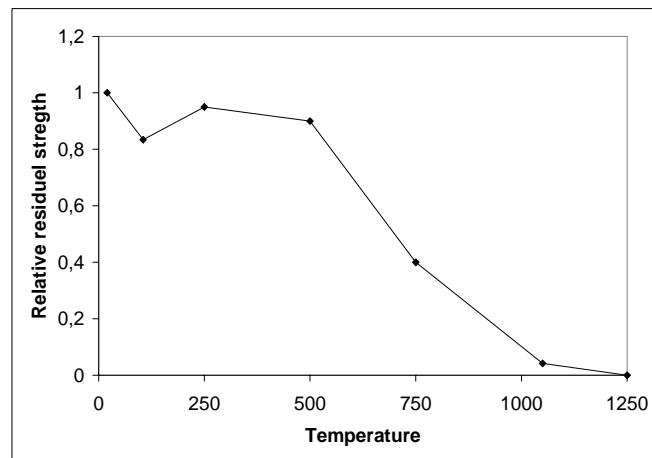
Figure (6): Residual relative compressive strength

The compression test was carried out according to ASTM C109 standard in order to determine the residual relative compressive strength of heated in comparison to reference concrete specimens. The ultimate strength of reference concrete at 28 days was 63 MPa. Figure 6

shows the results of this test.

From Figure 6, it can be seen that the compressive strength loss of HSC drops with temperature starting from 250°C. The retained compressive strength at 500 °C is 90% compared to the unfired strength, while after 750°C the strength is 40%. The compressive strength

value drops sharply to 0.4% after 1250°C compared to that of unfired specimens

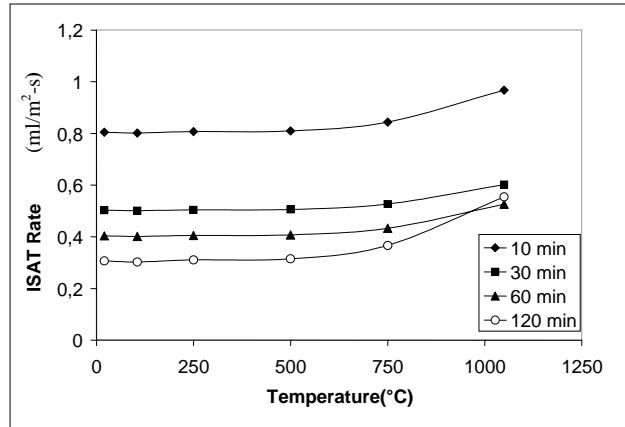
Figure (7): ISAT rate versus heating temperature

Initial surface absorption rate of water by concrete is the rate of flow of water into concrete per unit area at a stated interval from the start of the test at a constant applied head and temperature. The initial rate of absorption test was conducted on the concrete cube specimens based on the procedure laid in BS 1881: Part 5. The rates of absorption of water at 10, 30, 60 and 120 minutes from the start of the test were noted. The results of this test are presented in Figure 7.

For all testing intervals, the ISAT rate increases with the increase of heating temperature. This has proven the damage caused by high temperature in concrete specimens. The noticeable ISAT rate fast increase is for temperatures beyond 500°C. At these temperatures, concrete surface cracks are more visible.

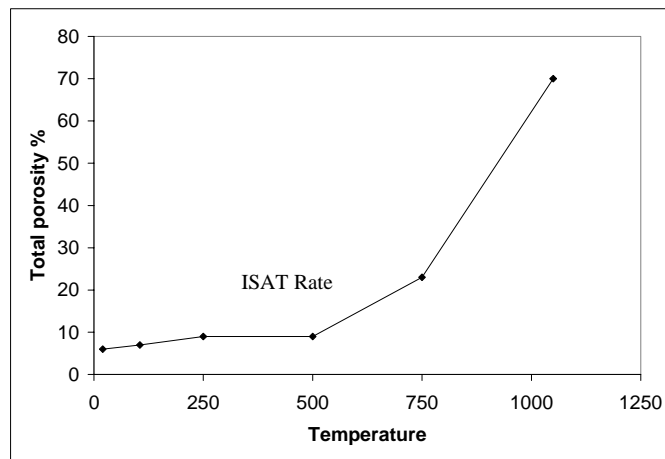
Figure (8): Total porosity versus temperature

Total porosity data (%) are summarized in Figure 8.

In general, up to 500 °C, the total porosity increases slightly and linearly (Eq. 2) with the heating temperature, and then a significant increase in porosity was observed. After heating at 500 °C, the increase of the total porosity follows a power law (Eq. 3) confirming a material degradation that can have an effect on the mechanical properties. In particular, with reference to undamaged concrete, the porosity values increased to three times with an exposure to 750 °C and to ten times at 1050 °C. At the temperature of 1250°C, concrete specimens were strongly cracked and the test was not possible.
