## Failure Analysis of the Reducer Nipple of a Propylene Gas Tank in a Petrochemicals Complex

Failure Investigation was carried out on a fractured reducer nipple of pipeline connected to a propylene tank in a Petrochemical complex. The Investigation was carried out with the aim of determining the root cause of the failure. In the course of this investigation, Metallurgical techniques including micrography and fractography as well as stress analysis of the piping were carried out on the failed part. The root cause of the failure was identified as vibration induced fatigue enhanced by the non-homogeneity of the microstructure of the nipple. Remedial measures to prevent a reoccurrence were proffered.

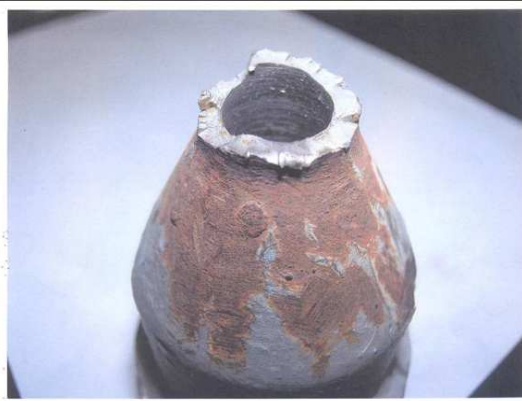
This article is based on the root cause analysis of a fractured reducer nipple of pipeline connected to a propylene tank in a Petrochemical complex. The line operated at a pressure of 32kg/cm<sup>2</sup>. The fractured end of the nipple has an outside diameter of 0.885in and a thickness of 0.167in. Picture of this nipple is presented in figures 1. Records showed that the piping have been in service for about thirteen years and failed within this period under similar circumstances and was repaired.

*Figure 1: Failed Reducer Nipple*

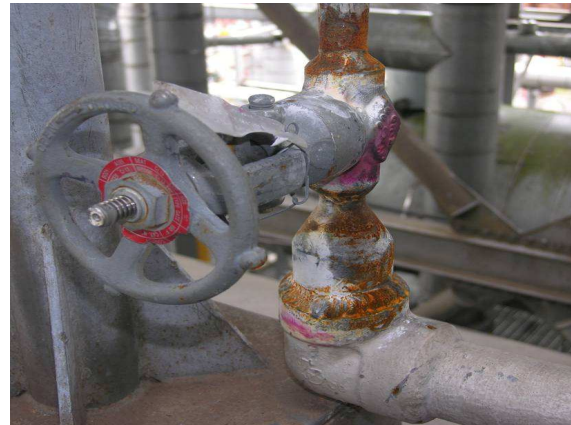
*Figure 2: Repaired Reducer Nipple*
