# The Effects and Impacts of Quarrying on Forest Land: the Case of Gami Quarries, Mwache Forest, Kwale County, Kenya

This paper highlights the effects and impacts of quarrying on Forest Land, with Mwache Forest, located in the Kwale County, whose land use is defined as conservation –as the study case. Despite the defined land-use, Gami Quarries Ltd had been given the rights of exploiting the rock out-crop in the forest to make ballast –a raw material needed in the construction industry. Ballast processing operations were initiated through blasting the rock structure using explosives inserted onto holes drilled on the rock, disseminating it into boulders that were sized into smaller rocks that were transported for processing into ballast. The explosions resulted into the generation of wave energy that weakened the rock formation and, damaged the existing neighbouring infrastructure; it produced dust and higher levels of noise. Transport of the rock material for processing into ballast, resulted in the emission of fugitive dust due to tracking on the unpaved road. This was in addition to the emission of the oxides of nitrogen and sulphur, carbon monoxide, suspended particle matter (

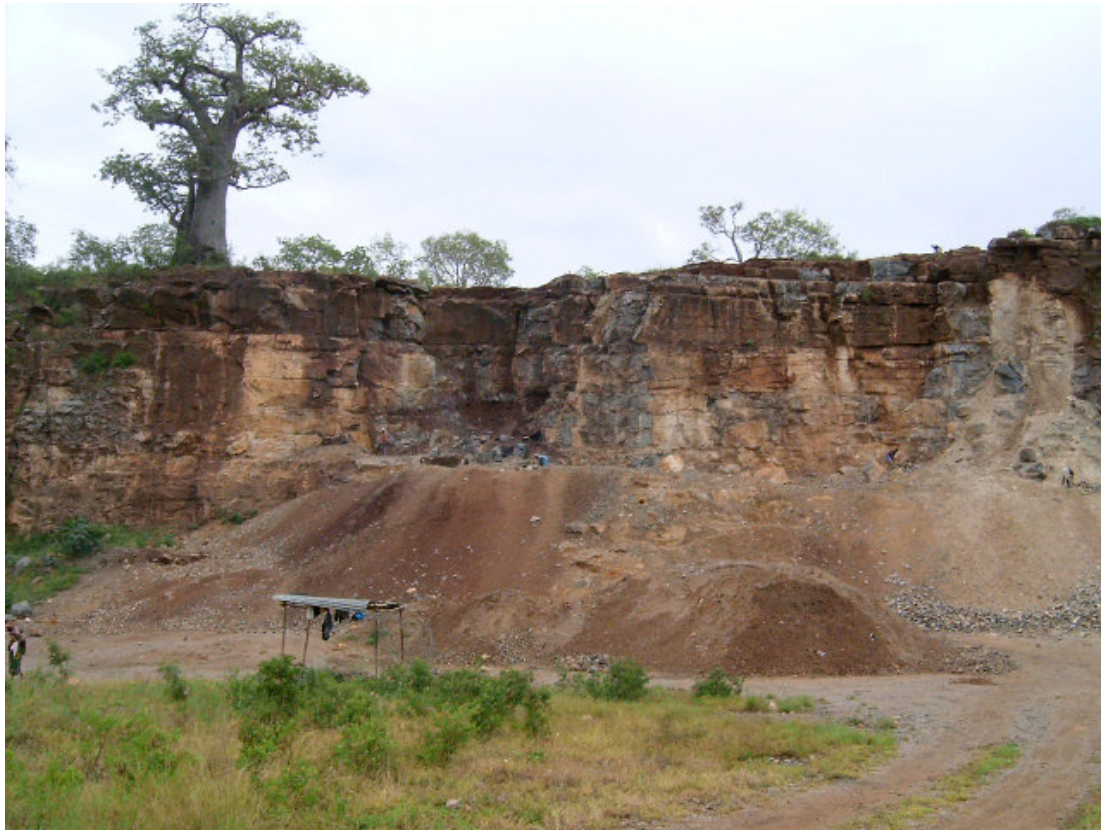
The quarry is divided into three portions and allocated to three licensees. The quarry occupies the high ground on the eastern side of the river embankments. The portion of the quarry allocated to Gami Quarries Ltd is identified as A2 on the map (Fig. 1). It occupies a surface area of 1.0 Ha and has an average height of 20 m. The excavating area is 0.833 Ha with a frontage of 0.22 Ha. It is planned to produce 200,000 tonnes of ballast per year. The company has also been allocated an additional frontage area for the storage of explosives, which it has fenced. Two caves traverse the quarry area with tunnels that are said to reach out into the sea. This cave-tunnel system is held sacred by the Mijikenda tribes of Coastal Kenya and, are used as places of worship and offerings in times of distress. The depth of the quarries which averages about 20 m (Fig. 2) was limited by the preservation of the tunnels, running under the bedrock. Mijikenda elders have no problem with the quarrying activity amidst their shrines as long as their cave system is protected.

Fig. 2: A view of the quarry with baobab trees in the background

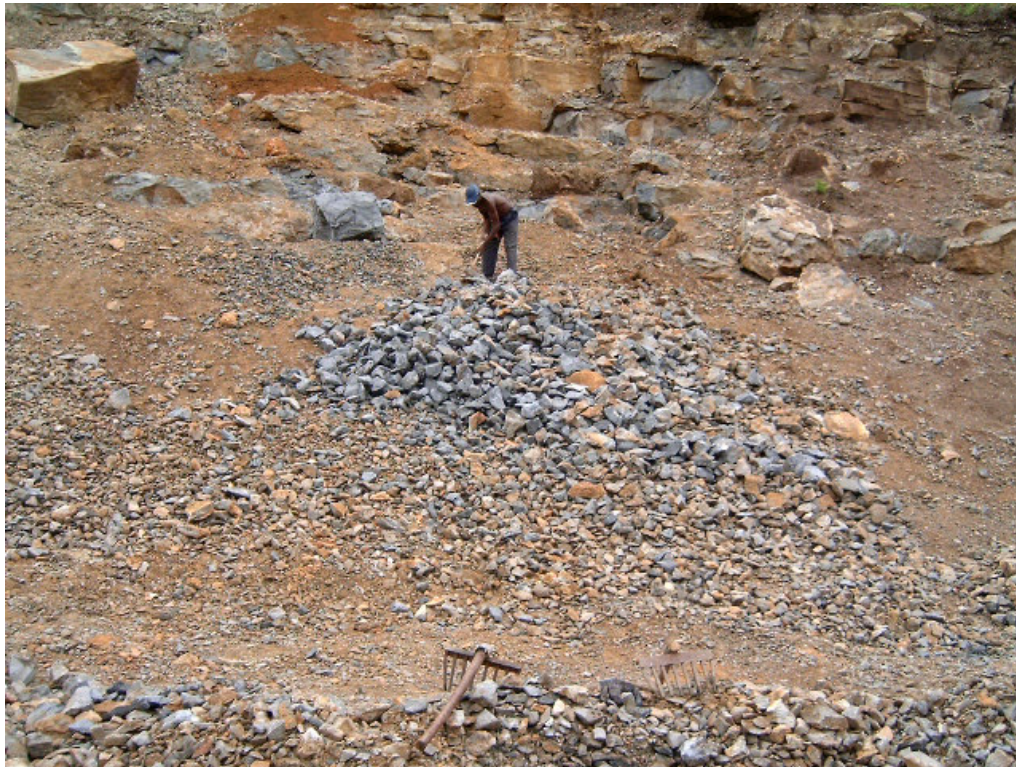
Fig. 3: The manual breaking of boulders to small sized stones

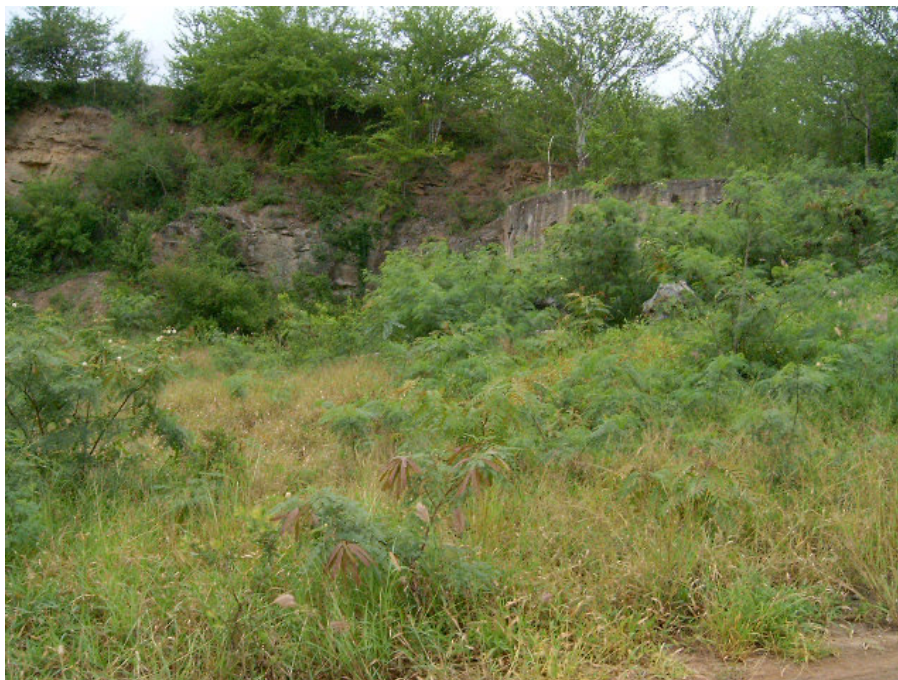
Quarrying for ballast production had created open lands, damaging the landscape –a situation that should not have arisen because the strategy adopted was to progressively rehabilitate excavated areas through tree planting, as the quarrying operations moved to new areas Though this was attempted, (Fig. 5), it was not sustained.

Fig. 5: Rehabilitation of quarried land by reforestation

In the strategy, the quarried were to be levelled and spread with top soil spread ready for tree planting. Tree seedlings were availed by the Forest Department, which maintained a tree nursery in the forest with support from Gami Quarries Ltd and other licensees, which was part of the licensing conditions for undertaking the quarrying activity in the forest. Unfortunately, at the time of the study, the trees planted had weathered partly as a result of the drought, but more so due to the insufficient amount of the top soil spread on the rock basement. Tree planting if properly instituted, could restore the landscape, promoting re-establishment of the local climate and repopulation of the area by flora and fauna.

successful in tree planting, the Company should move adequate amounts of topsoil into the quarried areas to aid germination and growth of the tree seedlings. Rigorous supervision by the forest Department is crucial to the success of this initiative. Re-vegetation, shall minimize erosion in the quarried areas and attenuate contaminant movement into the water bodies. The high noise level posed an occupational health threat to the workers who routinely avoided wearing protective gears. They should be made to adorn them. The noise from explosives was also strong enough to damage infrastructure as seen from the cracked walls of the Forest's Dept. Offices. Explosives will continue to be used in the quarry operations and, as such, future infrastructure development near the quarry should be avoided. The impacts on air quality was largely localised and, its effects were occupational. Such were addressed through provision of protective gears. The impact from fugitive dust and vehicular emissions from trucking along the gravel road encompassed the wider Mwache Forest route and, was subject to transport and dispersion by winds. The terrain in Mwache and the thick forest cover helped to trap some of the dust generated and, contained it within. Vehicular emissions also contributed to air pollution, however, it is concluded that the wind regime scattered and diluted this contamination. Cleaner emissions from the vehicles could be assured by regular and proper maintenance of truck engines and, this apart from decreasing the amount of emissions, addressing the air pollution problem, improved fuel efficiency and, minimized running costs. Paving the road could also be considered as another strategy for minimizing pollution of air from dust. Workers lacked sanitation facilities and, these should be provided to avoid the potential contamination water with faecal matter, to avoid impact on human health from water borne diseases. The risk of malaria infection from mosquitoes in the forest environment was real. To minimize this, the formation of stagnant water ponds was to be avoided. Drainage channels were to be maintained. The potential for fire hazards was also real and, the fire drills that were organized periodically should be made, taking into consideration the personnel turn-over in the work station. On occupationally health and safety, the workers should be informed of benefits of following the code of work practice to ensure they adhere to occupational health and safety rules and regulations.
