The Emerging Flood Risk on the Lower Part of Transboundary Meric/Maritsa River Basin

Abstract

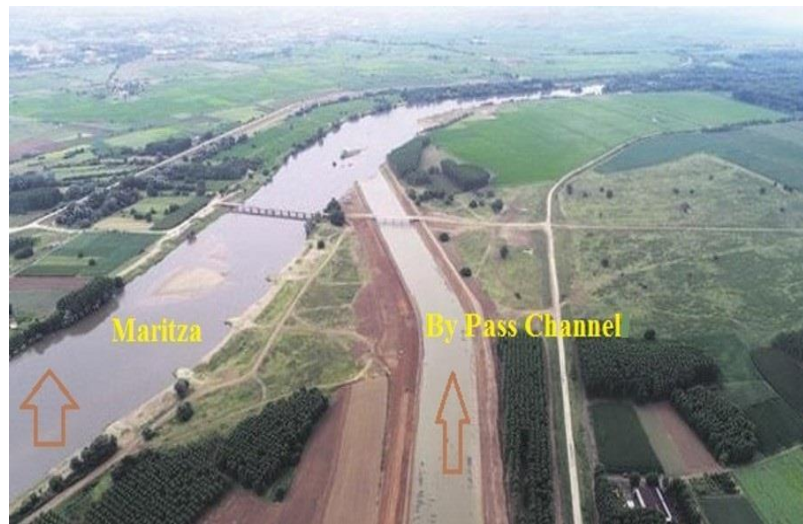
Figure 1b. Bypass Channel and Meric River.

Flood protection measures in Turkey have become an urgent matter and Turkey has decided to take its own measures. Turkey built a bypass channel to protect Edirne City and agricultural lands (Fig. 1 b)

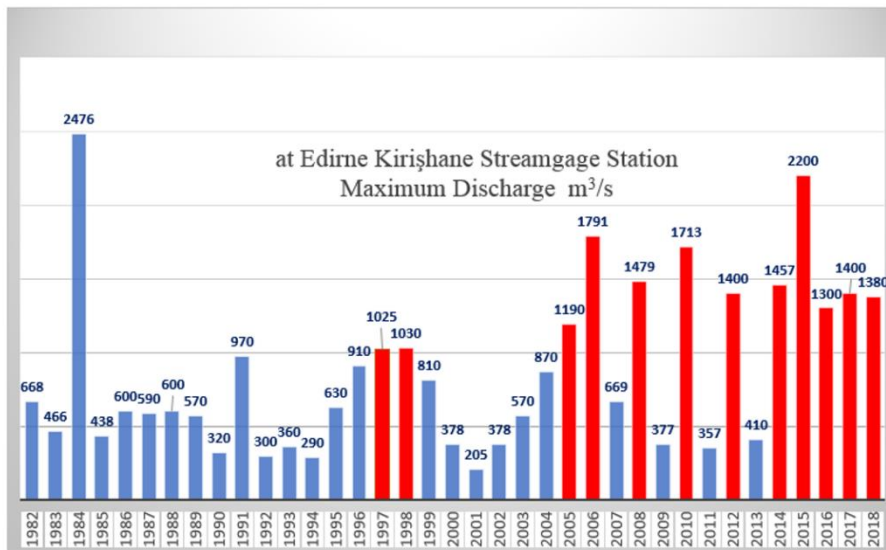
Figure 5a. Maximum discharge measured at the Edirne Kirişhane Streamgage Station.

Fig 5a shows us flood discharges measured at the Edirne City has increased dramatically. They were mostly more than 1200 m³/s since last 13 years. This figure indicates us in each year as of 1500 m³/s as a maximum average discharge in Meric River at Edirne, is highly probable. In general, the flood comes in February and March as it is seen in the same period in Ergene River.

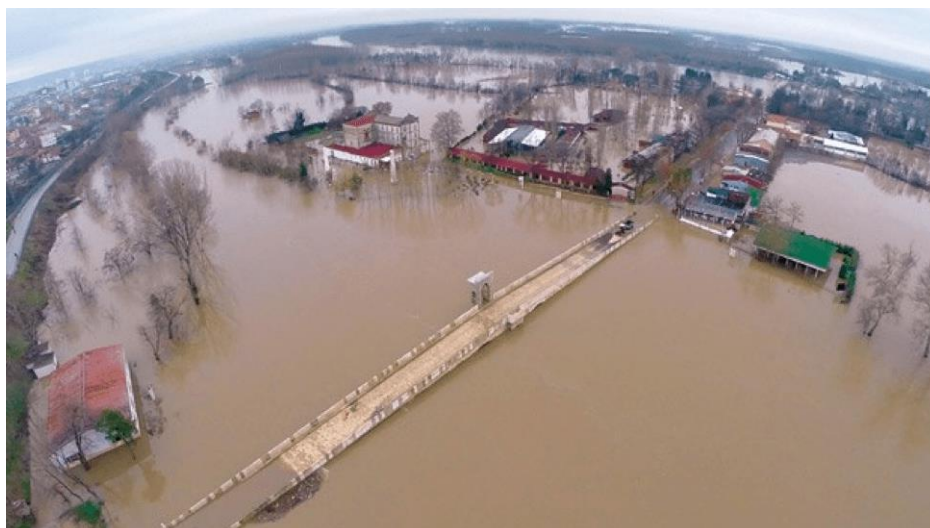
Figure 11. Edirne flood in 2006.

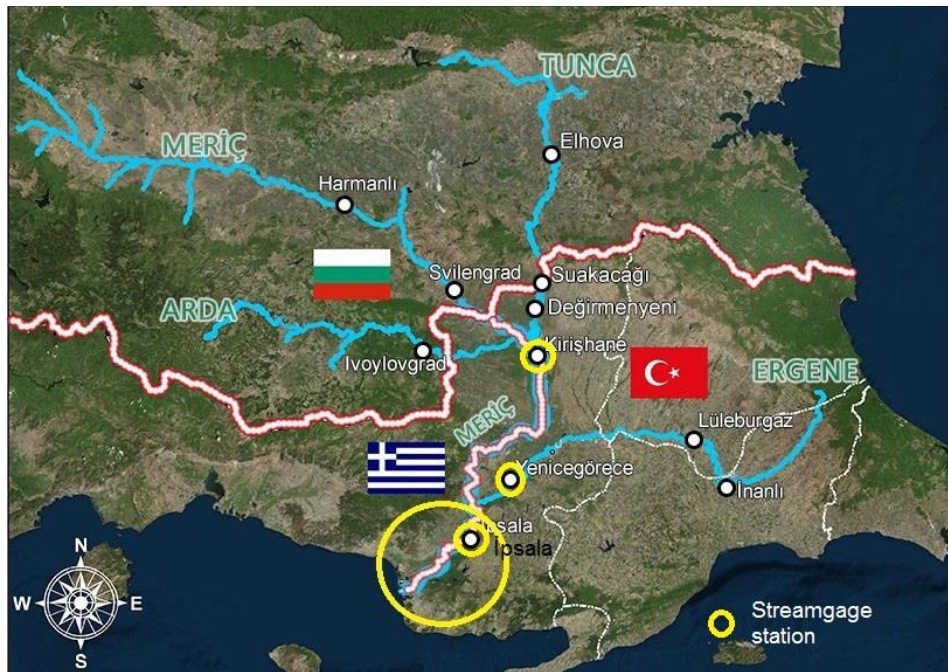
Figure 12. Lower Part of the Meric Basin and used streamgauge stations in this study

Taking into account the flood retention time in the vicinity of Edirne (Fig. 10). and travel time between two streamgauge stations, cross check analysis were carried out with the daily on line discharge data obtained from the Edirne-Kirişhane, İpsala and Ergene-Yenicegözüce streamgauge stations.

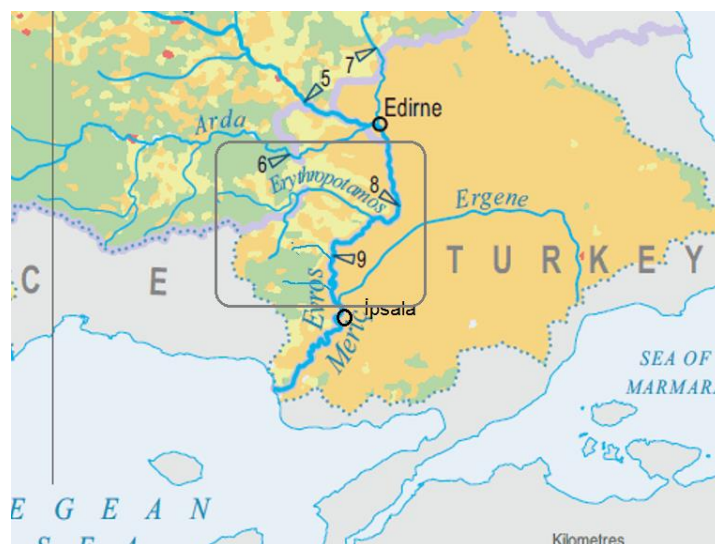
Figure 13. Inter basin of Meric River between Edirne and İpsala city.

The Erythrotamos River is the largest river which flows into the Meric River in the Inter Basin between Edirne and İpsala excluding Ergene River (Fig. 13). It is born in Bulgaria and after running for about 10 km on and alongside with the Greek Bulgaria border. It enters Greece and flows into the Meric River at the level of the town of Didymotichon.

Amount of streamflow's enters to Meric River along the inter basin between Edirne and İpsala is not available (Fig. 13). Therefore, we calculated it using daily average online data and considering travel time between two streamgauge stations given in the article (1), due to focusing on flood risk assumption in the lower part of the Meric Basin we used data of flood period of time (Jan-April). Used data for this calculation was also compared to each other's for the similarity .Correlation coefficient was obtained as of 0,96 (Fig. 14).

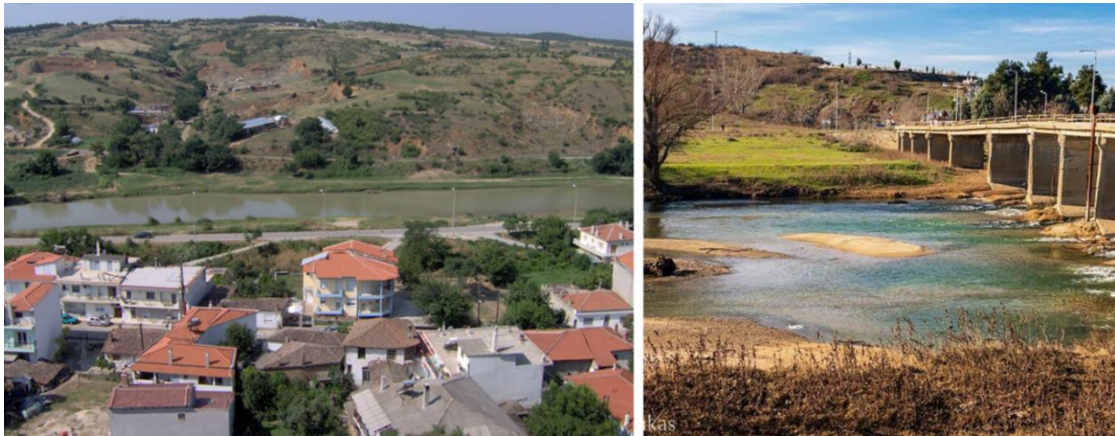
Figure 14. The Erythrotamos River (Red River, Mad River, Kızıldelisu).

The source of the river is in the eastern Rhodope Mountains in the western Meric regional unit, Greece, near the village Mikro Dereio. Its largest tributary is the Byala reka ("white river") in Bulgaria. Considering name of the river we can predict the river flows often with flood discharge.
