An Example of Sound Insulation Analysis in Building Elements with Different Materials on the Interior Surface

Zuhal Ozcetin
Fine Arts and Design Faculty, Department of Architecture,
Siirt University, Siirt, Turkey
E-mail: zuhalozcetin@gmail.com

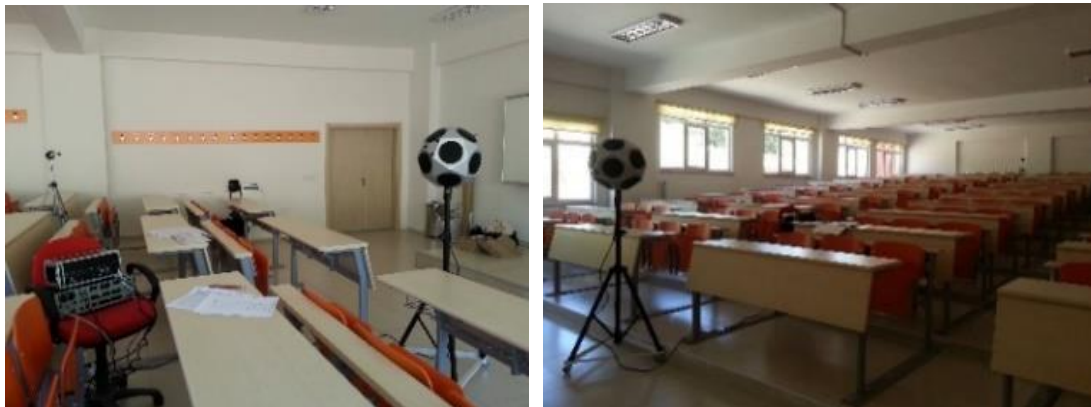
Picture 1. Photos before application

In this study, the walls of a lecture hall in the Faculty of Economics and Administrative Sciences were analyzed before and after the works of improvement. The measurements were performed when the hall was empty using a sound source of type 122dB-re: 1pW, a power amplifier of 2734-A: (500W), a 4192 1/2 inch microphone, and a Brüel&Kjaer microphone preamplifier of the model 2669-B. Measurements required under the standard TS EN ISO 16283-1 for building elements and structures in the classrooms were performed at the designated source and receiver points in accordance with the space/area dimensions, spatial arrangement, and the relation of the space with adjacent spaces. For interior walls, the wall between the lecture hall and the hallway (inner wall-1) and the wall from one lecture hall to the other (inner wall-2) were measured. The material used on the existing walls was known to be a brick-based plaster.

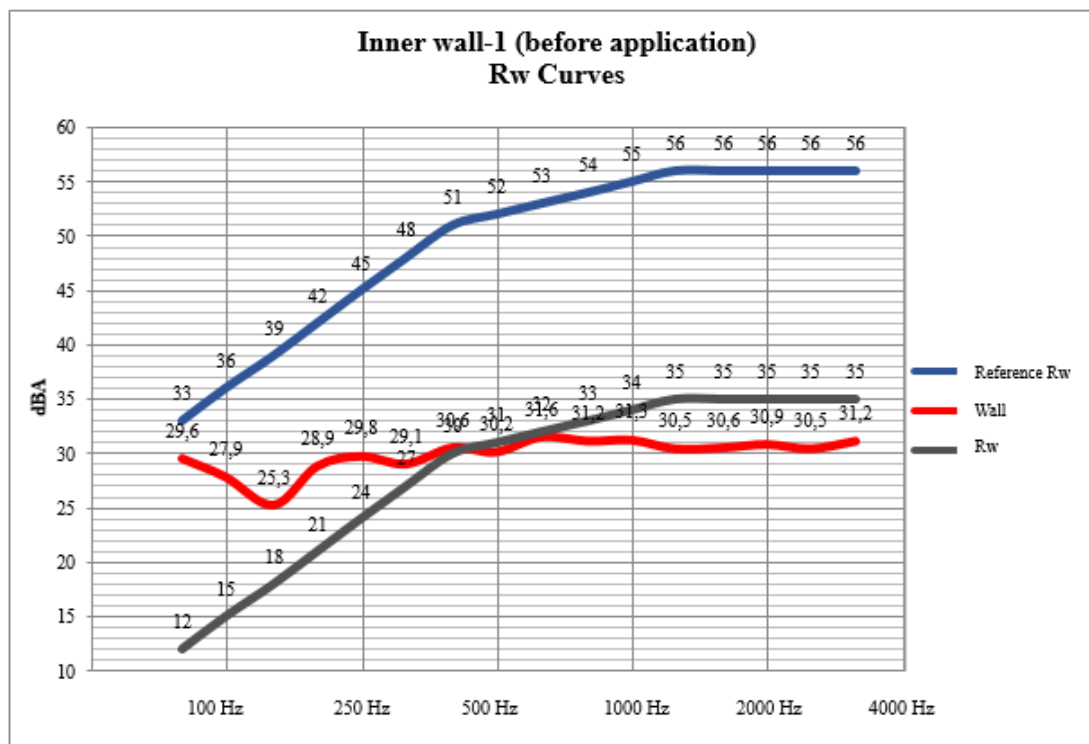
Figure 2. Inner Wall-1 (before application) R_w graphic

Figure 2 shows the evaluation of the sound transmission loss value for the inner wall-1 based on the reference curves in the standard TS EN ISO 717-1.

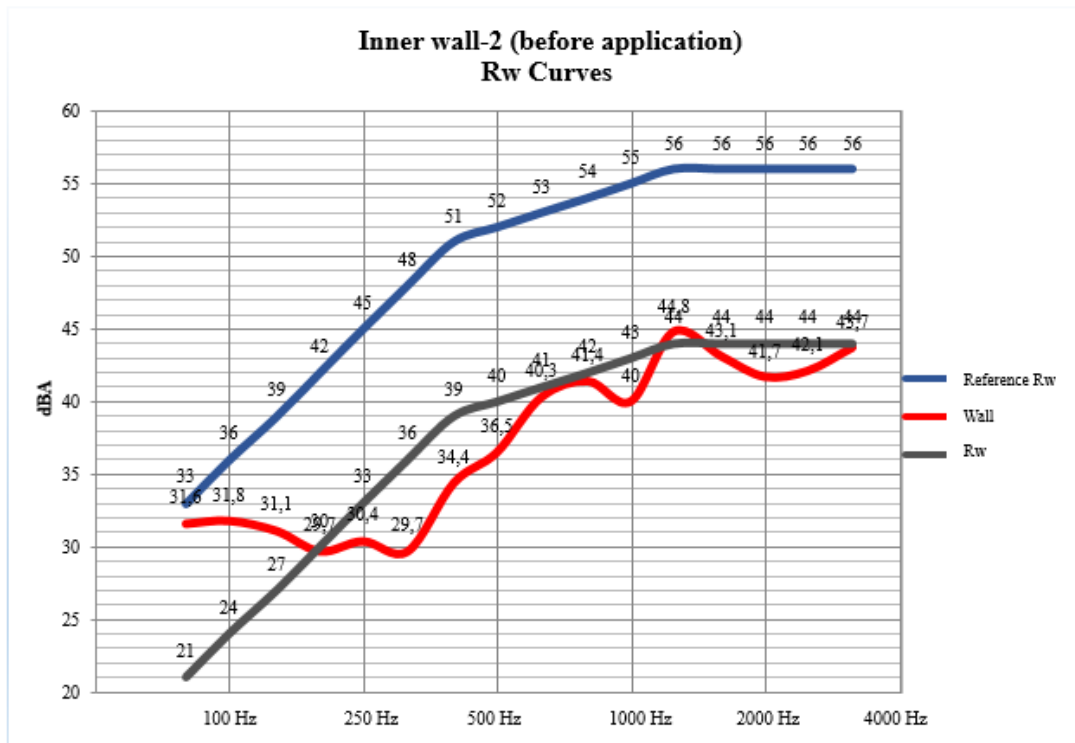
Figure 3. Inner wall-2 (before application) R_w graphic

Figure 3 shows the evaluation of the sound transmission loss value for the inner wall-2 based on the reference curves in the standard TS EN ISO 717-1.

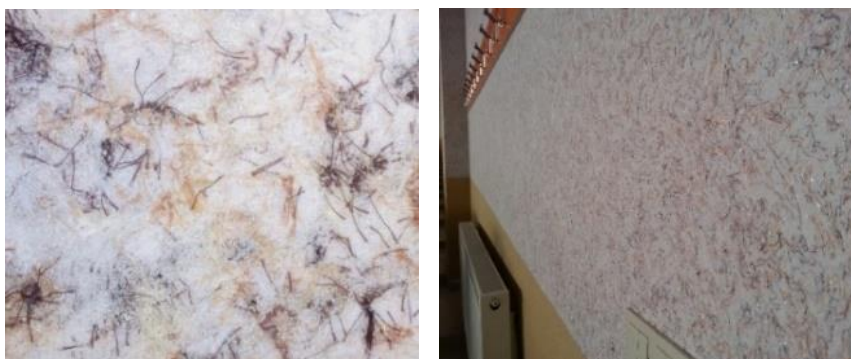
Picture 2. Silk (live) plaster detail made during the application phase

The walls were made of brick with plaster coating before the improvement, which involved applying a coat of silk (live) plaster on the existing coating. This material is in the form of cotton approximately 2-3 mm thick. Silk (living) plaster is a building material made of natural fiber, Styrofoam, cellulose, and silk. It is known to provide acoustic effects besides heat and sound insulation. Not only is its application easier compared to paint or wallpaper, but silk (live) plaster lasts longer, as well.

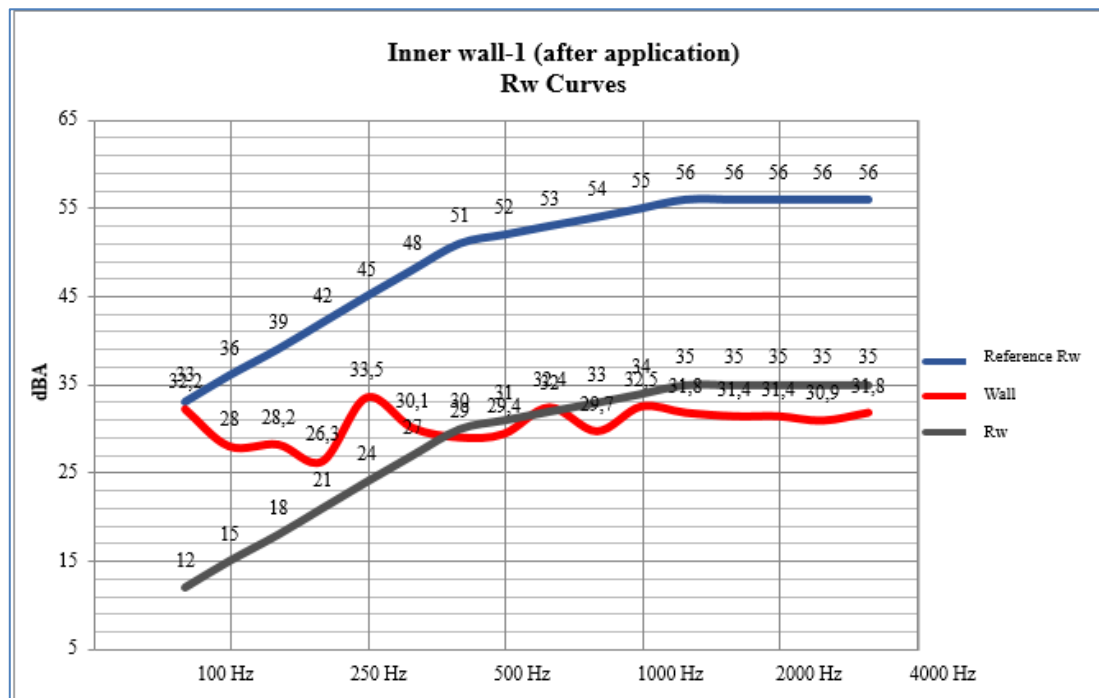
Figure 4. Inner wall-1 (after application) Rw graphic

Figure 4 shows the evaluation of the sound transmission loss value for the inner wall-1 based on the reference curves in the standard TS EN ISO 717-1.

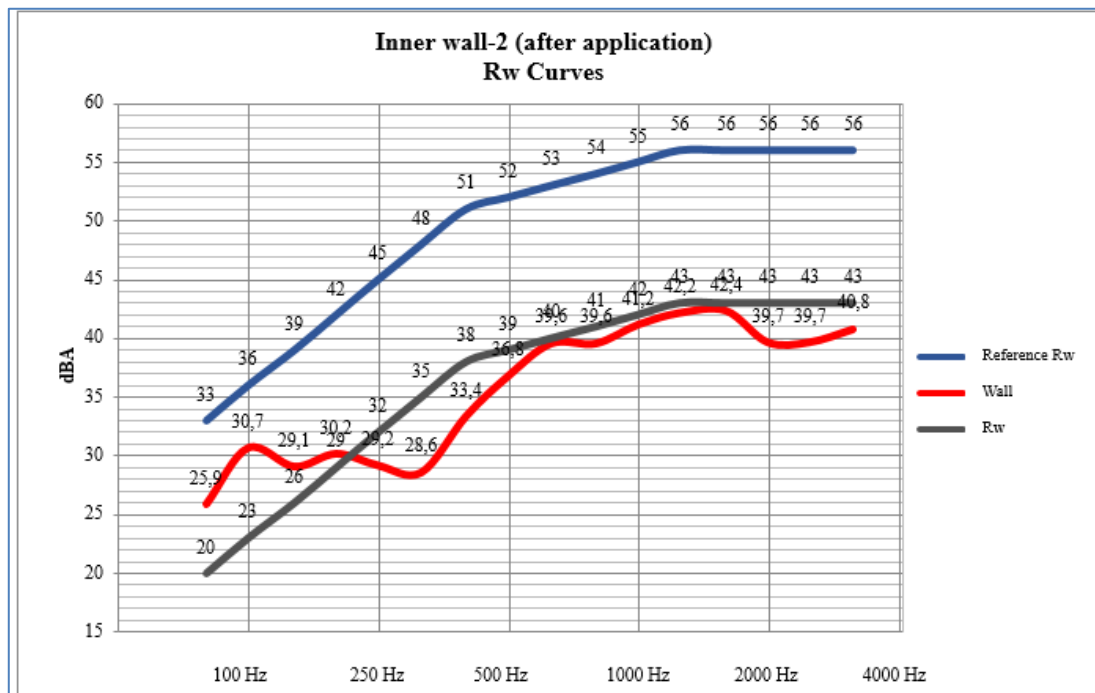
Figure 5. Inner wall-2 (after application) Rw graphic

Figure 5 shows the evaluation of the sound transmission loss value for the inner wall-2 based on the reference curves in the standard TS EN ISO 717-1.

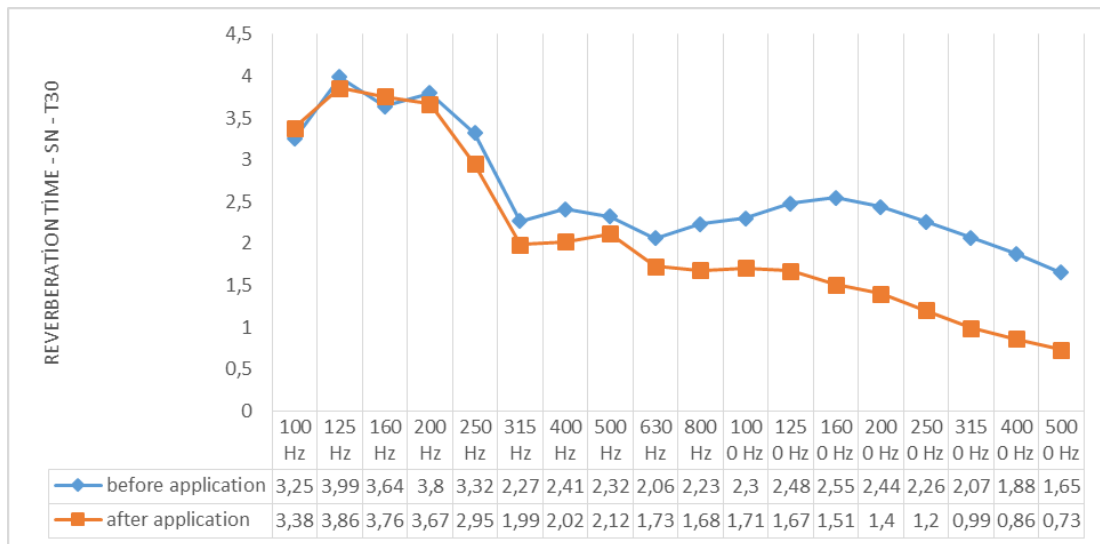
Figure 7. Reverberation time values before and after application

There was a significant decrease in the reverberation time at frequencies as high as 630 Hz after the application of silk (live) plaster. This indicates for the reverberation time at the lecture halls, silk (live) plaster shows a better performance at higher frequencies.
