# Geophysical Investigation into the Cause(S) of Structural Failure within Bacosa and Faculty of Science Buildings, Bowen University Temporary Site, Iwo

Cracks on concrete and walls could be bothersome for quality of life and for property claims. Geophysical investigations was carried out around Faculty of Science and BACOSA buildings of Bowen University Temporary site, Iwo with a view to establish the possible cause(s) of failure of buildings within the study area.

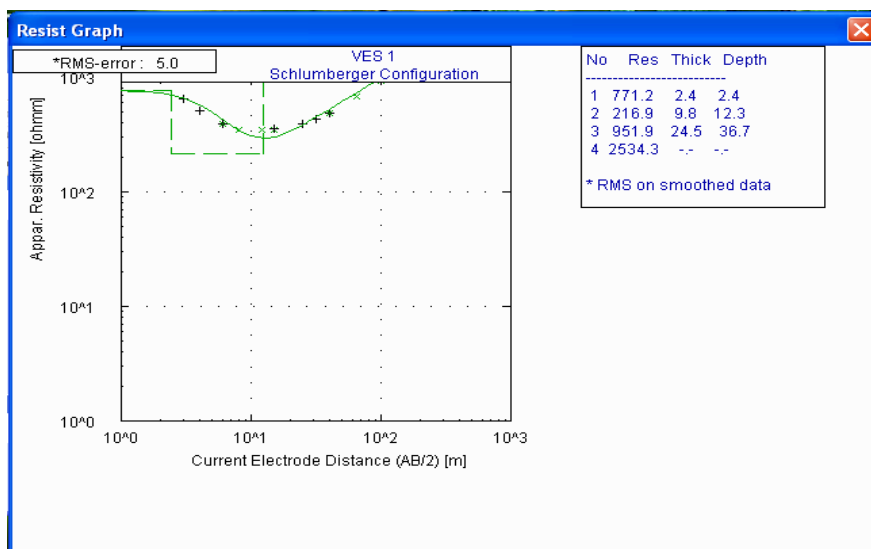
Figure 16: The Schlumberger Depth Sounding beneath VES 1 at BACOSA

The resistivity sounding curves of the six VES stations (Figures 16 to 21) obtained from the survey area consist of four geoelectric layers, with VES 1-3 (HA type); VES 4 (KH type); VES 5, (QH type) and VES 6 (AA type). The curves were characterized according to their signatures, which mirror the layering of the subsurface. The four geoelectric layers that were delineated include the topsoil, weathered layer, clayey sand and fresh basement with resistivity ranging between 121.3 to 771.2 ohm-m, 134.4 to 595.8 ohm-m, 81.6 to 951.9 ohm-m and 1474.7 to 5134.4 ohm-m respectively. The thickness ranges from 0.5 to 2.4m, 1.8 to 9.8m and 2.7 to 24.5m. Depths to bedrock are generally less than 40m. It was however observed from the six VES stations which circles around the distressed building (Figures 1 to 8) showed that the weathered layer has resistivity values of 216.9, 165.2, 134.4, 163.1, 196.5, 595.8 ohm-m and thickness 9.8, 9.4, 8.7, 4.8, 1.8 and 2.1m respectively. Since the topsoil with thickness varying from 0.5 to 2.4m will be excavated during foundation construction, this layer is believed to act as support for foundation. From the resistivity values, the weathered layer in this study area is seen to be characterized of clayey materials of thickness ranging from 1.8 to 10.2m. Therefore, probable reason for the structural defect on the buildings could be the problem of swell and shrinkages of clayey soils. Seasonal variation in the level of saturation of clayey soils is expected to have given rise to the seasonal swelling and shrinkages of buildings subsurface. The swell and shrink might have caused the ground movement which invariably should have cause defect (cracks) and foundation instability of the buildings. The contrast between the shrinking clay and non-shrinking zone might have also contributed to the ground movement which in turn could bring about risk on the structure.
