# Non-Destructive Testing Techniques for Corrosion Assessment in Reinforced Concrete Structures in Kenya

Violah J. Salbei<sup>1</sup> Cox M. W. Sitters<sup>2</sup> Prof. John Vantomme<sup>3</sup>

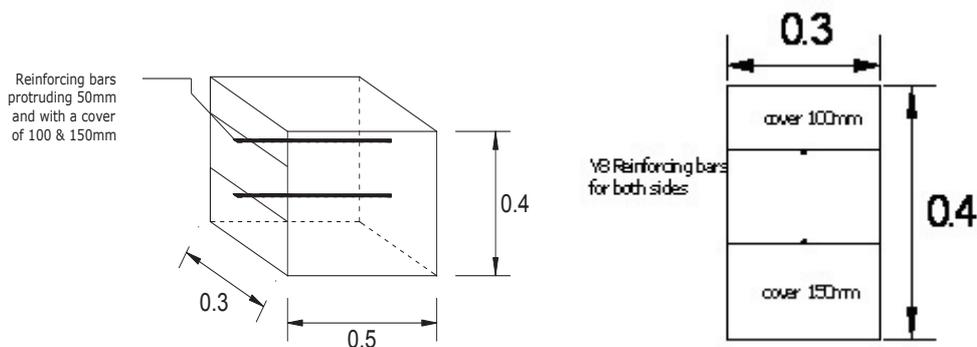
Figure 1: Block B1 specimen and the cross-section

Before carrying out the field tests it was deemed important to cast blocks to test the effect of the different field conditions on the measured potential. The block sizes were 0.5 m by 0.3 m by 0.4 m as shown in Figure 1. In the blocks shown, the cover depth, bar diameter and curing conditions of the blocks were varied as indicated in Table 2 for measurements to be carried out in different conditions. A total of 10 blocks were cast.
