Bridge Collapse in Nigeria: A Case Study of Tatabu Bridge in Mokwa Local Government Area of Niger State

Jibrin Sule., Ibrahim A. Inuwa., Surajo Lawan Abdullahi., Danladi S. Matawal
(Affiliation): Nigerian Building & Road Research Institute, NBRI House
10 I.T. Igban Street, Off Obafemi Awolowo Way, Jabi PMB 5065 Abuja, FCT, Nigeria

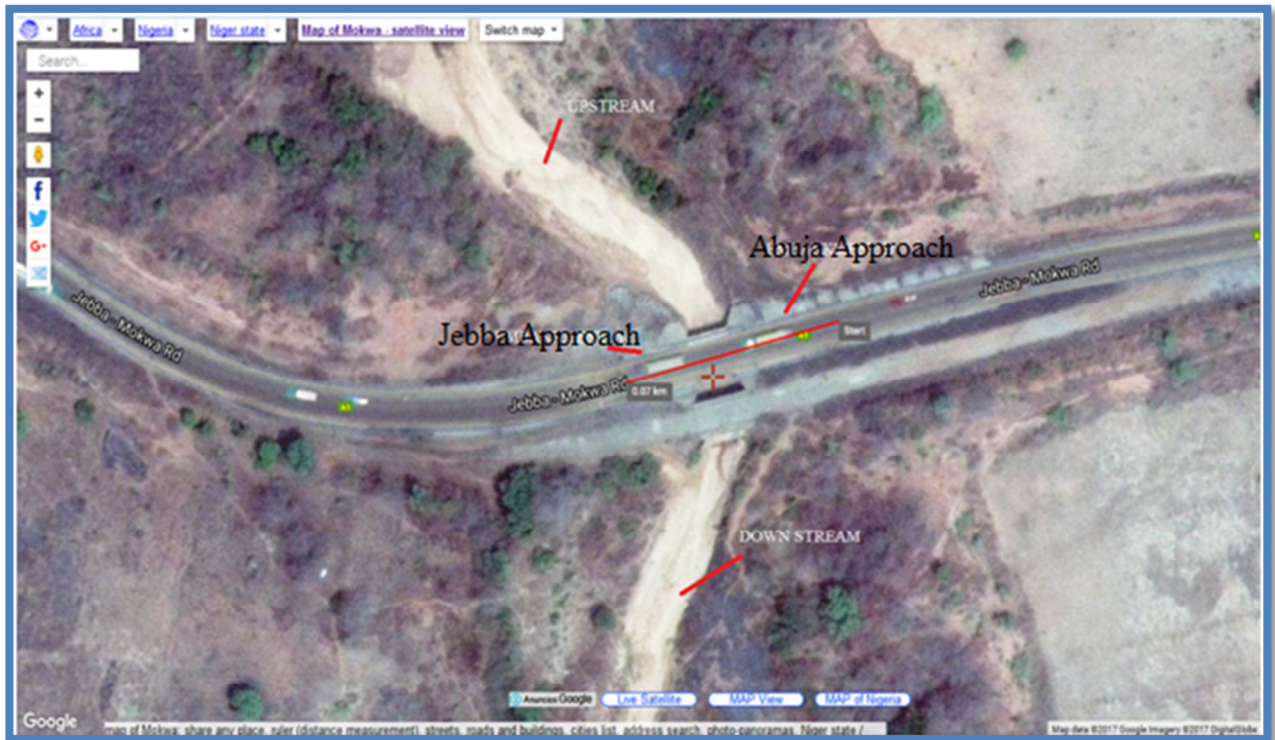
Figure 1: Satellite Imagery of collapsed Tatabu (Mokwa) bridge

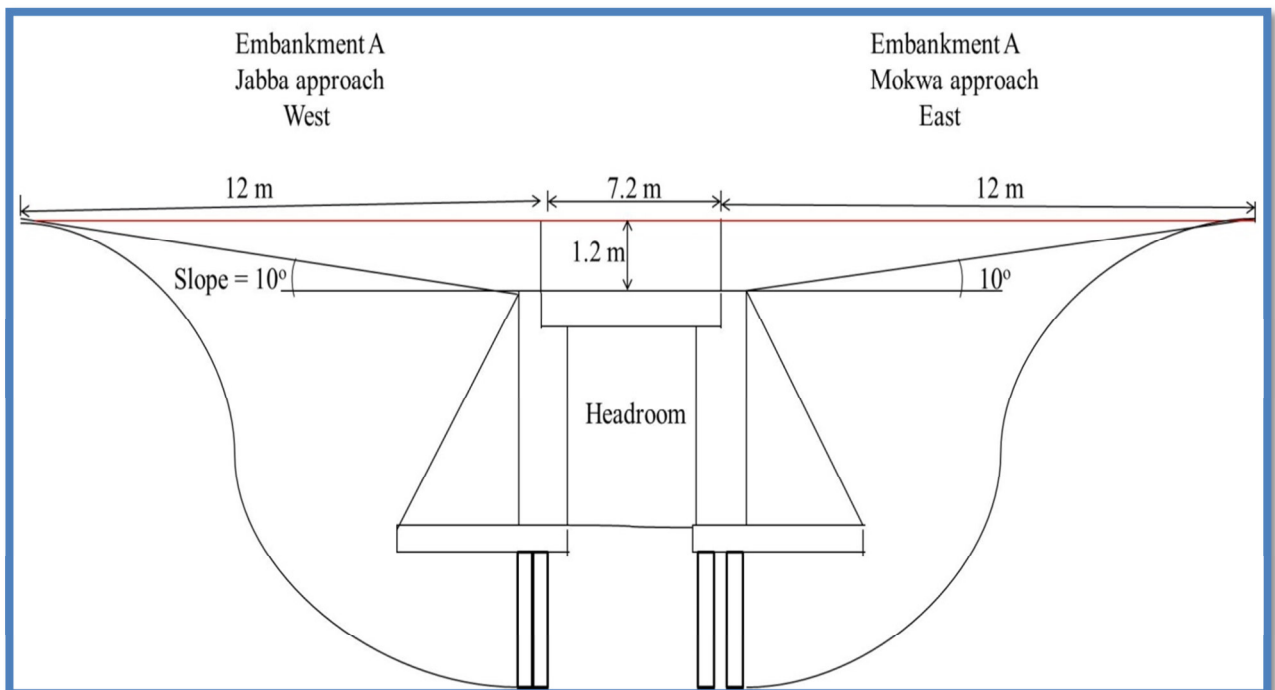
Figure 2: Schematic Diagram showing the sharp slope

The bridge as-built drawing was not obtainable at the time of the research hence the team had to manually take measurement of the collapsed bridge at site as shown in Figure 2 and 3. The bridge structural drawing was used to create the geometry of the bridge site in details in ANSYS Geometry. The in-filled embankments at both Abuja and Jebba approaches were shown in Figure 4. The created geometry was later exported to ANSYS-Fluent and Structural separately. The structural bodies and fluid body were then suppressed in ANSYS-Fluent and Structural respectively, before the meshing. Figure 7 shows the modelled geometry of the site in ANSYS Geometry.

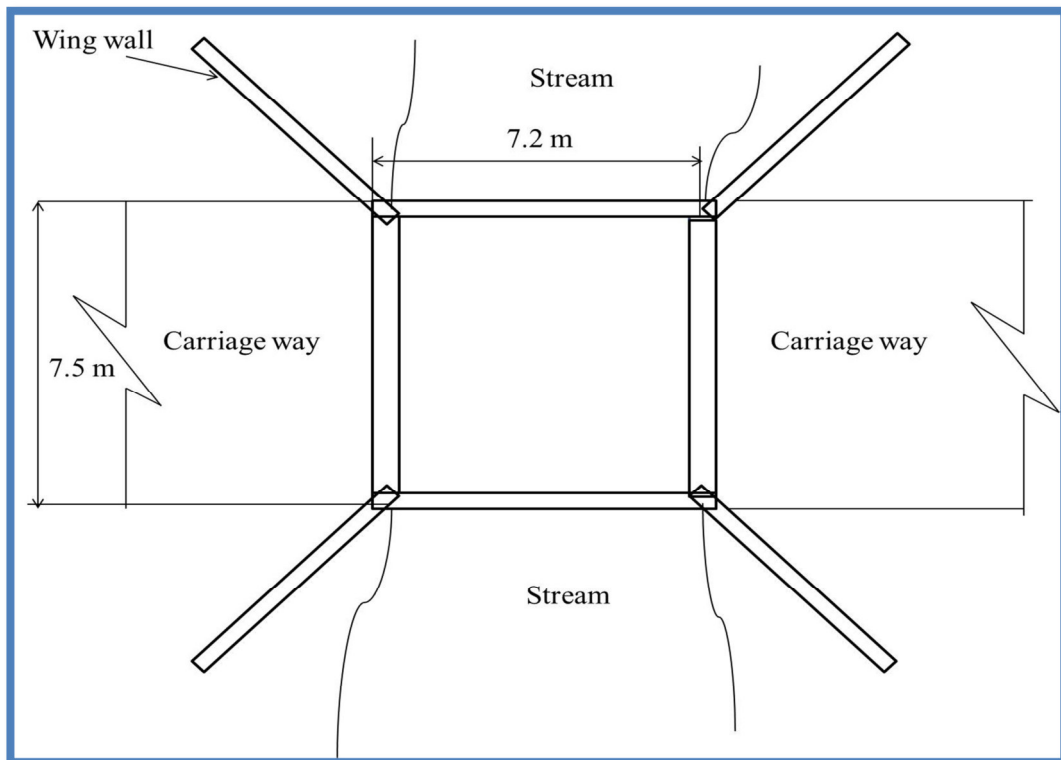
Figure 3: Schematic Diagram showing the plan

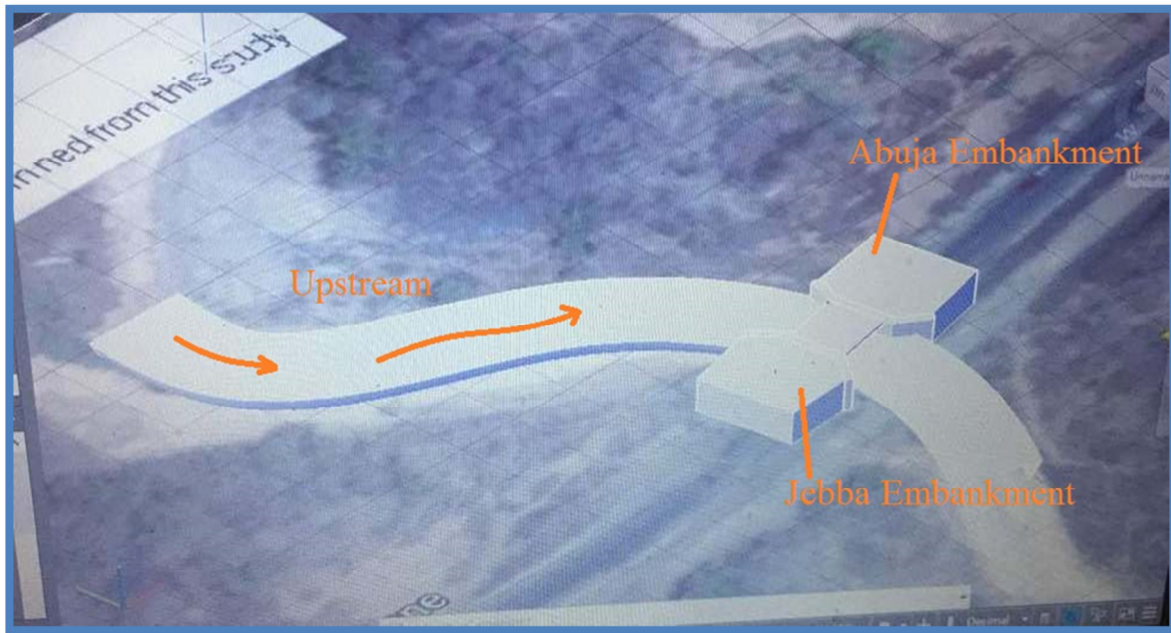
Figure 4: Modelled geometry of the bridge in ANSYS Geometry

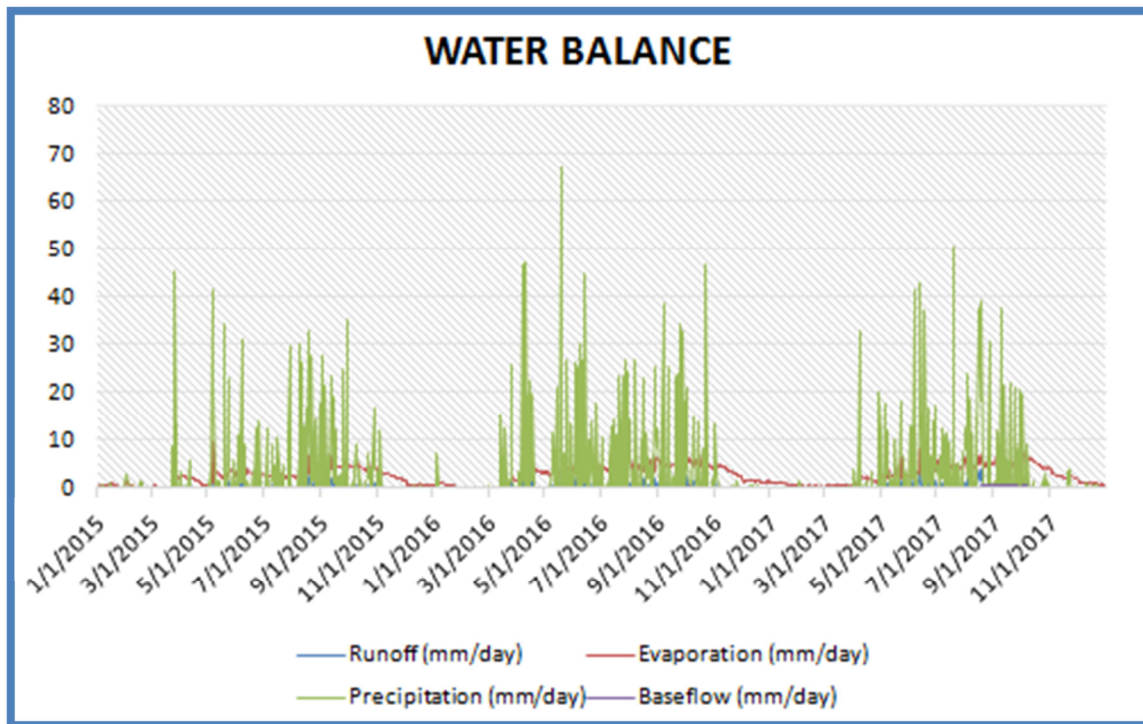
Mokwa and its environment experiences its annual precipitation around March - April. From the result presented in figure 3, it can be observed that the peak period for the 3 years data collected fell within June - September. In 2015 the peak period was in August with precipitation of 241.93 mm/month while 192.377 mm/month in September and 84.114 mm/month day in October respectively. A steady increase in rainfall from 2015 to 2017 was also noticed. The steady increase in precipitation from the past year may have caused the rise in river level and subsequently flood. The team measured the flood height to about 1.7 meters above Jebba approached as shown in Plate 3. Therefore, these results proved that the increase in water volume may have been part of the reasons for the flood and subsequently overtopping of the bridge and its embankments as shown in Figure 5.

Figure 5: Trend in Rain data variation (Source: NIHSA, 2017)

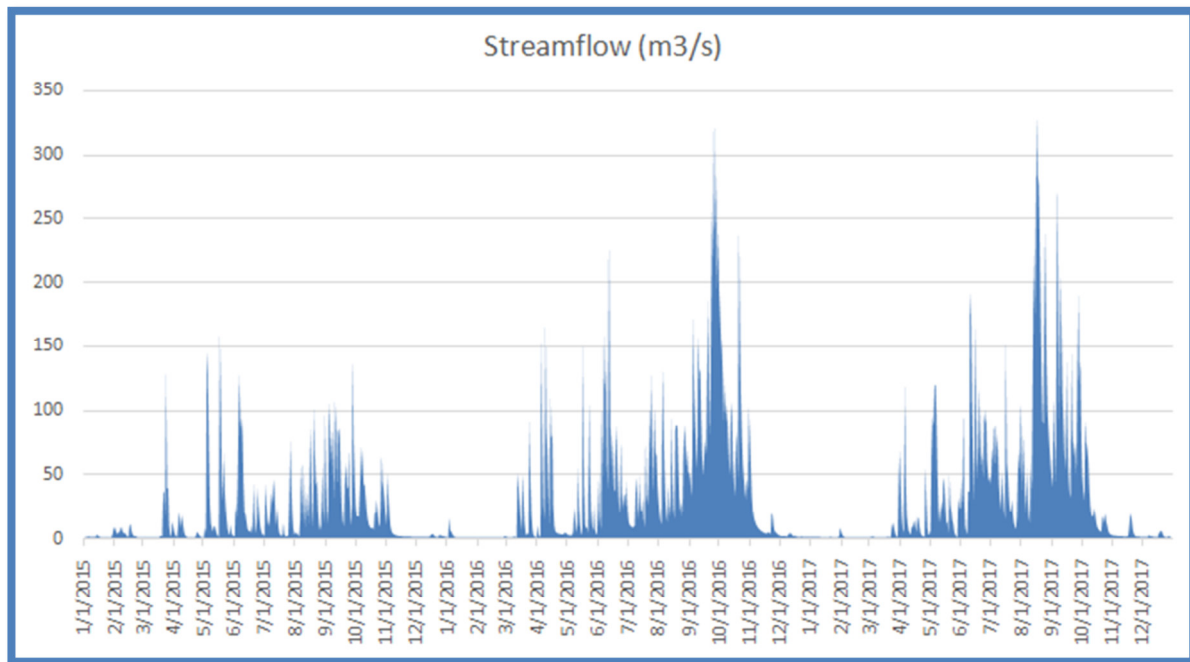
Figure 6 below shows the Flow results from 2015 to 2017. The peak flow in 2015 was recorded in September with flow rate of 1655.58 m³/s, in 2016 the flow has double the previous year to about 3978.32m³/s in September, while in 2017 it maintain the same flow rate of 3830.58 in August. One of the important factors that can induce erosion of approach embankments, especially on the upstream faces, is the high flow that can occur near parallel to the embankment with intense concentrations at the abutments.

Figure 6: Stream flow (Source: NIHSA, 2017)

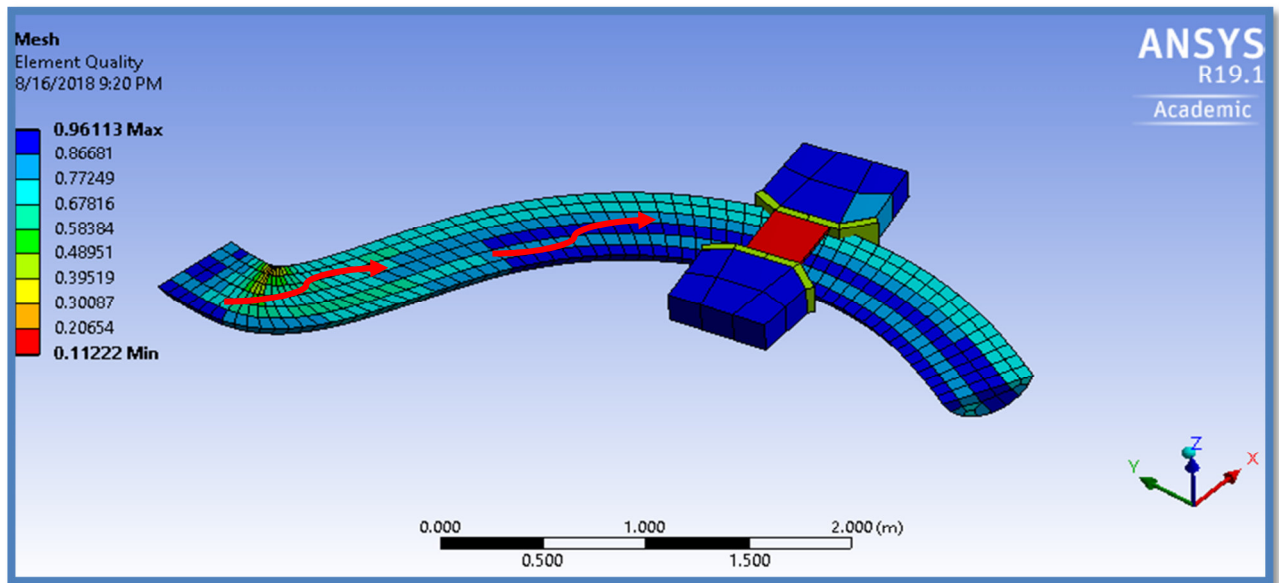
Fig. 7: Geometry and mesh diagram of Tatabu Bridge Site.

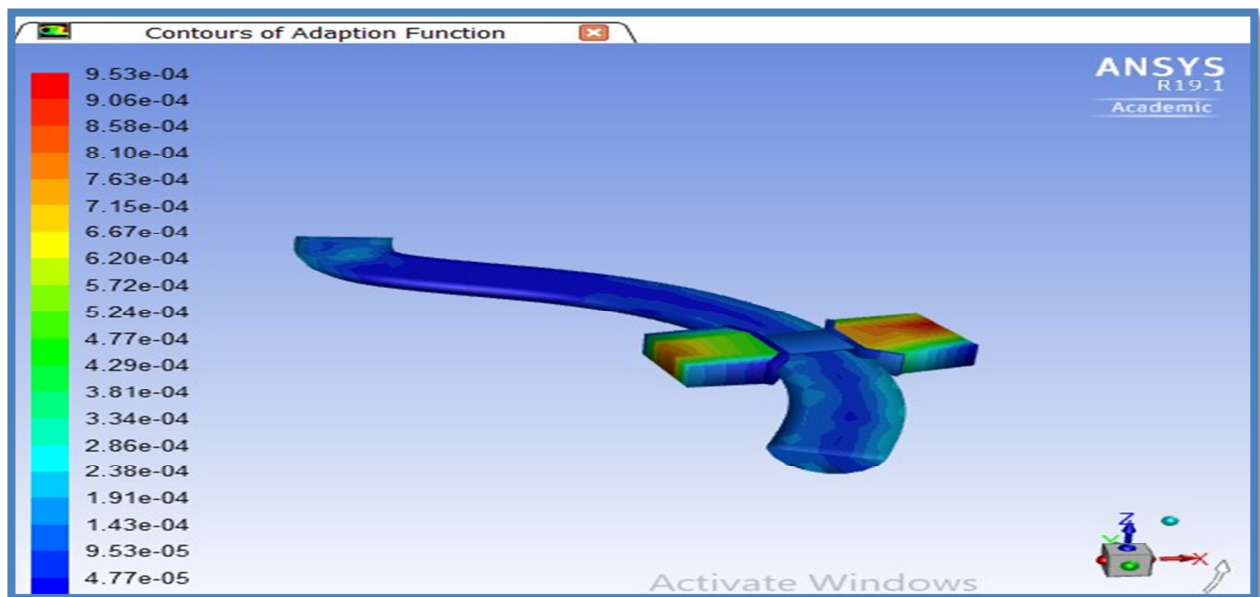
The contours adaptation of velocity and pressure during the flood are shown in Figure 8. As presented in Figure 9, the pressure of the flow within the Abuja approach bridge abutment is higher than the other parts. Possibly, this happened as a result of the meandering nature of the flood path. This high pressure flood collide and wash off the relatively soft in-fill soil providing support to the embankments resulting to collapse of the entire structure. Figure 9, Figure 10 and Figure 11 shows von Mises stresses in the bridge and displacement of embankment soil respectively.

Figure 8: Image showing Fluid Flow.
