# Investigations on the Material Efficacy of Failed Helical Gears in a Gear Train

O. O. Joseph,\* O. A. Abidakun, A. O. Aniyikaye, O. O. Folorunsho

Department of Mechanical Engineering, Covenant University, P.M.B.1023, Ota, Nigeria

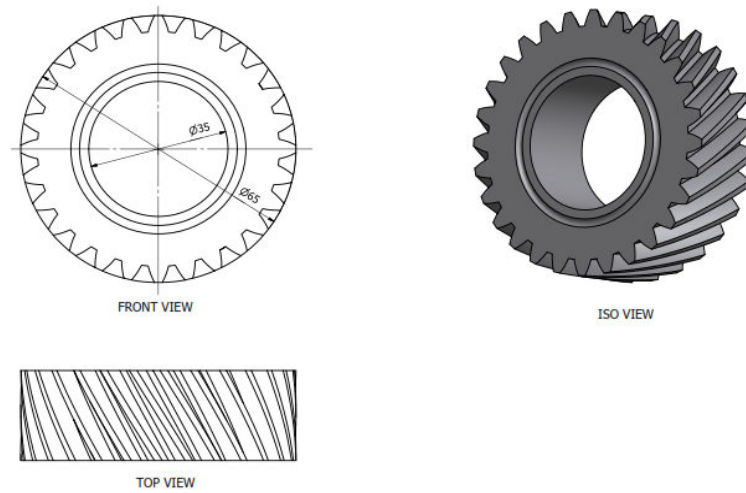
**Figure 2a** Schematic of gear sample A.

Parameter	Sample A	Sample B
Number of teeth	28	32
Helix angle	30	30
Inside diameter (mm)	35	45
Outside diameter	65	75
Number of failed teeth	7	0

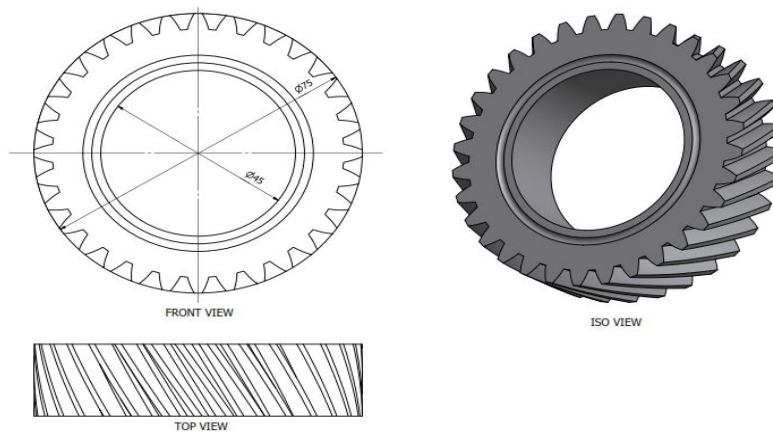
**Figure 2b** Schematic of gear sample B.

Spalling was observed in sample B. Both modes of spalling (surface and subsurface) were observed. Surface spalling is indicated with the red curve and subsurface spalling with the yellow curve. However, it is noticeable that the surface of sample B remained smooth and lacking in obvious damage, while a few micrometers below the surface, processes culminating in the formation of a wear particle were taking place.
