Seismic Performance Comparison of a Building Made with Old Masonry Bayburt Stone According to Old and New TBDY.

Omer Can
Civil Engineering Department, Bayburt University
21 Subat street Bayburt 69010, Turkey
E-mail: ocan@bayburt.edu.tr

In this study, it is aimed to compare the earthquake performance analysis of a masonry structure made with Bayburt stone according to Old (TBDY-2007) and New (TBDY-2018). For this purpose, a technical Vocational High School for Girls building located in the city centre of Bayburt was handled and the survey work was carried out. After moving the measurement to AutoCAD program, the modelling was done with the help of StatiCAD-Masonry Program and performance analyses were obtained and results were compared.

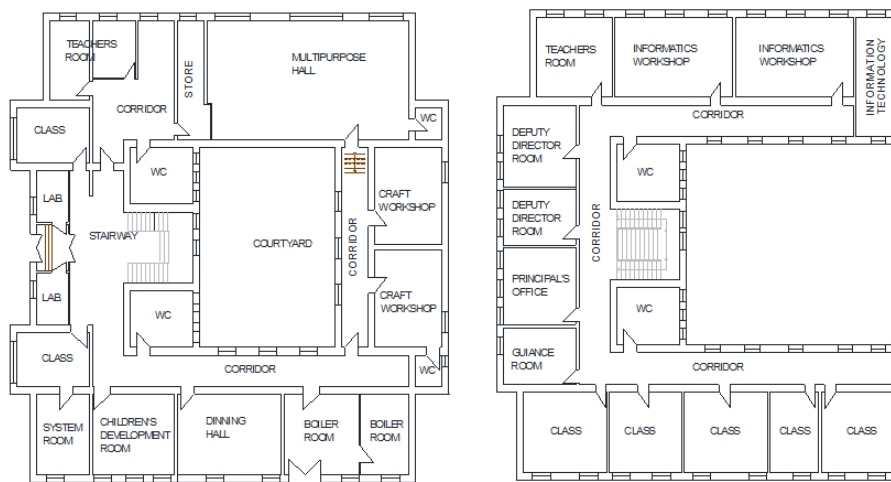
For the modelling process of Girls' Vocational High School building, firstly, a survey work was performed. Although the first purpose of the building was to rest and accommodate passengers, the quality of the building did not lead to any change in the façade, although, small restoration works were observed. Survey Examples of Girls Vocational High School Building are given in **Figure 2**.

Figure 2. Survey Examples of Girls Vocational High School Building

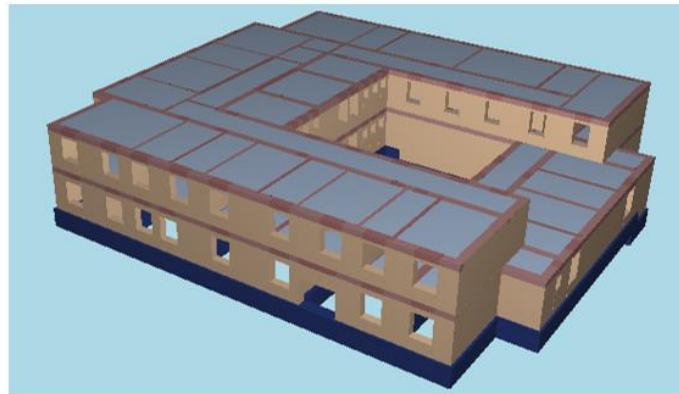
Figure 3. Three Dimensional View of Girls Vocational High School Building
