A Critique of the Architecture of Faculty of Science Complex, University of Lagos, Nigeria

Adewale Segun Alabi*

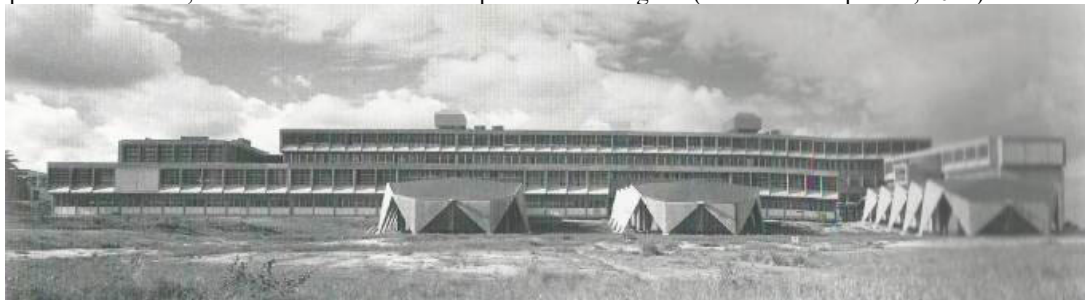
Figure 1: View of the just completed faculty of Science complex from the Lagoon (Source: Godwin & Hopwood, 2012)

The complex can be classified as an international style, mostly related to modern architecture which was a fashion and norm at that period especially in most federal institution of learning in the country. The science block is located towards the eastern end of the campus at the edge of the lagoon. A dense grove of trees covers the longitudinal approach from the north view, making the building a mystery to be solved as just a glimpse of the building is seen. The peek seen through the trees gives an instant impression of an iconic building. Within full view, the structure is unique, easily recognizable and simple, a gem located out of sight!

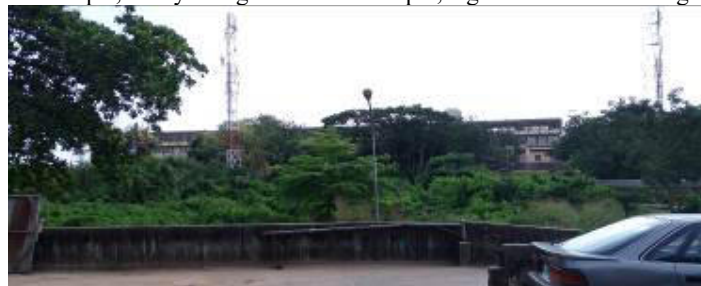
Plate 1: North approach view (Source: Author, 2016)

The main entrance is situated at the mid-section of the longitudinal north elevation, although not pronounced, it is raised to allow free flow of air within the building synonymous to Le Corbusier's approach to modern architecture permitting stack effect. Promoted as new architecture, Le Corbusier described it in his book "*Vers Une Architecture*" published 1923, translated as *Towards a New Architecture* (1927), in which he celebrated amongst other things the beauty and adventure associated with ocean going liners (Le-Corbusier, 1923).

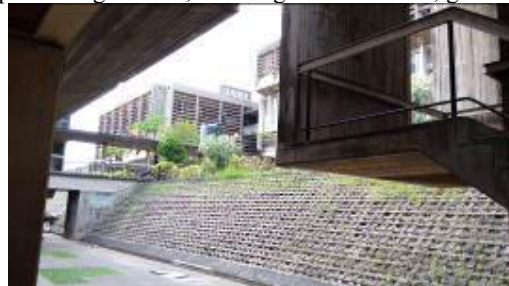
Plate 2: Concrete retaining walls with basket weave appearance perforations (Source: Author, 2016)

The retaining walls serve a great function in holding up the sloping terrain towards the south and also serve as the basement floor. The gardens create good scenery for passersby. The natural landscape considered in the design of the retaining walls cushions the hardness imposed by the massive concrete of the building. However, over time, the original intention of keeping the gardens within the courtyard area green has somewhat been encroached upon with the unguided intrusion of some services such as indiscriminately installed pipes and water tanks.

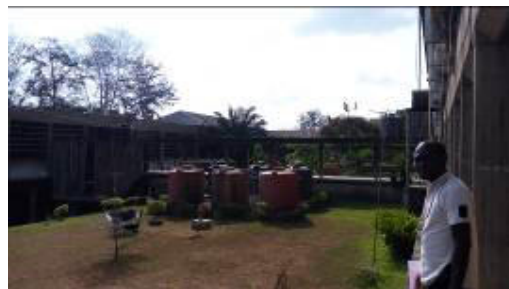
Plate 3: Courtyard area encroached upon with unguided intrusion of some services (Source: Author, 2016)

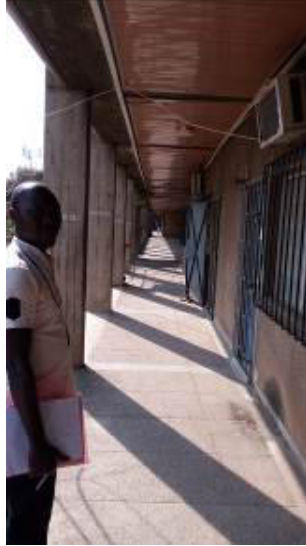
The design was intended to make maximum use of ventilation in order to have an adequate micro-climate by applying good orientation of the structure and the introduction of sun shading devices which would also act as funnels guiding air into the structure. It appears that this was not fully achievable because of the presence of air conditioners dotting the structure in an obviously unplanned arrangement. These ACs are fitted into any conceivable available space such as the roof and windows. The need for these mechanical coolants is probably due to the ability of concrete to absorb and conduct heat in large quantities thus making rooms hot despite constant flow of natural air. The interior spaces had been originally insulated with the use of wood panels which

over time were stripped away and replaced with PVC panels which do nothing about insulation. Small wonder, the heat gain of the building required a mechanical solution.

Plate 4: ceiling replaced with PVC panels (Source: Author, 2016)

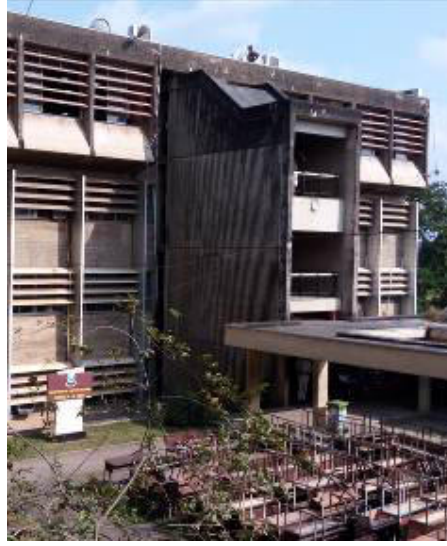
Conversely, the installations were not properly and neatly carried out, which now gives the façade of the building a deformed look especially where outlets have been drilled on the parapet walls and units mounted on windows and wall surfaces in an unsynchronized manner.

Plate 5: Drilled parapet walls for AC piping (Source: Author, 2016)

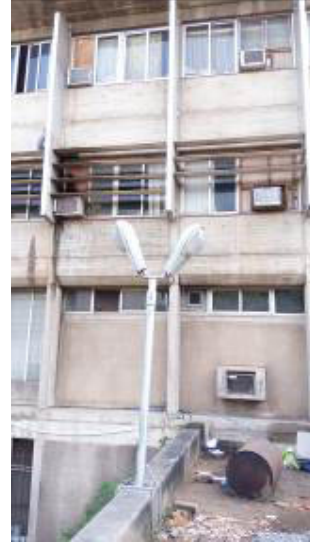
Plate 6: Units mounted on windows and walls in a haphazard fashion (Source: Author, 2016)

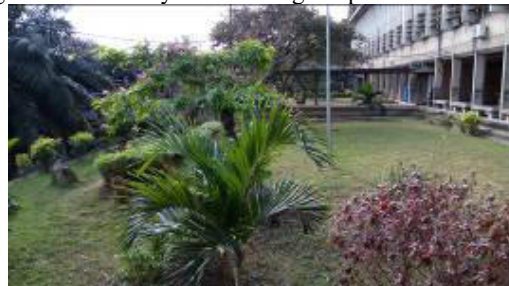
Plate 7: Courtyard Garden, defining the portions between the links (source: author, 2016)
