A Case Study on Blowout and Its Control in Krishna-Godavari (KG) Basin, East Coast of India: Safety and Environmental Perspective

Abstract

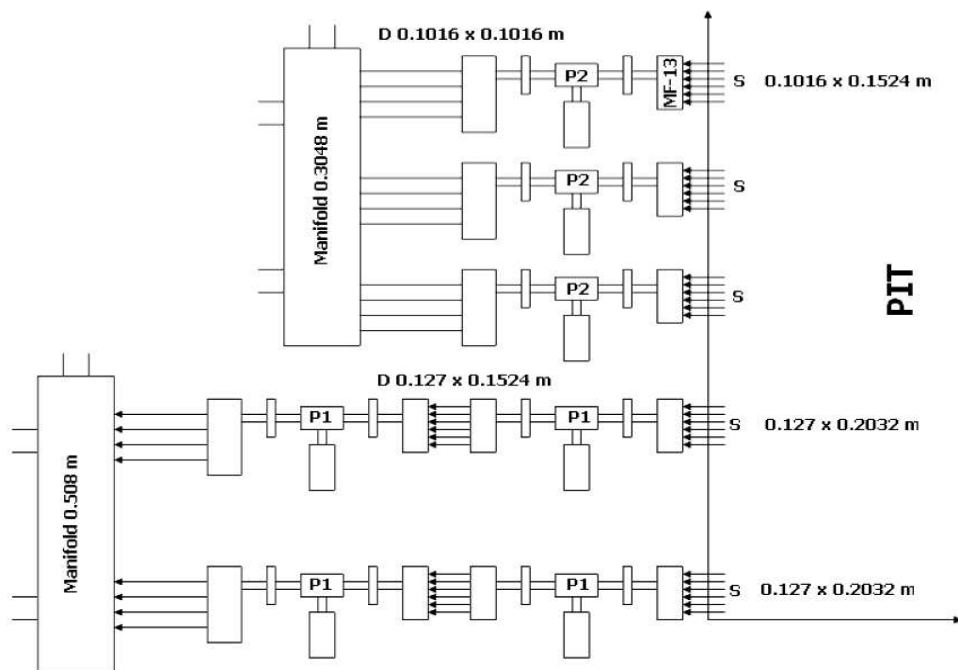
Figure 4. Arrangement of water pumps to create a water umbrella over the flame (Jain, 1995).

- Six pumps of 20,000 gal/min total capacity were used for spraying of water and to create a water umbrella over the flame to reduce the temperature of the flame and surroundings for approach of the safety rescue personnel and for clearing the debris at the site. To prevent the damage of the pumps, they were placed in the well site. A schematic of the pumps arrangement used for combating the blowout is shown in **(Figure 4)**. The details of the pumps used for pumping the water are given in **(Table 2)**.

Type of Pump	Discharge (m³/min)	Head (m)	Suction and Delivery Manifolds
Red Adair 2 sets in series	18.92706 each	129.54	0.127×0.2032 m suction, 0.127×0.1524 m delivery connected to 0.508 m manifold
Kirloskar 2 Nos.	15.14165 each	129.54	0.1016×0.1524 m suction and 0.1016×0.1016 m delivery connected to 1.8542 m manifold
Transfer pumps 2 Nos.	15.14165	30.48	N.A.

Table 2. Details of pumps used for creating water umbrella over the flame (Jain 1995).

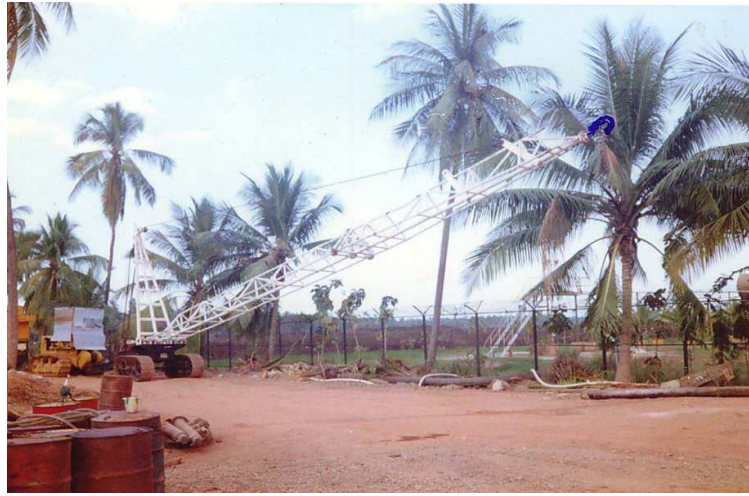
Figure 5. Athey Wagon clearing the debris at the well site.

- Athey wagon **(Figure 5)** was employed (Kelly, 1993) to clear the debris at the well site so that it was easier for the safety rescue personnel to reach within 20 m radius of the blowout area.

- Drums of plastic explosives of each approx... 200 kg were dispersed over the flame, to suck up all the oxygen and to extinguish the fire. But many attempts failed. In another attempt, approx... 400 kg of plastic explosive was dispersed onto the flame with the help of Athey wagon and the finally the fire was extinguished. This brought much needed relief to the crew and experts at the well site.

- The surroundings were cleaned with the use of Athey wagon, bulldozer and a crane with hook. A relief well (Wright, 1993) from a distance of 1.5 km from the site of blowout was drilled to connect to the bottom of the blowout well. High density drilling mud was pumped to control the flow of gas from the reservoir into the well bore. The choice of spraying foamy fire retardant chemicals was not tried to put off the fire.

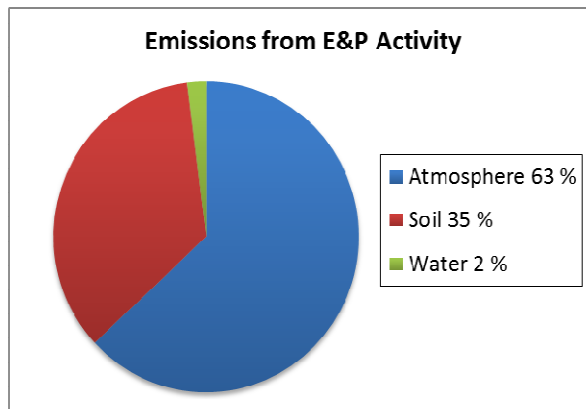
Figure 6. Relative contribution of emissions from E&P activity to Atmosphere, Soil and Water.
