Construction of Soil Conservation Structures for improvement of crops and soil productivity in the Southern Ethiopia

Abay Ayalew

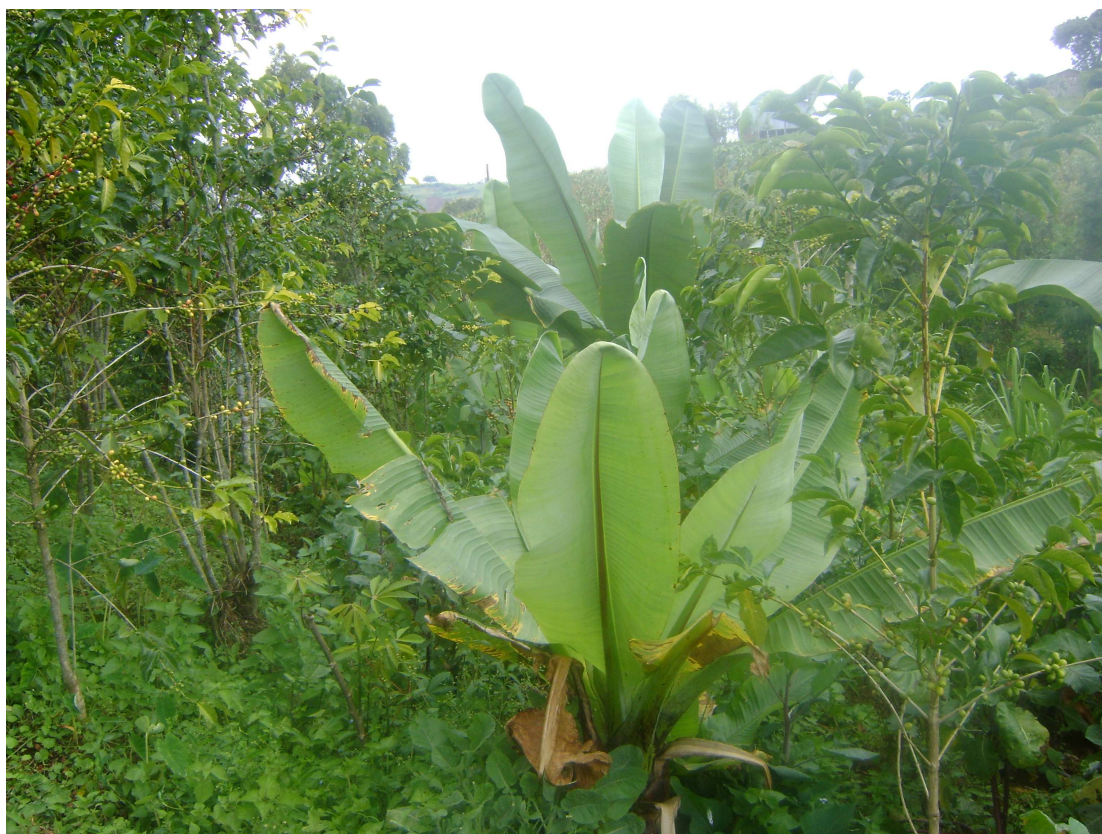
Fig 1. Perennial crops completely covered the soil at the homestead of Gununo farm

Having the problems, the farmers in the area continued cultivating the lands without trying to combat the soil erosion problem. Since the homestead areas are planted with perennial crops (Fig 1) like enset (false banana), banana, coffee, yam, taro and sweet potato, they are not affected by soil erosion as these plants cover the soil enough to reduce the detachment power of rain drops. The problem is on the outer field where cereals are mostly practiced. These parts of the farms are steeper than the homesteads and very much affected by erosion. Most of the farmers in the area perceived that erosion washes away the top fertile soil, seeds sown and applied fertilizers to down slope. But none of the farmers could control the erosion. Rather they preferred either to continue cultivating on the eroded and none protected land or leaving to other area because they could not

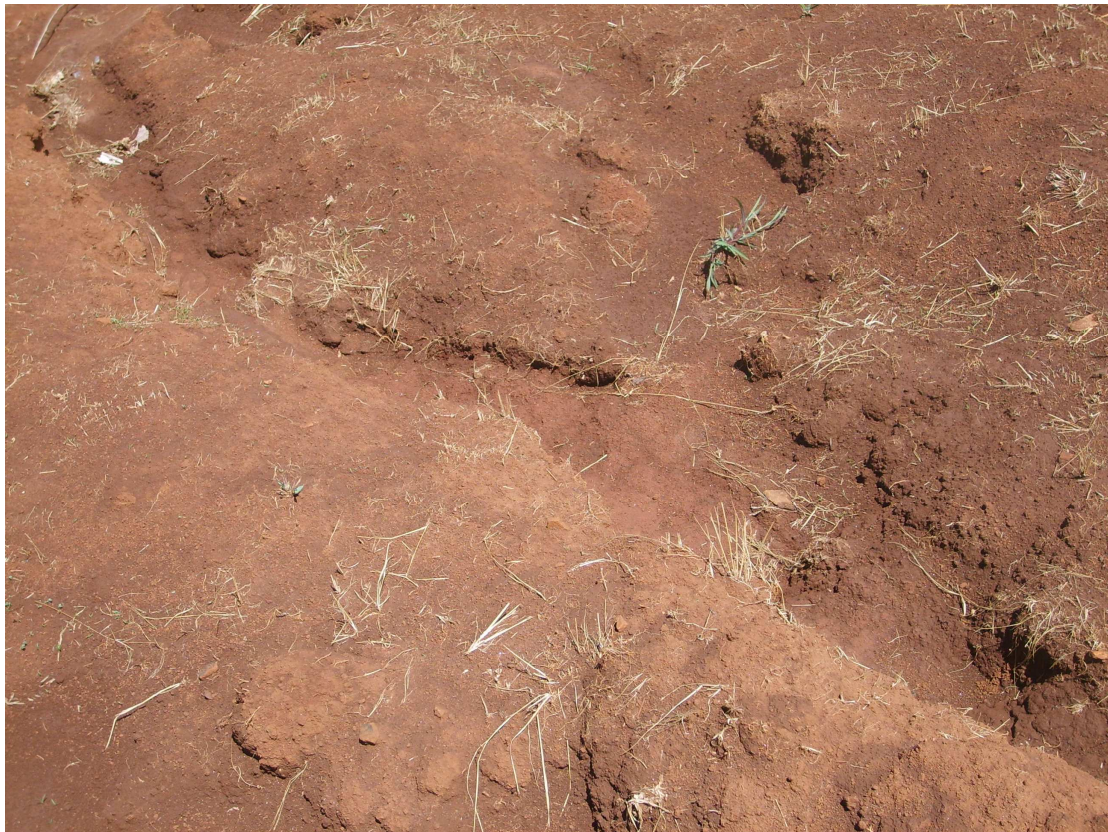
Fig 2.Eroded farm at Gununo before the introduction of soil conservation measures

Looking at this problem and not getting a solution some of the farmers in the area decided to leave their farms and be engaged in off farm activities until research intervention was introduced in to the area. Soil erosion removes top soil (Fig.1), which is the richest layer of soil in both organic matter and nutrient value. Implementing soil and water conservation measures that restrict runoff and erosion minimizes nutrient losses and sustains soil productivity (Bierman and Rosen, 2005). Soil fertility improvement on sloppy lands without soil conservation is unlikely as both mineral fertilizers and organic matter applied can be lost with erosion. Therefore, this study was initiated with the objective of conserving soils by constructing soil conservation measures.

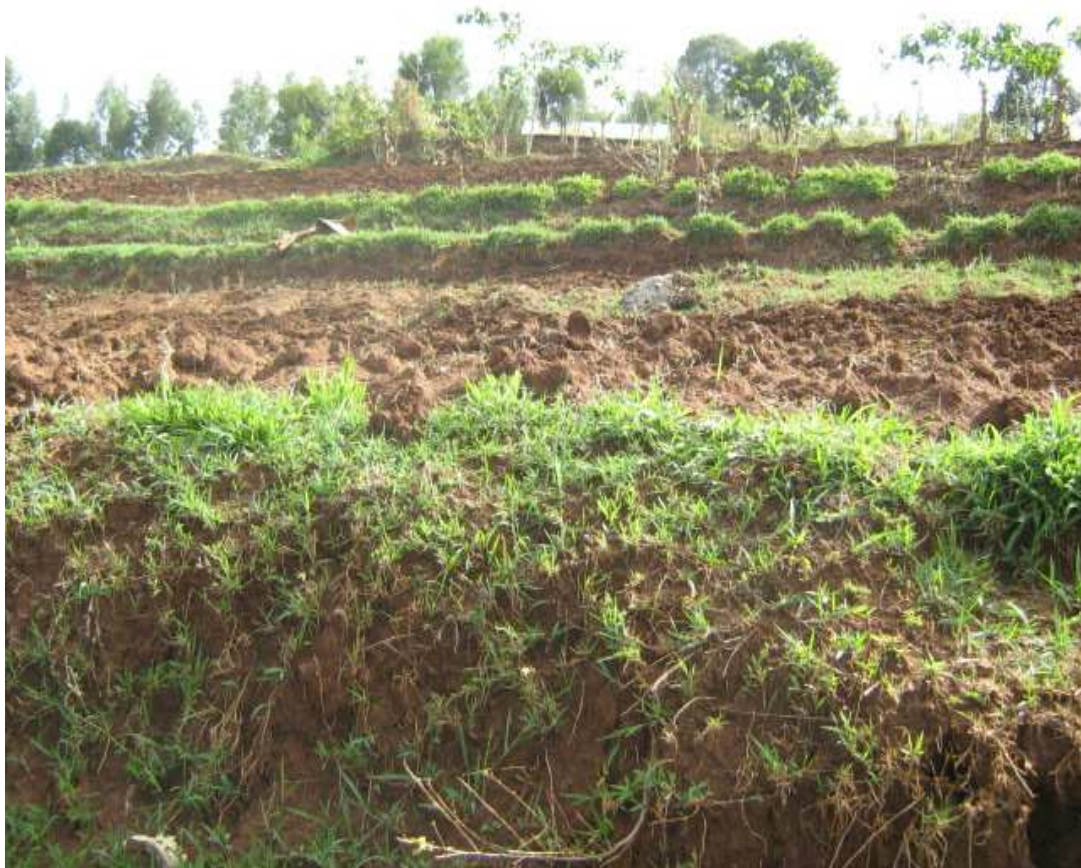
Fig 3. Elephant grass planted on newly constructed soil conservation structure

Forage plants such as Elephant grass and *Sesbania sesban* were planted on the soil conservation structures as stabilizers of the structures. The soil bund stabilizing grass reduced soil losses, improved the availability of organic inputs for soil improvement, and offered animal feed and consequent increase in cash income (Tilahun Amede, 2003). These forage plants are fast growing and the farmers harvested frequently and fed their cattle. The farmers who have these forages at their homestead could not suffer from the shortage of feed as those who had not planted. The plant species also greatly contributed to the stabilization of the soil conservation structure. *Sesbania sesban*, legume plant species, besides being used as bund stabilizers and feed, it was chopped and incorporated in to the soil for improvement of soil fertility.

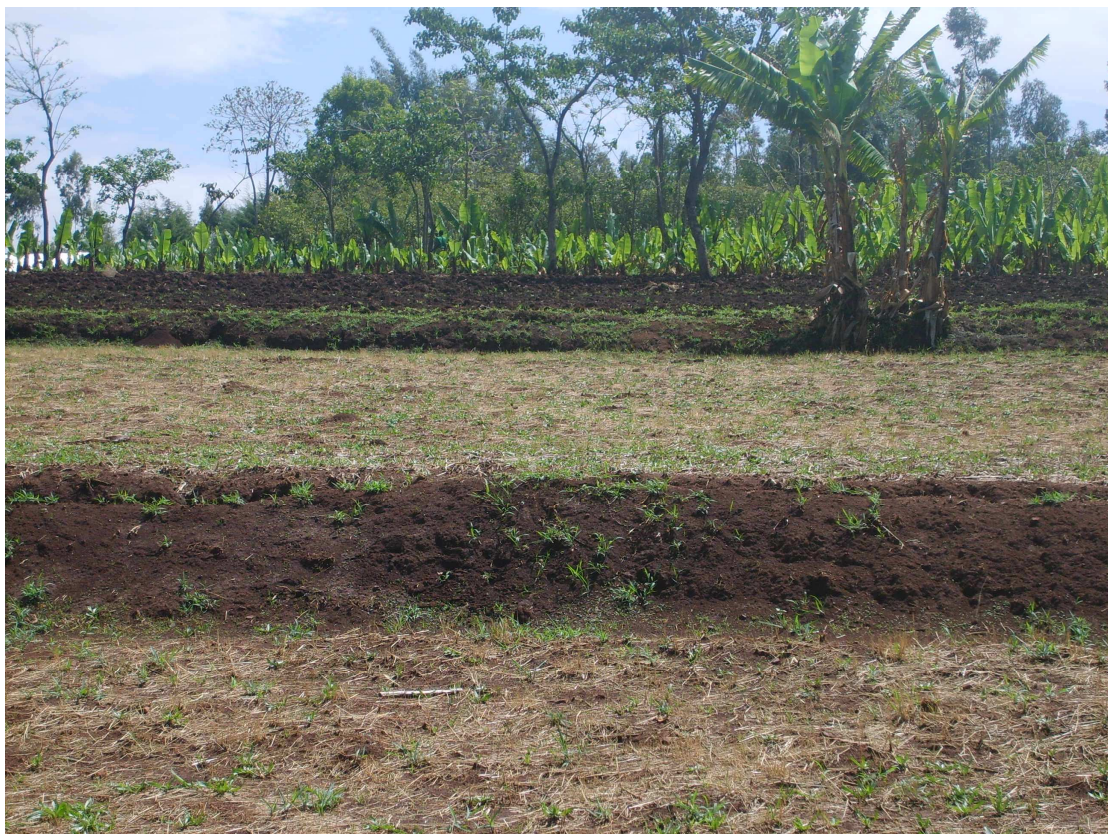
Fig 4. Well conserved farm in Gununo area

Mr. Temesgen said that he prefers the soil conservation technology to all the other technologies introduced to the area. The farmers in the area very well perceived that the soil conservation measure protects the washing away of soil, seeds and fertilizer and thereby increases crop yield. There is no any sign of soil erosion observed on the field, the soil is built up, it became dark, retained moisture well due the construction of the soil conservation measur(Fig 4).
